## STRUCTURAL ASSESSMENT OF THE 13TH CENTURY GREAT MOSQUE AND HOSPITAL OF DIVRIGI: A WORLD HERITAGE LISTED STRUCTURE

**Abstract.** *The Great Mosque and Hospital of Divrigi is located in the central eastern part of Turkey, in Divrigi, Sivas. The historical facility consists of a monumental mosque and a two-story hospital, which are adjacent to each other. The structure dates back to 13th century Mengujekids period and has been listed by the UNESCO as a World Heritage since 1985. Great Mosque and Hospital of Divrigi is particularly notable for its monumental stone portals that are decorated with three-dimensional ornaments carved from stone. The structural system of the monument consists of multi-leaf stone masonry walls and stone piers that support the roof structure which consists of stone and brick arches and vaults. The structure is located about 90 km away from the North Anatolian Fault Line, that has been causing several destructive earthquakes. Consequently, the structure is prone to destructive seismic activities. In this study, after a brief introduction on the structural system and current condition of the structure, the structural performance of the Great Mosque and Hosp

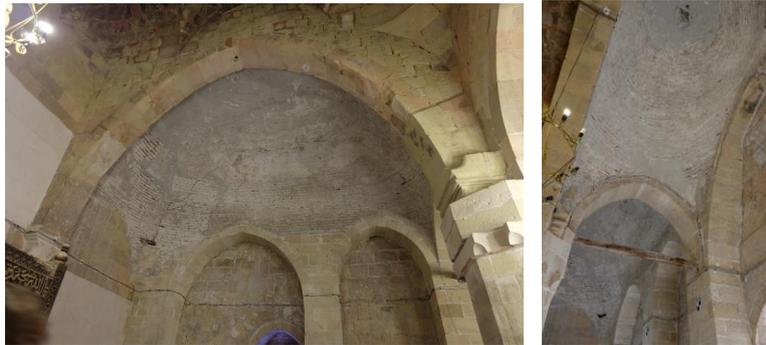
The walls are approximately 1.4 m thick multi-leaf walls with cut-stone outer leaves and a rubble masonry infill. The roof structure consists of stone arches and vaults. The only exception to this use of stone masonry is the brick masonry vaults (Figure 5) covering the areas adjacent to the western façade that are known to be damaged/collapsed and rebuilt together with stone buttresses adjoining with the western façade main wall. Another surviving trace of this incident is the significant out-of-plumb top displacement (almost 60 cm) of the mosque section western façade wall and portal (Figure 6).

**Figure 5:** Brick vaults adjacent to the western façade of the mosque section

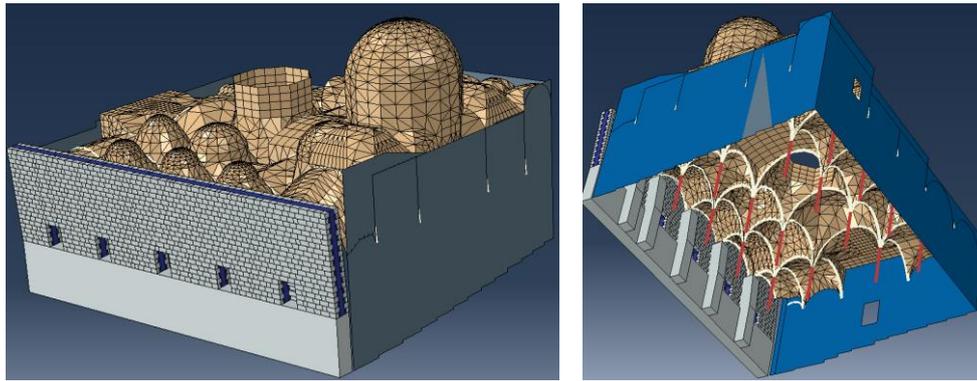
The second FE model was developed by using Abaqus 2019 FE software [4]. As the main purpose of this FE model was to investigate the safety of the tilted part of the western façade wall, the wall and the supporting buttresses (which were added to the inner face of the western façade wall during past interventions) were modeled in detail using eight-node 3D solid elements with simplified micro modeling approach. Material and geometric nonlinearity approaches were adopted in the modeling of the western wall. All other structural components were modeled as in the first FE model described in Section 3.1. Besides the tilted part of the western wall, other components of the structure were included in the model in order to represent the wall boundary conditions realistically. General views of the model are shown in Figure 11. Due to different modeling approaches and the tilted geometry of the western wall, gaps between the western wall and the adjacent walls were present in the model. Nonetheless, kinematic constraints were defined in those regions to provide connection between structural elements.

**Figure 11:** General views of the second FE model

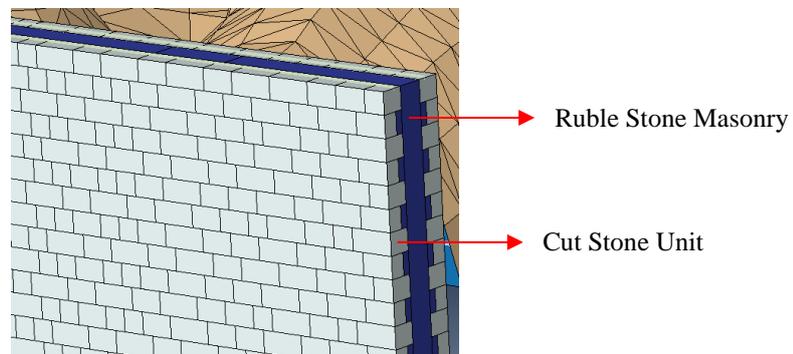
The multi-leaf masonry wall is made of two cut stone masonry units at the exterior and interior faces which are separated by rubble stone masonry units in the middle. Further information on the behavior multi-leaf walls can be found in [5-7]. The dimensions of the examined part of the western wall are 33 meters in length, 12 meters in height. The thickness of the wall is 1.4 meter. The rubble stone masonry was modeled as one solid part, while the cut stone masonry units were modeled as separated micro elements. In order to represent the randomness of the stone unit configuration, different cut stone unit dimensions were assembled in the model. The length of the cut stone units was ranging between 0.40 and 0.80 meter, whereas the thickness of the units was either 0.30 or 0.45 meter. The assembled wall configuration is presented in Figure 12.

**Figure 12:** Wall configuration with different wall unit geometries

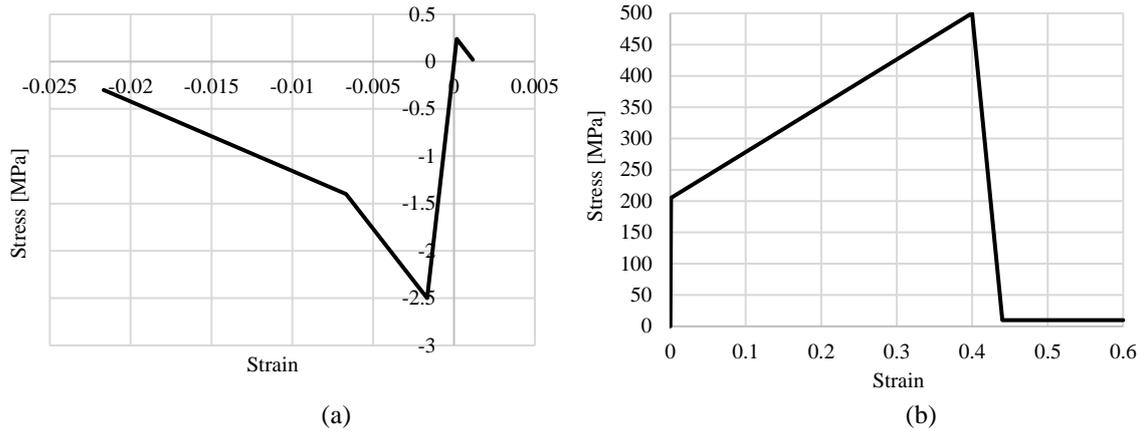
The nonlinear stress-strain relationship for the rubble masonry wall is presented in Figure 13a. The cut stone masonry units were modeled with linear elastic material properties with a Young's Modulus of 2500 MPa. The interface behavior between rubble stone and cut stone units were modeled with nonlinear cohesive-frictional interaction properties. Hard contact was defined between all surfaces in contact. The cohesive-frictional interfaces remain elastic until the normal stress and/or shear stress values at the interfaces reach the specified strength values ( $f_{ti}$  for interface tensile strength,  $\tau_{oi}$  for interface initial shear strength in Table 1). Then, the interactions continue to transfer shear forces with respect to the friction coefficient ( $\mu$ ) and the normal stress ( $\sigma$ ) acting on the surface. Conversely, the interfaces between cut stones were modeled without cohesion and tensile strength as no grout between

**Figure 13:** Nonlinear material properties: (a) Rubble stone; (b) AISI 316

provide ties to whole structure, 50-mm-diameter tension rods with AISI 316 steel class were proposed to connect the vertical components of the structure. The stress-strain relationship of AISI 316 and a view of the planned layout of the steel ties are shown in Figure 13b and Figure 16b, respectively.

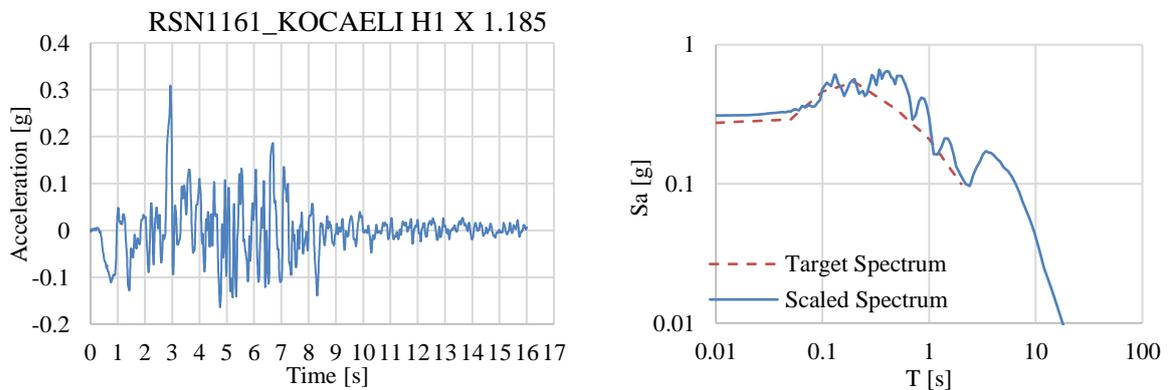
Site-specific response spectrum with 475-year return period was used to investigate the safety status of the western wall against seismic actions with its current condition. As a case study, an acceleration time history record was provided from PEER Ground Motion Database [8]. H1 component of ‘RSN1161’ Kocaeli earthquake record (1999) was selected and scaled by 1.185 to match the site-specific response spectra (Figure 14). The acceleration time history was applied in the out-of-plane (OOP) direction of the western wall. In the time-history analysis, the wall exhibited large OOP displacements which eventually initiated the instability and resulted with the collapse of the wall (Figure 15).

**Figure 14:** (a) Selected acceleration record, (b) target and obtained response spectra
