Failure Analysis of a Total Damage by Hail Impact of an External Thermal Insulation Composite Systems

Abstract. *A hailstorm has heavily damaged a glass fibre mesh reinforced mineral render of an externally insulated composite system (ETICS) of a family house. While a neighbouring house of identical design and of the same age showed only minor defects, for the house under investigation it was a total failure of the render. Material probes were taken from the damaged façade and analysed physically and chemically. Before renovation, the hail resistance of the façade was determined with a unique artificial hail impact test method: Clear ice balls were shot against the façade with the help of a launcher, where the kinetic energy of the projectile can precisely be controlled. The type of damage due to natural hail could be reproduced. The impact energy needed to cause a damage similar to the one caused by the natural hail was determined. The hail impact damage was also identical to results from hail testing performed in the laboratory on similar systems. Since the amount of rendering material on the façade was not according to standards of the Swiss Society of Engineers and Architects

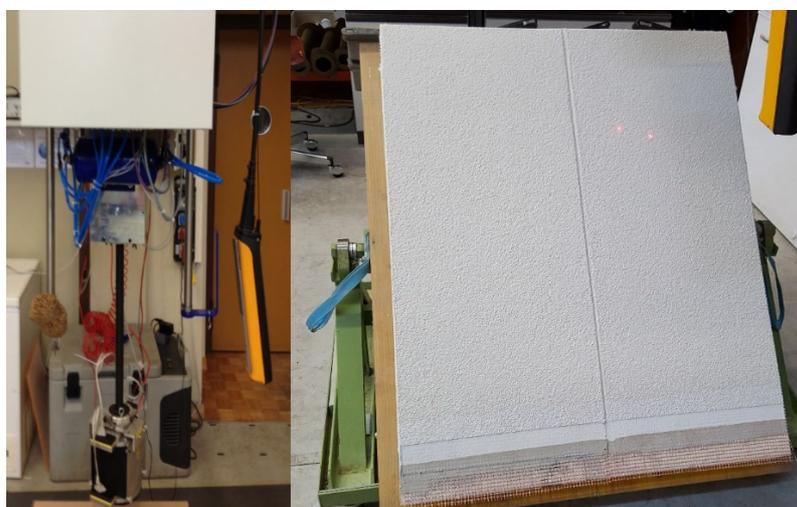
Figure 6. Air gun for artificial hail tests (left) - reference specimen before hail testing (right).

The hail tests were carried out with the Empa air gun for hail testing as well as with the ice ball launcher used onsite, see Fig. 6. The tests were carried out according to CFIA regulation No. 8 (ACFI, 2014). Both specimens were bombarded with 20 mm, 30 mm and 40 mm ice balls, which were made by the melting method from natural ice. The tests were performed at 23 °C / 50 % r.h. The aim was to reproduce the damage caused by the bombardment on the façade and to determine the threshold values for a crack, a full circle fracture and breakouts.
