SLOW-MOVING LANDSLIDE DAMAGE ASSESSMENT OF HISTORIC MASONRY CHURCHES: SOME CASE-STUDIES IN ITALY

CHIARA FERRERO^{1,2*}, LUDOVICA CAMBIAGGI¹, ANDREA FENIALDI¹, PERE ROCA², RITA VECCHIATTINI³ AND CHIARA CALDERINI¹

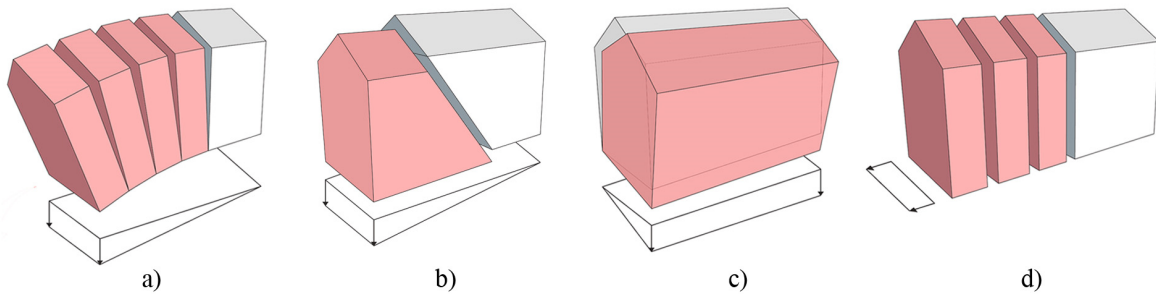
- a. **Hogging.** This damage mechanism can be attributed to a concave-upward bending (hogging) of the structure produced by an incremental vertical ground movement in the direction of the longitudinal axis of the church (Figure 1a). The structure exhibits vertical cracks in longitudinal walls, repeated in each bay. Such cracks progress over the entire height of the wall, increasing in width with height, and continue up into arches and vaults, cutting them transversally. No significant cracks or gaps are observed in the floor.

- b. **Shear deformation.** This damage mechanism can be attributed to a shear deformation of the structure produced by vertical ground movements along the longitudinal axis of the church (Figure 1b). Severe diagonal cracks propagating from the level of the ground are observed in longitudinal walls. A crack/gap in the floor can propagate between the cracks occurring in the opposite longitudinal walls.

- c. **Global rigid rotation.** This mechanism is related to an incremental vertical ground movement along the transversal axis of the church (Figure 1c). Along this direction, the church is quite stiff and tends to rotate as a rigid body. There may be cracks, but the most relevant effects are (i) the out-of-plumb of longitudinal walls, (ii) the distortion of transverse arches, and (iii) the inclination of horizontal elements such as tie-rods, balustrades, steps and floors.

- d. **Extension.** This mechanism is related to the horizontal component of landslide movement (Figure 1d). In this case, the structure exhibits multiple parallel diagonal cracks in vaults and floors, oriented in the same direction. In addition, severe vertical cracks occur in walls in planes perpendicular to the landslide direction. It is observed that these cracks propagate from the level of the ground and cut the structure over its entire height from floor to vaults, thus indicating that the church suffered extension in the direction of the acting landslide.

Figure 1: Global damage mechanisms identified in [1]: a) Hogging, b) Shear deformation, c) Global rigid rotation, d) Extension.
