## MODERN CONSOLIDATION METHODS FOR CATHOLIC CHURCH IN BAROQUE STYLE FROM ARAD FORTRESS, ROMANIA

ALEXANDRU C. ION<sup>1\*</sup> AND MARIUS MOSOARCA<sup>2</sup>

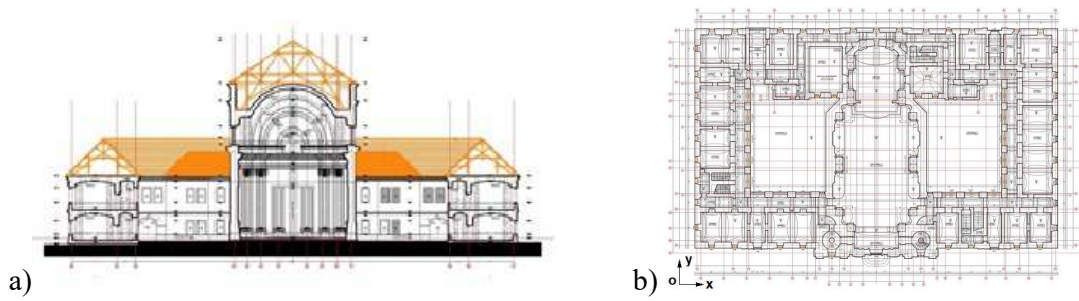
**Figure 2:** a) Monastery section, b) Monastery plan

The Franciscan Monastery (Figure 1) is made out of three different buildings (Figure 2): the Church of the Monastery and two side structures with two floors where the Franciscan monks had their cells. The bearing structure of the church is made out of masonry walls which are 1.5m thick. The foundations of the structure are made out of masonry and are continuous underneath the structure. The thickness of the walls of the towers is also 1.5m. At the entrance of the church there is a masonry vault that is supported by an RC arch, which was an unauthorized intervention, and the wall of the main façade. The RC arch is supported by four 30cm thick RC pillars. The entire church is covered with masonry vaults. Over the vaults there is a wooden bearing structure of the roof and the roof cover. The wooden cover of the roof is made out of props and templets which have the section dimensions of 20cm x 20cm and rafters and braces which have the section dimensions of 15cm x 17cm.

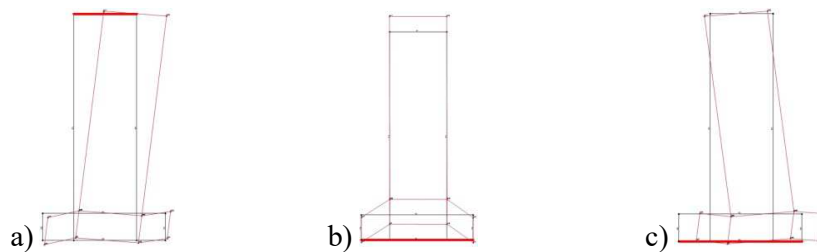
The analysis was created for peak ground acceleration of 0.20g according to the Romanian seismic code P100-1/2013. The vibration modes of the structure are shown in Figure 6. The vibration modes of the structure indicate a predominant solicitation of general torsion.

**Figure 6:** The vibration modes of the structure: a) the first mode: torsion,  $T_s = 0.518$  sec, b) the second mode: translation,  $T_s = 0.454$  sec, c) the third mode: torsion,  $T_s = 0.431$  sec

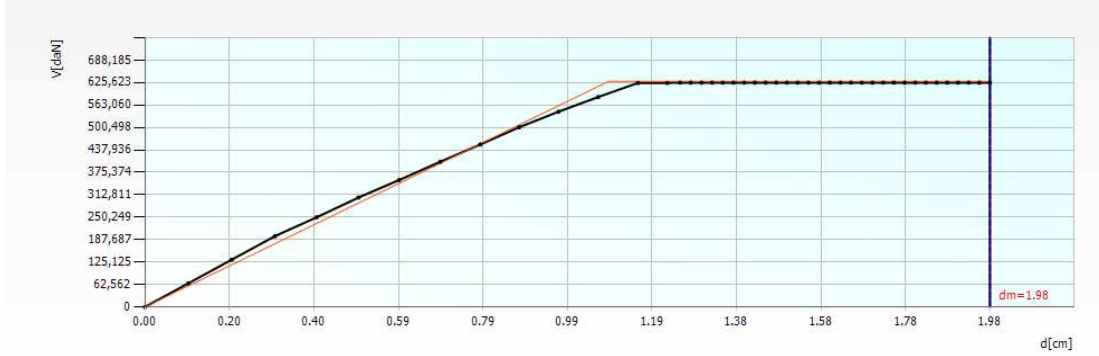
**Figure 7:** The force-displacement diagram, when the seismic force is applied on the Ox axis

On the Ox axis of the church the maximum horizontal displacement of the tower is 2 cm and the maximum shear force is 6200 KN as shown in Figure 7.

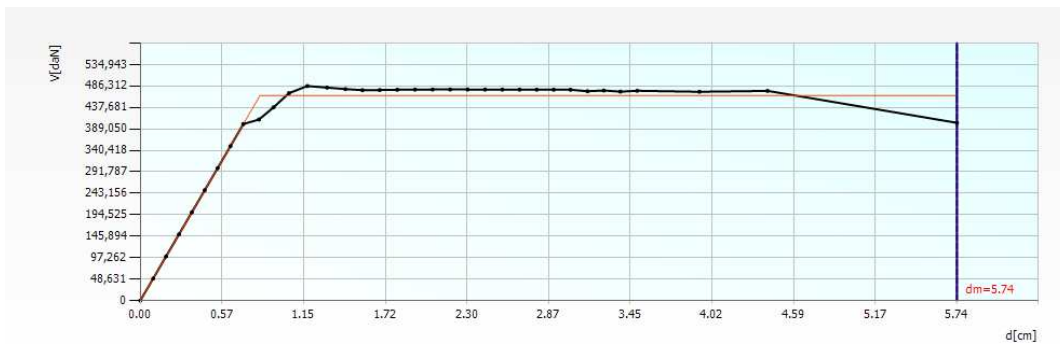
**Figure 9:** The force-displacement diagram, when the seismic force is applied on the Oy axis

On the Oy axis of the church the maximum horizontal displacement of the tower is 5.7 cm and the shear force is approximately 4800 KN as shown in Figure 9.

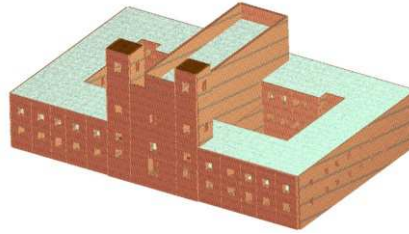
**Figure 11:** 3D model of the aggregate: church and monk cells

The second step was to realize another push-over analysis which contains the church in aggregate with the two side buildings that contain the cells of the monks. The 3D model is displayed in Figure 11 [8].

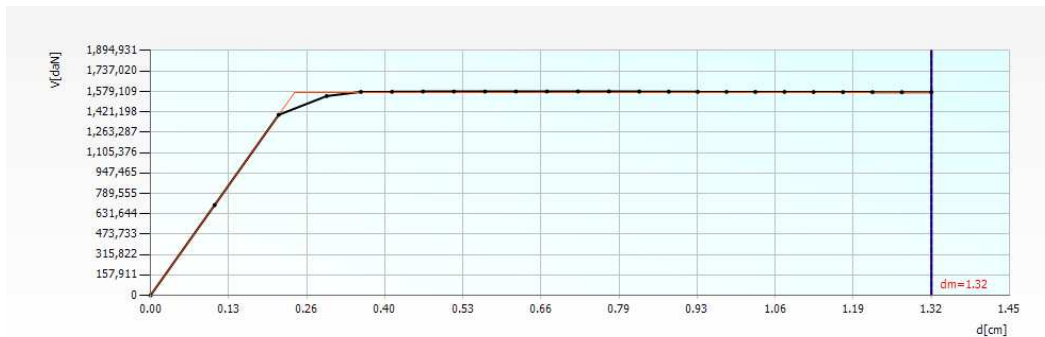
**Figure 12:** The force-displacement diagram when the seismic force is applied on the Ox axis

On the Ox axis of the monastery (Figure 12), the maximum displacement of the tower is 1.30 cm and the shear force is 15000 KN. Comparatively to the model where the church is modeled alone the maximum displacement decreased from 2 cm to 1.30 cm and the total shear force raised from 6200 KN to 15000KN.

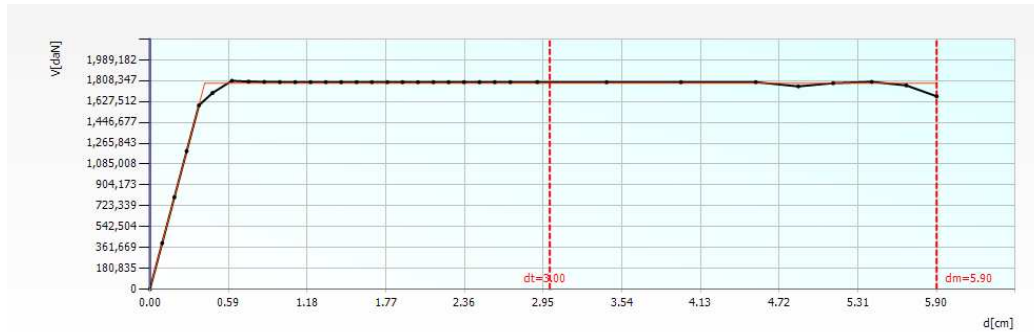
**Figure 14:** The force-displacement diagram when the seismic force is applied on the Oy axis

On the Oy axis of the monastery (Figure 14), the maximum displacement is raised from 5.70 cm to 5.90 cm and the shear force is raised from 4800 KN to 18000 KN.

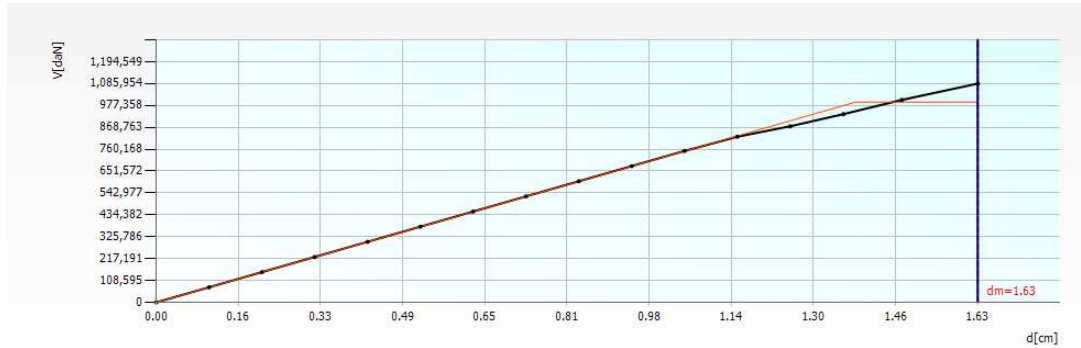
**Figure 20:** The force-displacement diagram when the seismic force is applied on the Ox axis

The analysis indicates that on the Ox axis (Figure 20), the shear base force grew to 10800 KN, and the horizontal displacement at the top of the tower went down to 1.60 cm.

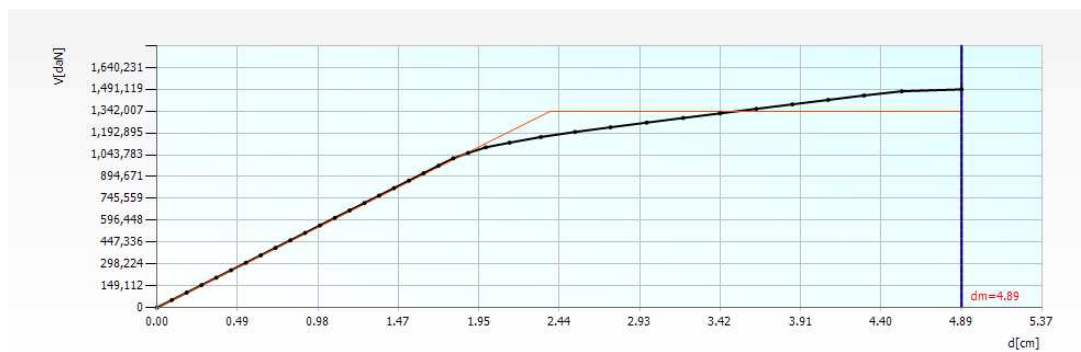
**Figure 22:** The force-displacement diagram when the seismic force is applied on the Oy axis

On the Oy axis the force-displacement diagram indicates (Figure 22) an increase of the base shear force to 15000 KN and a reduction of the horizontal displacement of the tower to 4.9 cm.
