SELECTED PROBLEMS REGARDING CONSTRUCTION OF LIGHTWEIGHT MOTORCYCLE SWINGARM

WOJCIECH NOSKO¹, MIROSLAW W. MRZYGLÓD²

Abstract. Manufacturers of light motorcycles have always sought the use of more and more advanced materials. The application of carbon fiber in motorcycle parts design can bring high strength, stiffness, and low weight in a manner previously unavailable. This article contains selected problems regarding the construction of a swingarm made of carbon fiber reinforced plastics (CFRP). The swingarm was made specifically for Honda NSF 100. For the analysis, series of tests such as geometry, FEM, and structural analysis was chosen. The analysis concludes that the swingarm shape that was adopted from the original steel made part is not suitable for CFRP use. The analysis showed manufacturing errors, like the inconsistent thickness of laminate and poor quality of assembling. The full potential of the CFRP material was not used.

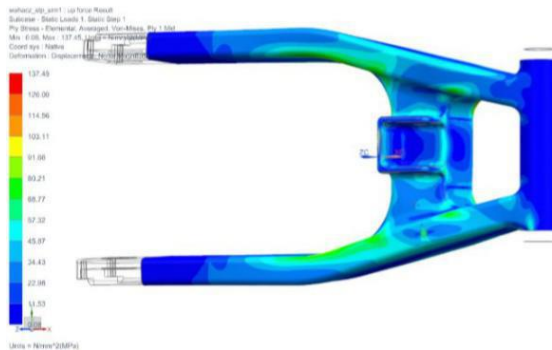
Figure 14: Von Mises stress in ply 1

Stress in plies is presented in Fig. 10-13. The changes and transition of stress in plies can be observed. Starting from ply 1 where the highest stress occurs in the mounting hole, finishing on ply 8 where the high value of stress (698 MPa) appears in the first hole from the left side of the swingarm. An increase of stress can also be seen in the area of suspension damper mounting (Fig. 14-17). Though stress around the damper mounting area is within the acceptable limit, it shows that there is a possibility for design optimization.

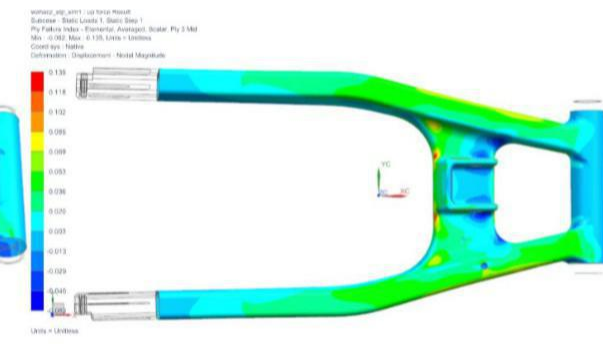
Figure 19: 3k fabric laminate ply 3 failure

Laminate ply failure analysis results are shown in Fig. 18. A safe 0.3 rate of destruction was applied. As seen on summary analysis safe rate is not exceeded and is 0.166. The biggest difference in stress and what follow safe rate is between 3k, and 12k type prepreg fabric used to build laminate thickness (Fig. 19-21) This behavior proves proper calculation results as the stiffness of 12k two layers laminate with a summary thickness of 1.04mm is higher than 3k three layers of summary thickness of 0.6 mm. Therefore, such disparity may be the reason for delamination on the border between ply numbers 3 and 4, 5 and 6. By laminating stiffer fabric on the top (12k over 3k) where stress which came from the load is highest such difference in stress distribution across laminate composition could be avoided.

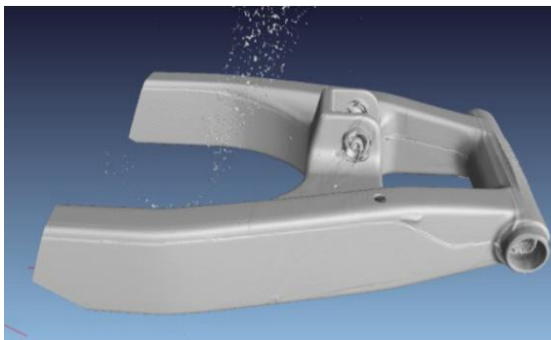
Figure 23: 3D model: view of right side

Structural analysis of swingarm was conducted to determine the quality of laminate. The internal structure analysis was conducted with the use of tomography Metrotom 1500 of Carl Zeiss company. At first, the 3D model was created by use of tomography, and with-it internal structure was revealed. In Fig. 23 and 24, different views of the same 3D model are shown.
