THE RESTORATION OF THE MEDIEVAL WALLS OF SAN GINESIO: A DEDICATED STUDY FOR THE CONSERVATION, REPAIR AND ENHANCEMENT OF AN IMPORTANT MILITARY FORTIFICATION

M. SARACCO^{1*}, F. MARIANO², A. A. GIULIANO²,
L. PETETTA² AND F. PICCININI²

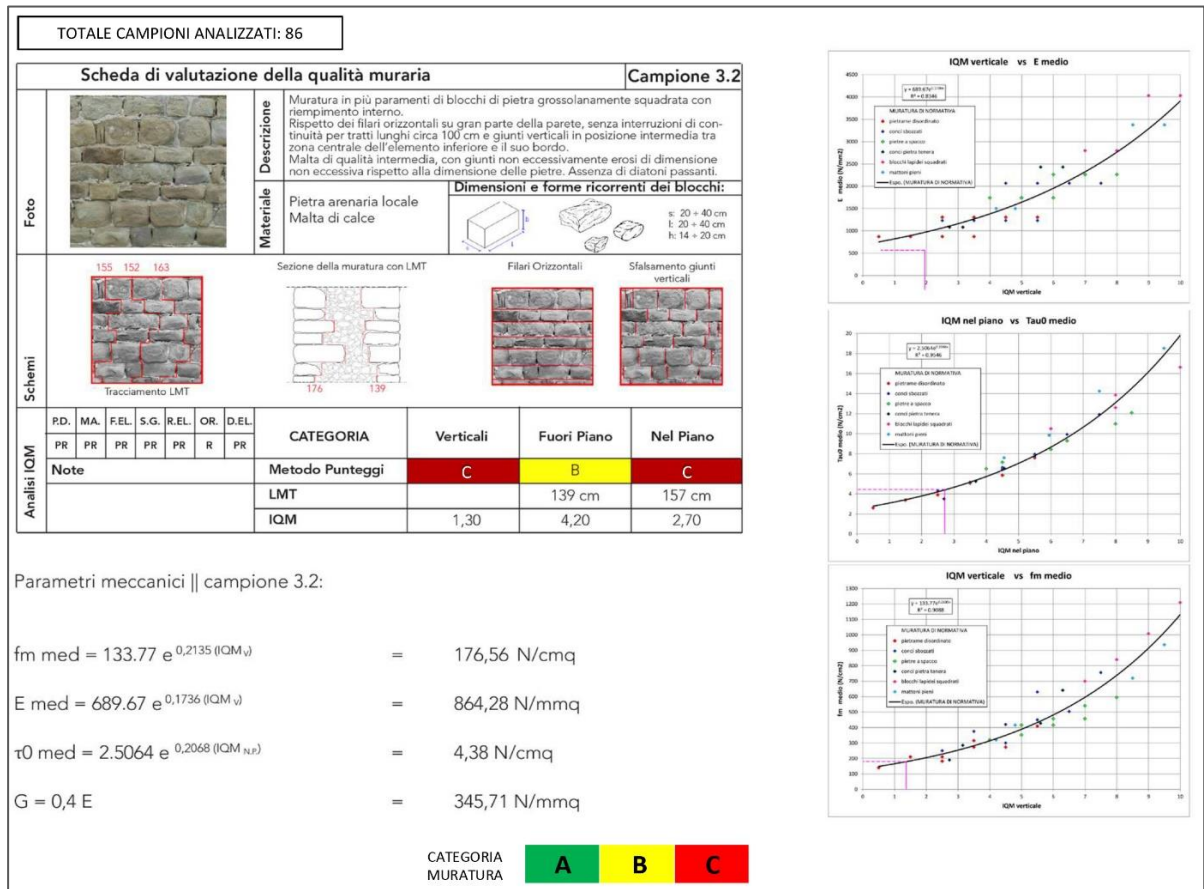
The calculation of IQM was carried out on all masonry samples surveyed, (so in three samples for each type of masonry) to obtain representative average values. The results showed low and medium, masonry quality indices in block 1, both for vertical loads, both for those horizontal in-plane and out of plane, while the situation in blocks 2 and 3 was appeared better, since only a single section has obtained a low masonry quality index for all expected loads (vertical, horizontal out of the plane, horizontal in the plane).

Figure 8: IQM analysis sheet, made for each sample of masonry detected. On the right, the correlation curves with the mechanical values, taken from Italian Technical Code 2008, tab. C8.A.2.
