HISTORICAL TIMBER STRUCTURES IN ADANA-TEPEBAĞ SETTLEMENT AND CONSOLIDATION APPROACH WITH MODERN TIMBER PREFABRICATED SYSTEMS

KERİMCAN APAK ¹

¹Adana Alparslan Türkeş Science and Technology University

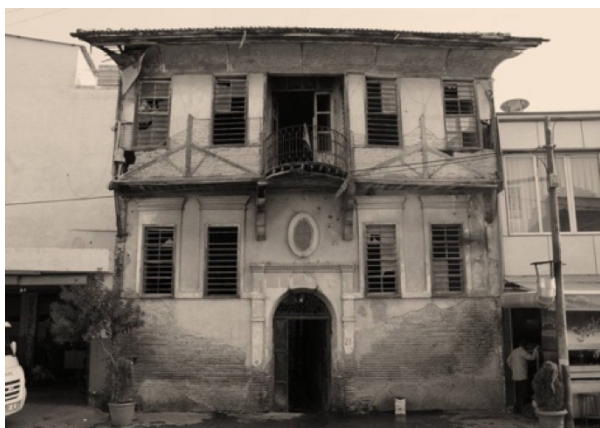
Figure 2: Adana-Tepebağ case study house, inventory number of the house is 152 [1].

On the ground floor, three spaces that are surrounded by masonry walls had some cracks. Those cracks are on the plaster, and they are not getting inside of the load-bearing structural system. However, the masonry walls, which are located on the first floor, especially the north wall, had deep cracks. Those cracks are affected the stability and bearing capacity of the first-floor load-bearing system (Figure 6). The north wall and the side walls are separated from each other, and it caused instability of the structure. These cracks and separations are occurred by seismic activity. Nevertheless, against the seismic forces, diagonal timber beams are used on the north loadbearing brick masonry wall (Figure 2) [1].

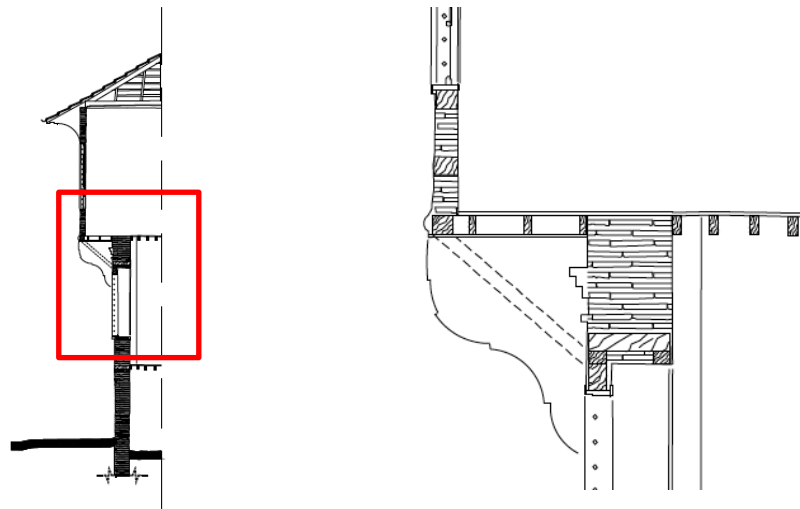
Figure 3: Adana-Tepebağ case study house: On the right, system detail, and on the left timber floor, load-bearing wall and oriel joint detail are shown [1,13].

The case study of this research is chosen from the historical timber house in Tepebağ-Adana. The inventory number of this building is 152 in the archives of the Adana endowment office. This building is composed of ground, mezzanine and first floor with load-bearing walls. The load-bearing wall is composed of 20cm x10cm x5cm mixed brickwork with 10cm x10cm timber tie beams. Each floor is constructed with timber beams covered with timber finishing plate materials (Figure 3).
