SEISMIC RETROFITTING OF HISTORICAL MASONRY HERITAGE STRUCTURES: A CASE STUDY OF AN ADOBE MASONRY BUILDING IN LIMA, PERU

TIAGO MARTINS^{1*}, JULIA GARCÍA¹, ALEJANDRO FERRÁNDEZ¹, NICOLA
TARQUE² AND JAIME FERNÁNDEZ¹

2.3. Damage survey

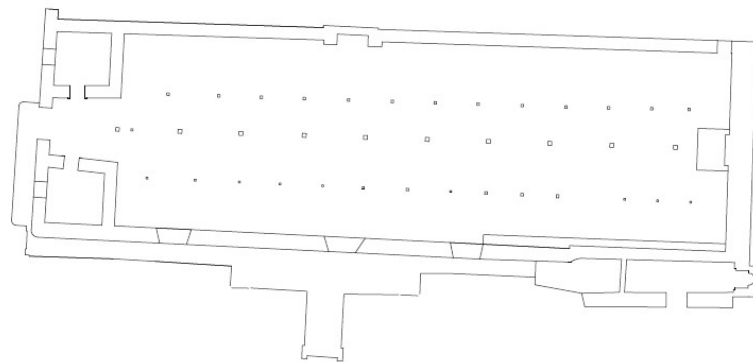
Figure 4. First floor (Source: Escuela Taller de Lima, 2007).

The wooden beam is supported by various wooden pillars along its length, represented by the circles in the middle of the main space in Figure 4 . The two lateral alignments of circles represent the struts that were added afterwards to avoid collapsing.

The damaged wood beam shall be removed, and the wooden girders repaired or replaced in order to allow a central open space without the multiple struts currently present in the structure.

The already mentioned inclusion of porticos will reduce the number of pillars needed for the central beam, giving the interior more usefulness.
