**Initial Building Investigations at Aberdeen
Proving Ground, Maryland: Building E5375**

ANL/ESD/TM-56

by K.L. Brubaker, J.M. Dougherty, and C. Tome

June 1993

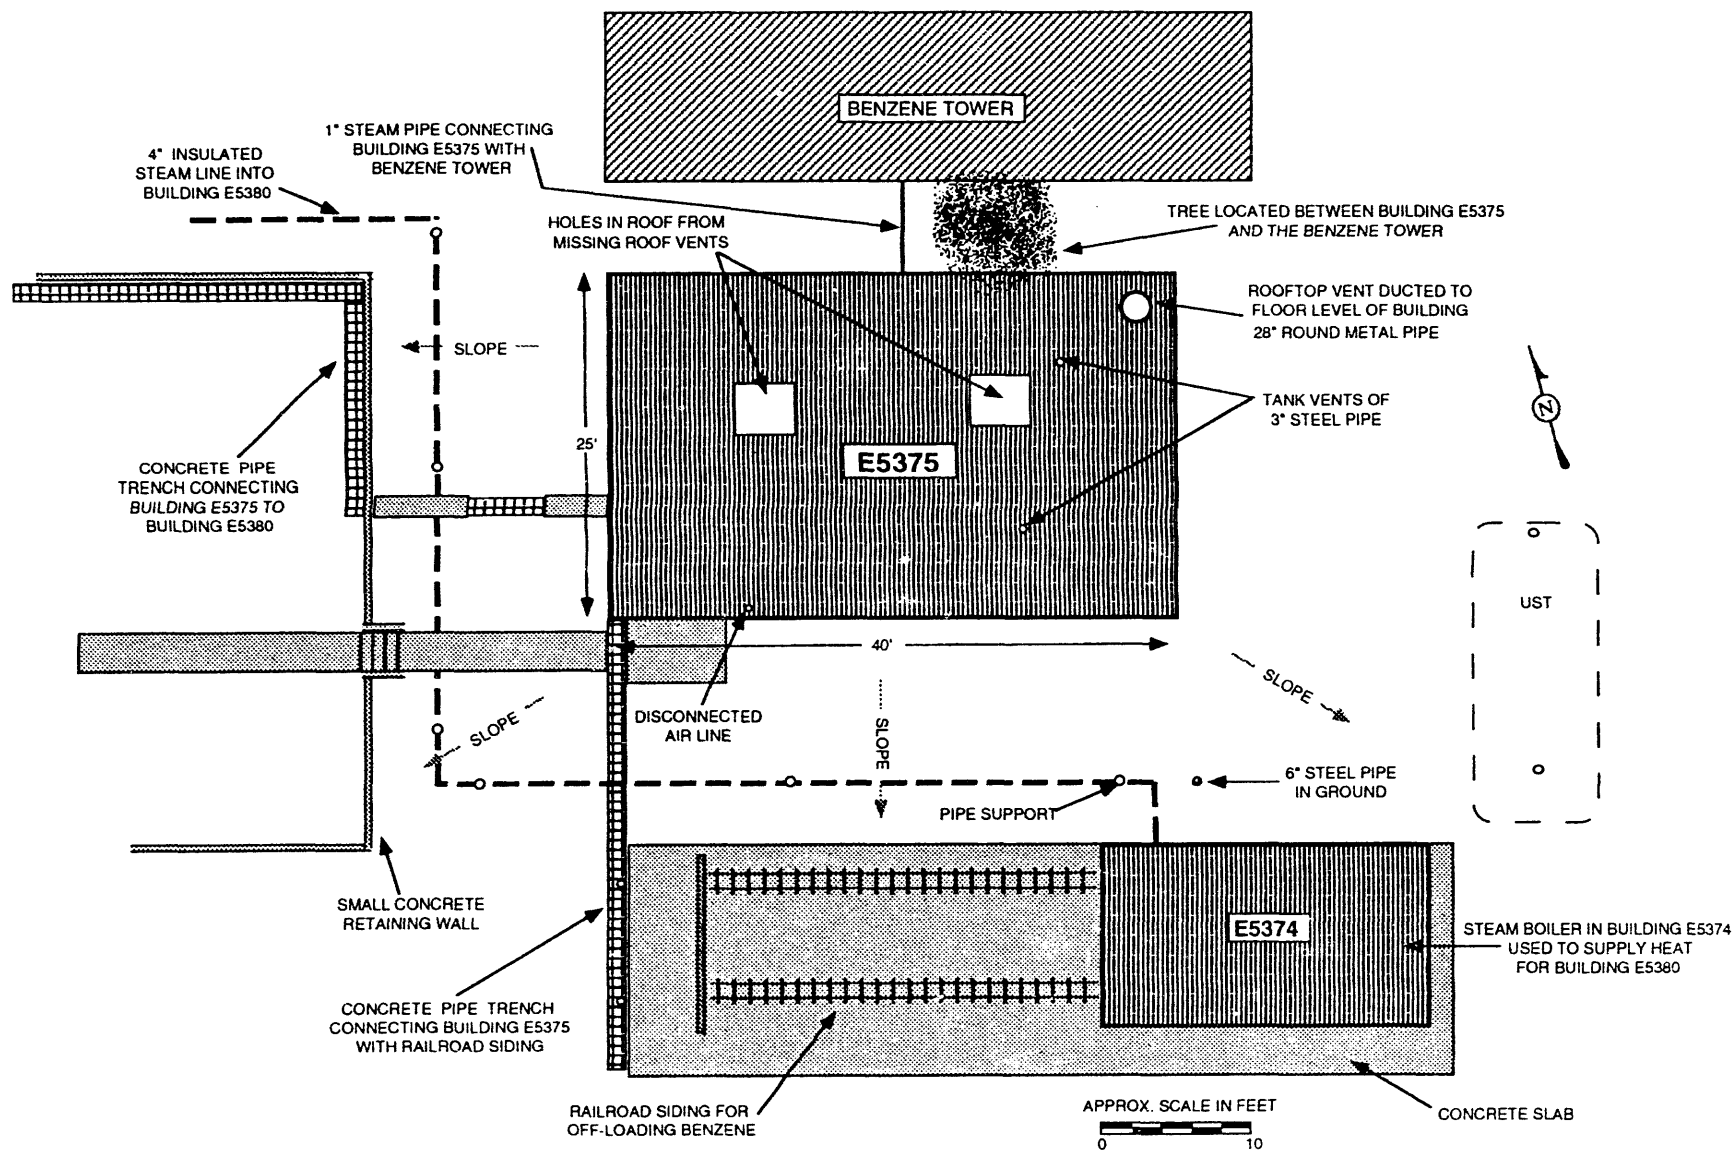
FIGURE 4 Building E5375 Site Plan

Building E5375 is connected to the CN production facility, Building E5380, by a below-grade concrete pipe trench covered with removable 1/4-in. diamond-plate steel panels, each about 4 ft long (Figure 4). This trench extends from the west side of Building E5375 for approximately 80 ft and enters the east side of Building E5380. The trench still houses two 2-in. pipes that were used to supply benzene when this facility was operational. The pipe trench is constructed of cast-in-place concrete approximately 3 in. thick \times 24 in. wide. Building E5375 is also connected to a two-track railroad siding 30 ft south of the building by a similar pipe trench (Figure 4); the present number and size of the pipes in this trench are unknown, but provision is made in the steel cover plates for a connection to each of the two railroad tracks. An existing engineering drawing (Whitman, Requardt, and Smith Engineers 1941a) shows that, at one time, three pipes connected Building E5375 with Building E5380 and that two pipes were present in the trench to the railroad siding. In each trench, one of the lines was a steam line. The railroad siding is no longer operational. The siding appears to have been the point where benzene was pumped from railroad tank cars into the storage tanks located in Building E5375. The depth of the two pipe trenches could not be accurately determined at the time of the building inspection because they contain silt and, in some areas, large patches of poison ivy, but they are believed to be no more than 20 in. deep.

Approximately 40 ft to the southeast of Building E5375 there is an underground storage tank. APG records indicate that this tank is a 10,000-gal fuel-oil storage tank (APG No. 91606) for a steam boiler located in Building E5374 (Figure 4) and is not associated with Building E5375.

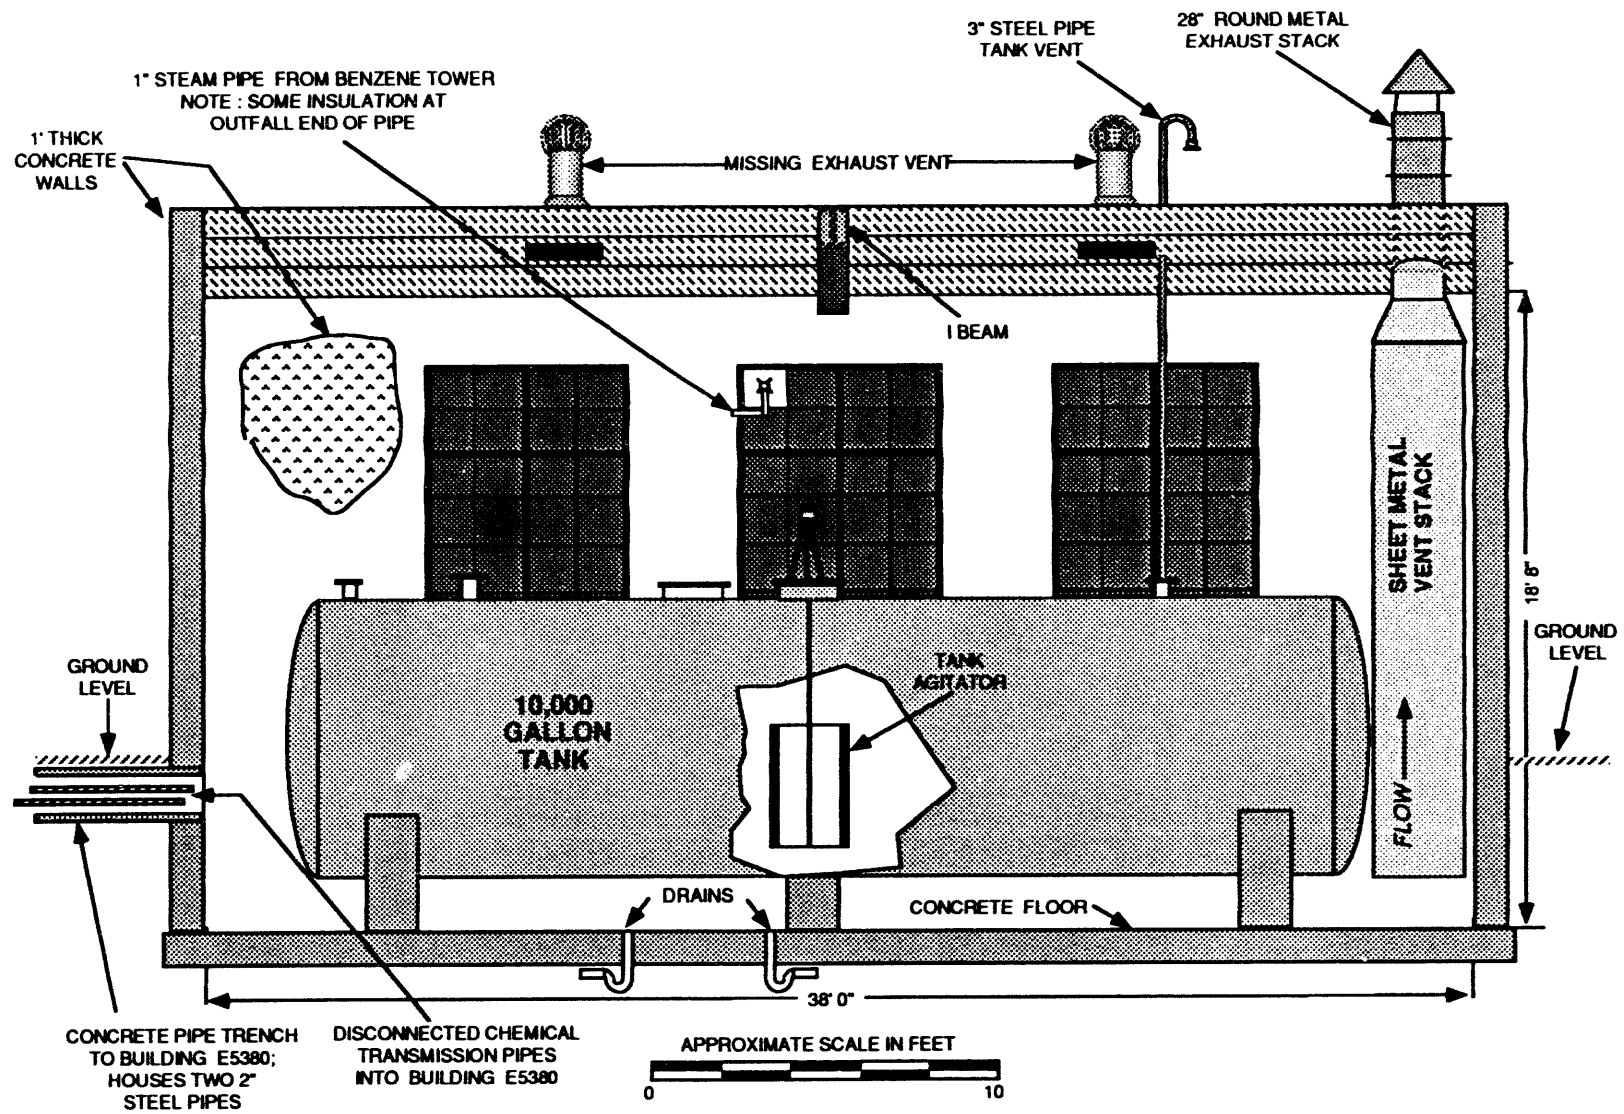
FIGURE 10 Building E5375 North Interior Elevation

Tank No. 1 is a cylindrical, welded-seam, steel tank, with an approximate capacity of 10,000 gal, that is oriented horizontally and parallel with the long axis of the building. The side of this tank is approximately 4 ft from the north wall. The tank has five connections in the top, four of which are capped (Figure 9), and has no other drain or pipe connection; from west to east, the first is a 1-1/2-in. capped connection, the second is a 6-in. capped connection, the third is an 18-in. capped portal, the fourth is an 18-in. portal containing a device that appears to be an agitator or stirrer, and the fifth is a 3-in. connection to a 3-in. pipe that extends upward through the roof (see Figure 10). All connections utilize a type of flanged connection hardware that is typically used when the contents of the piping will be under significant pressure.

Refer to Section 4.7.2 for a description of the wall characteristics. See also Figure 10.

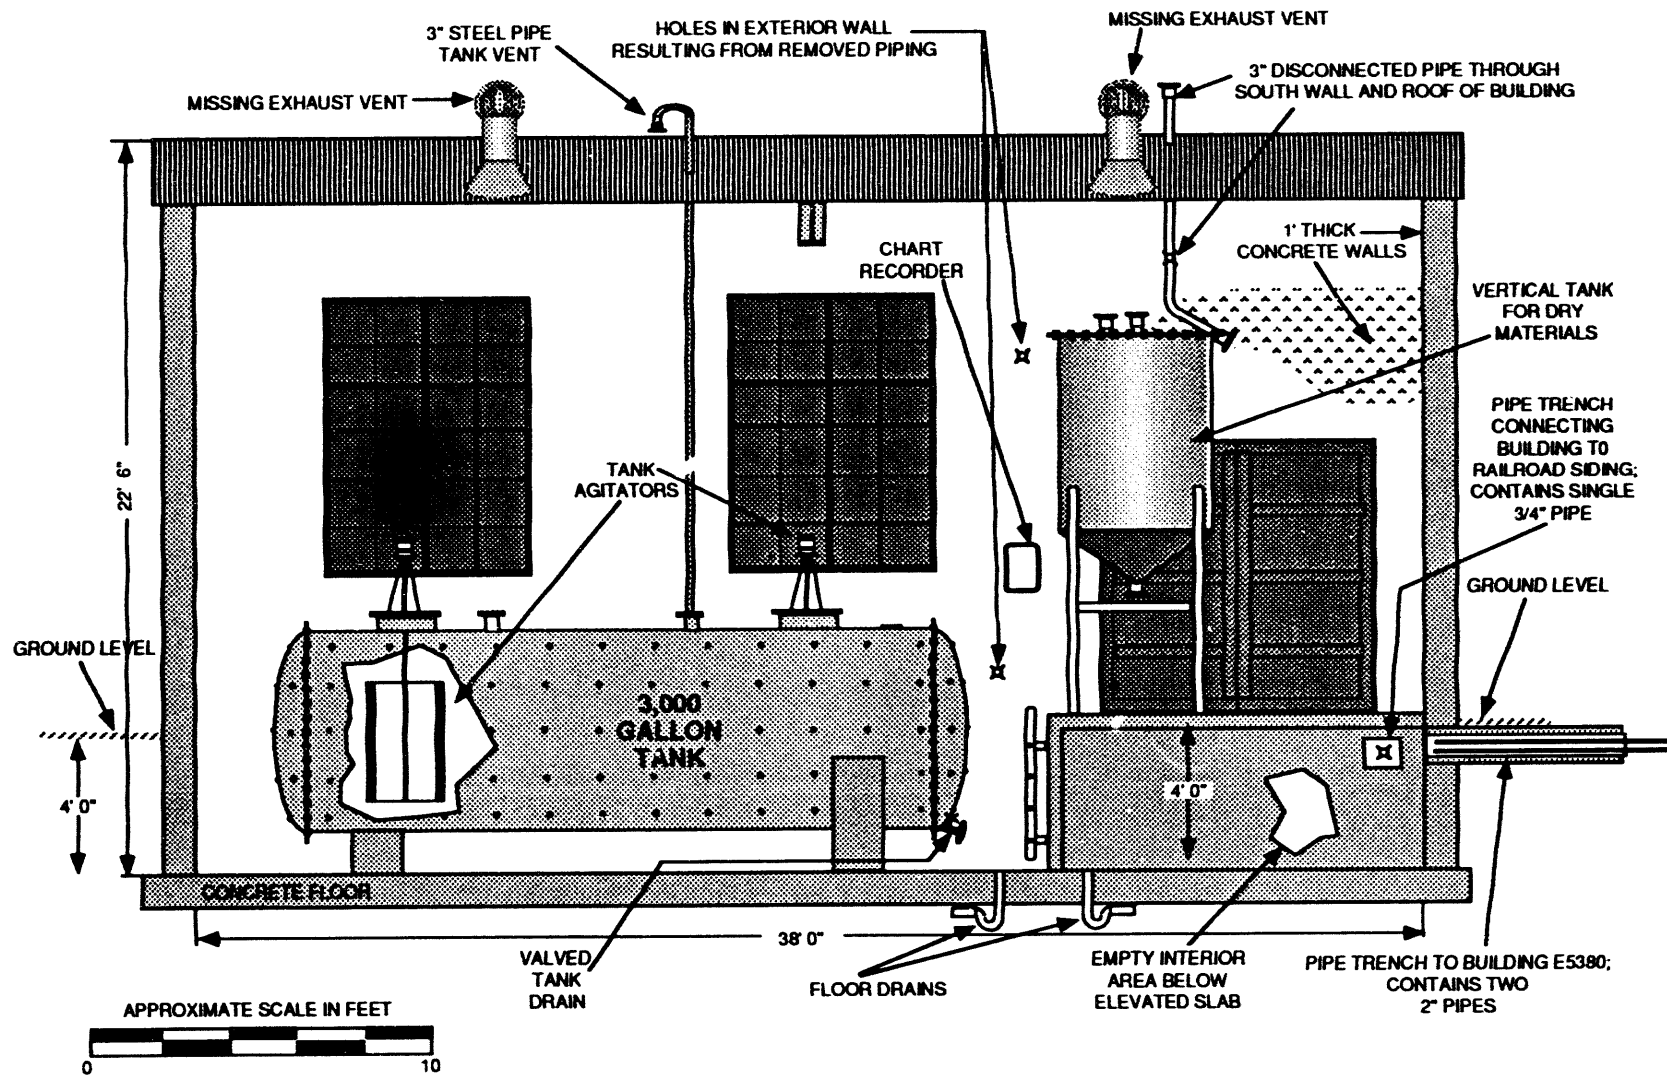
FIGURE 12 Building E5375 South Interior Elevation

In the southwest corner of the building, there is a 7 ft × 12 ft concrete platform elevated approximately 4 ft above the floor. The main entrance to the building leads onto this platform. A ladder leads down to the floor level of the building (Figure 13). This platform seems to have been the main work area within the building. The area underneath the platform is empty, unused space. One 3/4-in. high-pressure steam pipe that was used in off-loading benzene from tank cars on the railroad sidings extends through a hole in the north side of the platform structure (Whitman, Requardt, and Smith Engineers 1941a; see also Figure 12).

Tank No. 3 in Building E5375 is a cylindrical, welded-seam, steel tank with a conical bottom that is mounted on supports attached to the elevated platform at the entrance to the building (Figure 12). The capacity of this tank is approximately 500 gal. Two 2-in. open flanged connections are on the top of the tank.
