CLAUDIUS AQUEDUCT IN ROME - KINEMATIC ANALYSES AND EMPIRICAL EXPERIENCES FOR THE DEFINITION OF STRUCTURAL RESTORATION INTERVENTIONS

FABRIZIO DE CESARIS¹

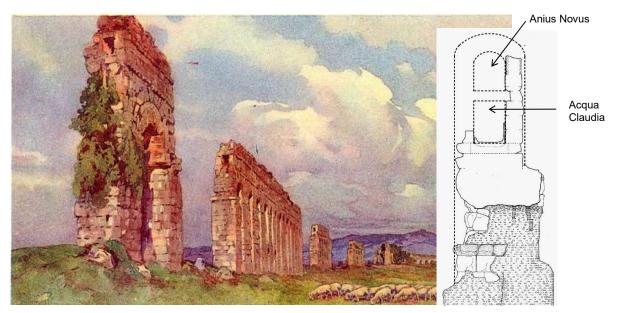
Figure 1: Historical image of the Aqueduct in a late 19th century watercolor. The typical cross section of the upper part of the Aqueduct is re-represented (archway, Claudius and Anius Novus water hydraulic conduit).

The masonries of the Claudio aqueduct were built exclusively in blocks, mostly of peperino, which is a volcanic sedimentary stone. Even though the architectural design of the arches has a rational rhythm, the size and quality of the blocks is completely heterogeneous in shape, size and quality. Modification, consolidation and reinforcement works already started in the 1st century. The constructive phases of the structure are characterized by the almost immediate overlap of the Anius Novus conduct. The use of the existing supporting structure for a double channeling follows other previous examples, but the Anius Novus is made of rubble masonry with sides in *opus mixtum* and is conserved only in minimal residual portions (fig. 1, right).
