## SEISMIC ASSESSMENT OF HERITAGE BUILDINGS IN BULGARIA

**Keywords:** Historical Structure, Seismic Assessment, Computer Modelling

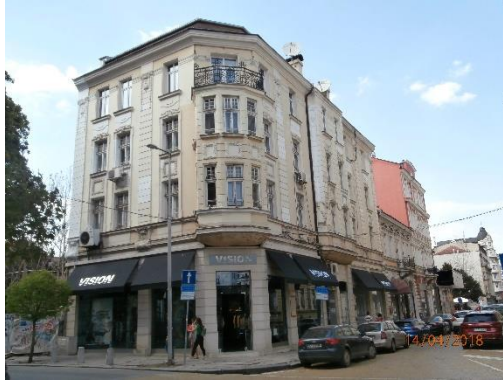
**Figure 1:** “Lege Palace” – actual view [11]

According to the standards in use, the checks for the displacements are basic for the assessment of the structural behaviour. Usually, for existing structures, the control of the damages as a result from excessive displacement are definitive for the behaviour. The results show that the displacements for the biggest part of the vertical elements (for the seismic combination) are not in the limits given in the standard. Analyzing the normal forces in the elements, it was found that the real value of the normal forces in the vertical elements also exceeds the maximum capacity of the elements.

The results of the seismic assessment show that the bearing capacity of the vertical structural elements is reached and for some elements even exceed the limit. The displacements of the biggest part of the vertical elements are bigger than the prescribed limit value. That is the reason to recommend to the Investors to keep the structure without further changes and to strengthen the original structure using the results of the analysis.

The provided checks show that the building needs remedial measures for the damaged elements but any future changes in the structure will affect significantly the safety. It is not recommended to make any interventions without a special design for the strengthening. Special care is necessary for the foundations. The observed high level of moisture in the basement requires the execution of waterproofing insulation.

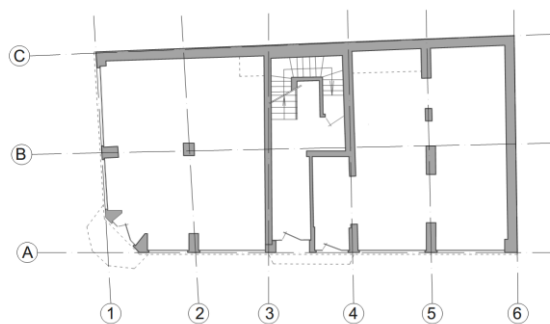
**Figure 2:** Plan of the ground floor (Lege Palace) [10]

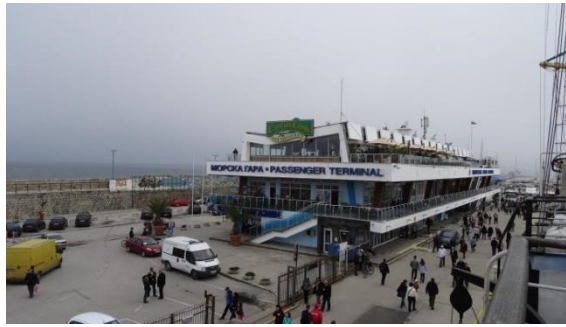
**Figure 4:** Marine Station, Varna - actual view [11]

For the structural seismic assessment a few numerical models in SAP2000 (Figure 5) are analyzed, using finite elements. The first 3 modal periods according to EC8 and the Bulgarian standards are practically the same. The elastic story drifts exceed the prescribed limits. The comparison is done according to EC8 [9] and according to the actual Bulgarian regulations [8].

Despite the overall relatively good condition of the building, the structure is seriously endangered because of the very active processes of carbonization of the concrete and the reinforcement (Figures 6). The high level of carbonization results from the high humidity and the aerosol impact of seawater.

Adjusting the building structure according to the contemporary standards is not possible for the following reasons: 1) Actual condition of the construction materials; 2) Lack of precise information for the detailing; 3) The parameters of the seismic performance- modal periods, story displacements, are not in accordance to the prescribed recommendations and limits; 4) The numerical checks show that serious number of structural elements are at the limit of the load-bearing capacity determined by the standards or even exceed it by the effect of the various load effects and their combinations. Here, it is important to add that the assessment of the physical condition of the construction materials and the actual condition of the elements limits the future activities. The intention of investment should be based on the provided assessment.

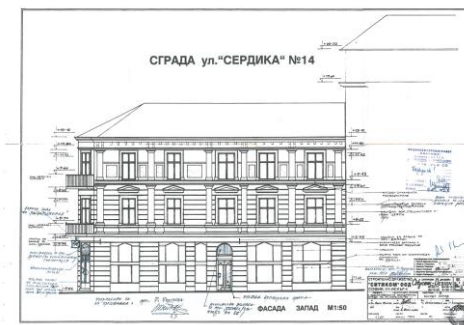
**Figure 7:** Serdica Building- main façade [10]

After the visual inspection and according to the design documentation, the following conclusion can be drawn: many changes are realized in the long life of the structure. The seismic safety of the building is significantly deteriorated compared to the same at the time of construction.

This is to a lesser extent due to a deterioration in the characteristics of building materials as a result of aging and to greater changes, mainly in: 1) Increased weight of the structure, leading to increasing of seismic forces (new internal changes and additional intermediate level); 3) Contact between the new intermediate level with the existing structure; 3) Reduced stiffness after reduced length of the brick walls (in comparison of the original design), additional openings in the internal and external brick walls; 4) Unfavorable influence of the irregularity in the geometry and the distribution of the stiffness.
