Aznalcóllar dam failure. Part 1: Field observations and material properties

E. E. ALONSO* and A. GENS*

The paper describes the failure of Aznalcóllar dam, in southern Spain, in April 1998. The rockfill dam slid forward and released a flow of acid-saturated tailings. The geology and geomorphology of the site are described. The results of a detailed laboratory testing programme on the tailings material and on the overconsolidated high-plasticity foundation clay are given. Special attention is paid to the identification of cementation of the tailings and to the strength and consolidation properties of the foundation clay. Failure features are interpreted on the basis of the field evidence, taking into account the measured geotechnical properties of the materials involved.

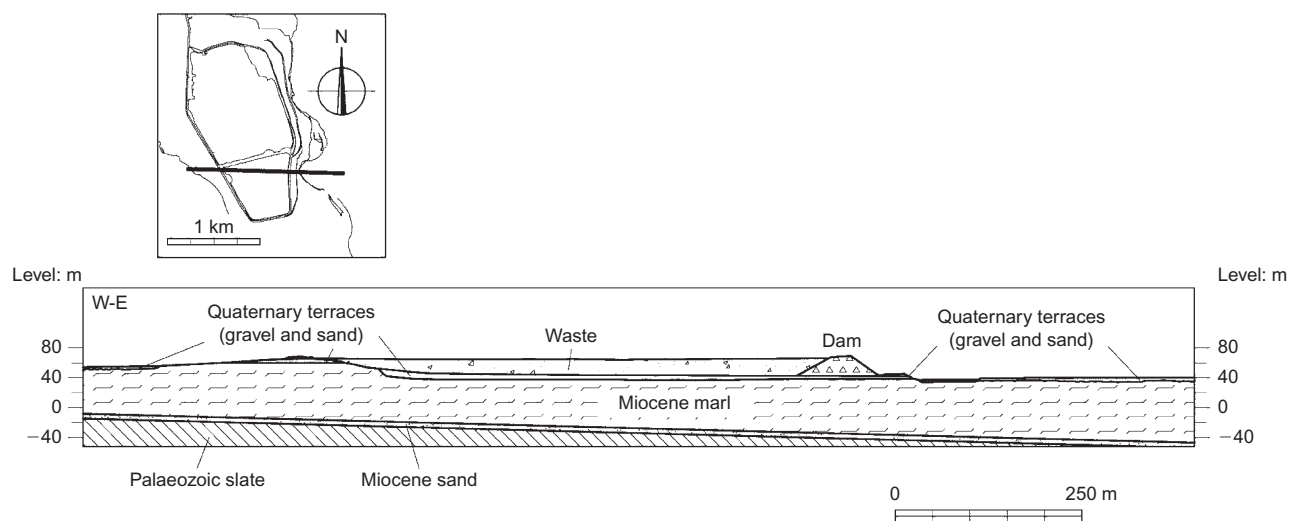
Fig. 5. Cross-section of tailings lagoon. Two stratigraphic discordances are observed: a lower one (high angle) between the Palaeozoic substratum and the upper Miocene deposits, and an upper one (low angle) between the Miocene clays and the Quaternary deposits

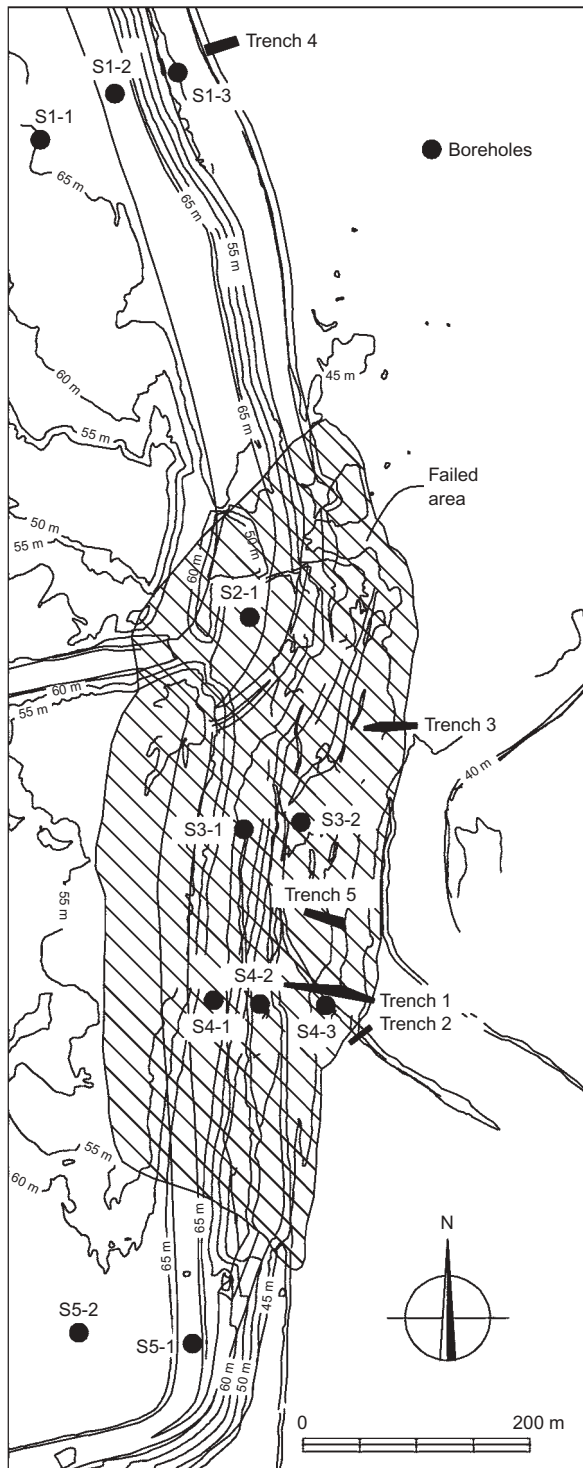
The geological description of the site is based on surface observations and on the interpretation of data provided by rotary-drilled boreholes and shallow trenches excavated after the failure in the locations shown in Fig. 6. The displaced area of the embankment, which affected the south-east part of the lagoon, is also shown in Fig. 6. Details of the slide, which was the ultimate cause of the dam failure, are given later.

Fig. 6. Location of field investigation boreholes and trenches performed after failure. Displaced area also shown (cross-hatched).

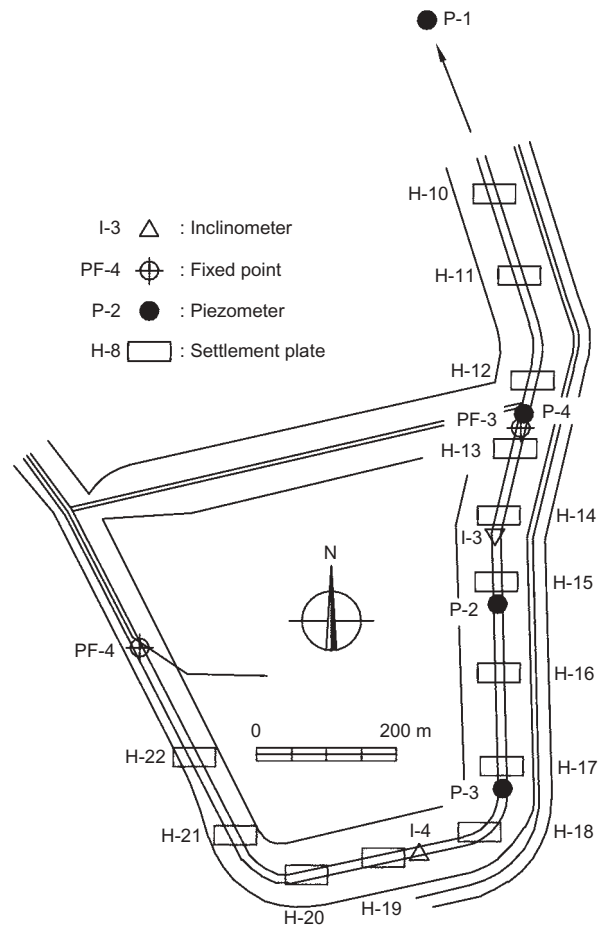
Following the recommendations of an evaluation, in 1996, of the dam safety, a monitoring programme was set up. Fig. 13 shows, in plan view, the position of the instruments in the length of the embankment later affected by the failure. Settlement plates, piezometers (in fact observation wells) and a few inclinometers were located along the crest of the embankment (a few fixed points, shown as PF in Fig. 13, were used as a reference for plate levelling). Great significance was assigned to piezometer readings, and a safety procedure was established in the event of piezometers indicating a rise in water pressure or in the case of abnormal outflow. The ‘piezometers’ were slotted open tubes penetrating 2 m into the foundation clay. It is clear that they were not intended to measure pore water pressures in the clay, but rather any water pressures developing in the granular alluvium or in the pervious rockfill.

Fig. 13. Position of monitoring instruments: south-eastern side of Aznalcóllar dam

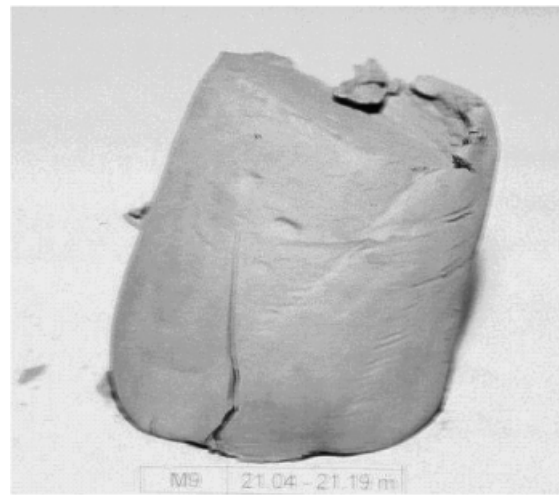
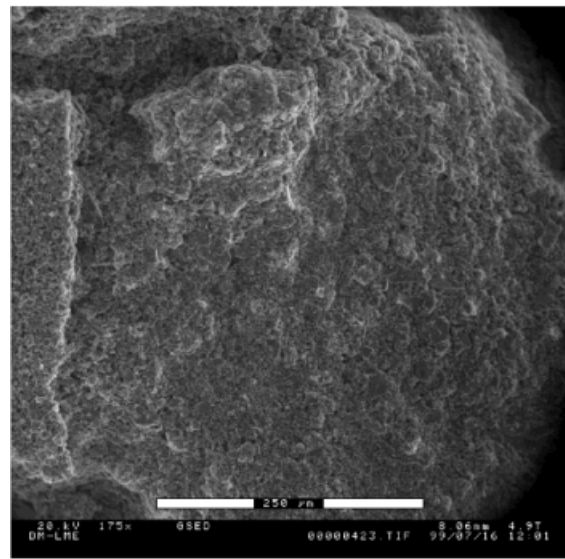
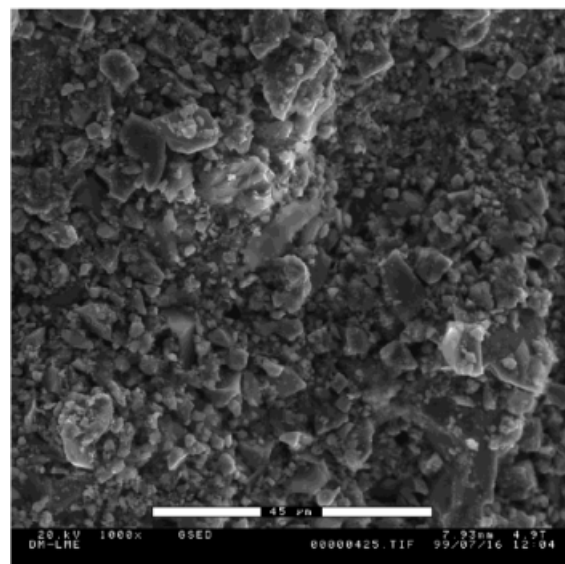
Fig. 26. (a) Specimen of pyrite tailings after triaxial testing; (b) view at $\times 175$ scale; (c) view at $\times 3000$ scale

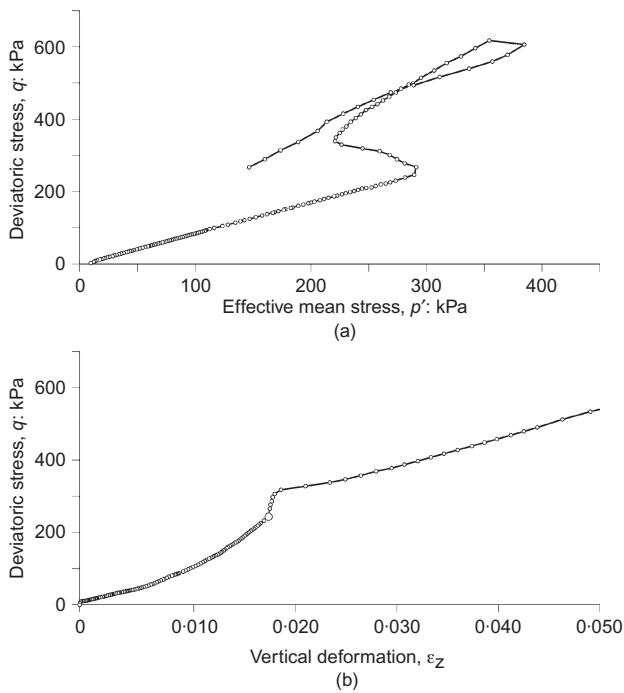
were performed on specimens belonging to the two deposits (pyroclastic and pyrite). Static liquefaction was never observed in triaxial compression tests, a typical example of which is shown in Fig. 27. This shows the stress path (Fig. 27(a)) and the deviatoric stress-strain behaviour (Fig. 27(b)) recorded in a test of a specimen taken at a depth of 20-90-

Fig. 27. Undrained K_0 consolidated ($K_0 = 0.5$) triaxial test on specimen M9 from borehole S5-2 (southern lagoon): (a) effective stress path; (b) deviatoric stress–vertical strain response

response and a rapid generation of pore pressure, indicating a collapse of the granular structure. However, as failure conditions were approached, a strong dilatancy changed the trend of pore pressure generation, and the path followed the strength envelope at increasing effective confining stress. When the test was stopped, at very large strains (24%), positive pore pressures were again recorded, although they may not be very significant in view of the large strains reached. Failed specimens, especially those coming from the pyritic lagoon, showed distinct shear planes.

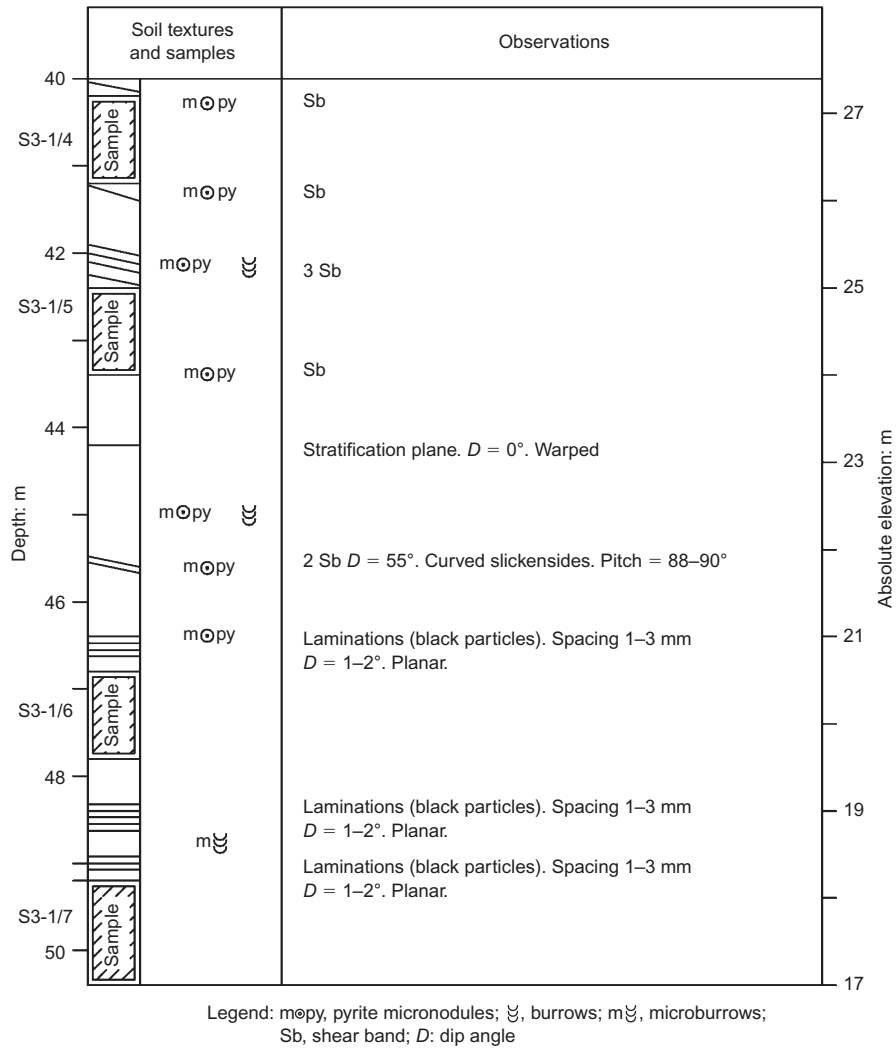
Fig. 33. Portion of stratigraphic column of borehole S3-1 between depths $z = 40$ m and $z = 50$ m (location of borehole shown in Fig. 6)

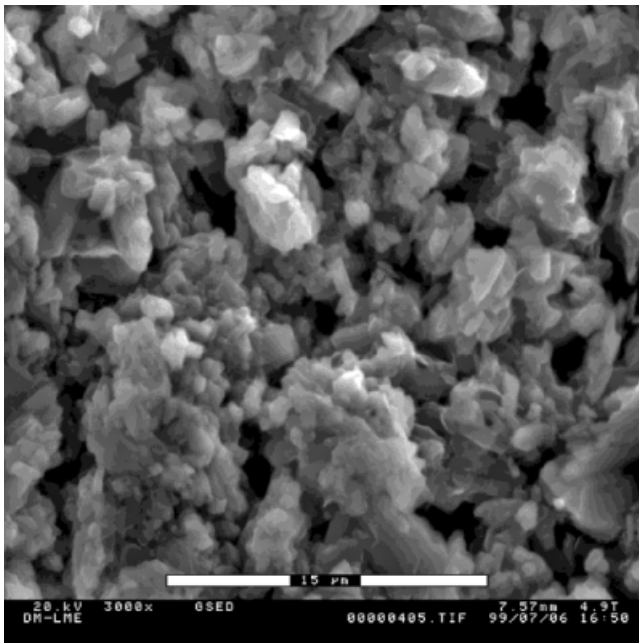
Scanning electron microscope observations were made on intact samples (by examining a surface induced by a tension failure) and on sheared surfaces. In all cases the clay minerals were seen to occur in aggregates of irregular ellipsoidal shape, having sizes of 5–10 μm (Fig. 35). Weathering (brownish colours) results in a more marked aggregate structure. Tsige (1998) found that the weathered clay had an

Fig. 35. SEM microphotograph (×3000) of a discontinuity surface of the blue clay

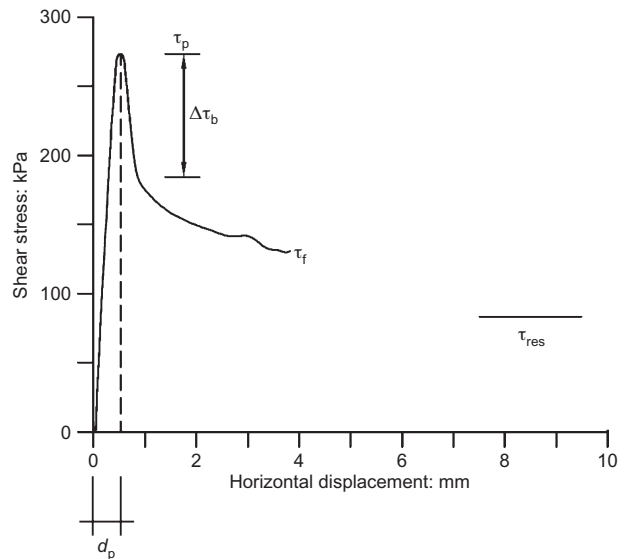
(a) All the specimens exhibited a brittle behaviour. Peak strength was found for displacements of 0.5–1.5 mm (for a range of vertical stresses of 100–400 kPa). Beyond peak the strength initially drops rapidly, then more gradually. This behaviour is illustrated in Fig. 36 for one of the specimens tested. This behaviour will be described by the following parameters: peak strength, τ_p ; displacement to reach the peak, d_p ; strength at the end of the test (for a displacement of 4–6 mm), τ_f ; rapid drop of resistance post-peak: $\Delta\tau_b$. An additional reference strength, the residual strength τ_{res} , may be calculated for a given vertical stress once the residual friction angle is known. As shown later, a representative value $\phi'_{res} = 11^\circ$ was found for this clay. Two brittleness indices are used: $I_f = (\tau_p - \tau_f)/\tau_p$ and $I_B = (\tau_p - \tau_{res})/\tau_p$. I_B is the definition proposed by Bishop (1967). It is clear that $I_B > I_f$. In addition, a measure of the rapid loss of strength after the peak is given by the cementation loss indices, $CL_f = \Delta\tau_b/(\tau_p - \tau_f)$ and

Fig. 36. Direct shear test on specimen of foundation clay from sample M3, borehole S3-1 (depth 39.20–40.1 m): normal effective stress 400 kPa

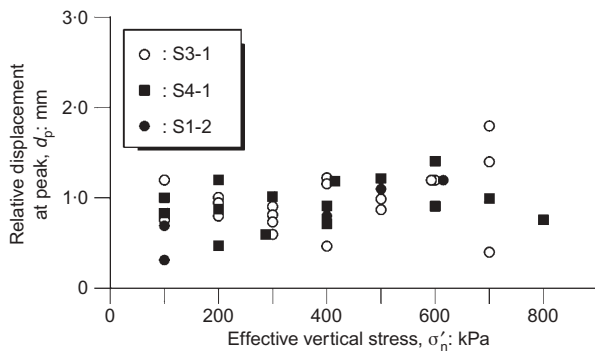
- (c) The displacement at peak, d_p , does not change with the applied normal effective stress (Fig. 38). The average value of $d_p = 1$ mm. The two brittleness indices I_f and I_B are also plotted in Fig. 39 against the vertical stress. A single I_B line is plotted in Fig. 39 because the residual strength corresponds in all cases to a common residual friction angle ($\phi'_{res} = 11^\circ$) and peak strength values derive from a common peak strength envelope ($c' = 65$ kPa, $\phi' = 24.1^\circ$; see below). Points in Fig. 39 represent the I_f index determined for each of the shear tests performed, and this leads to the scatter observed. The dashed line provides the mean value of I_f . A reduction of brittleness with vertical stress is observed, a common finding also in other soils (Fig. 40). The important point is that the Guadalquivir blue clay is highly brittle (I_B varies between 0.8 and 0.7 for effective vertical stress between 100 kPa and 400 kPa). Measured brittleness indices are similar to the values found for blue London clay (Bishop *et al.*, 1971; Fig. 40).

Fig. 38. Variation of peak displacement with effective normal stress for foundation clay

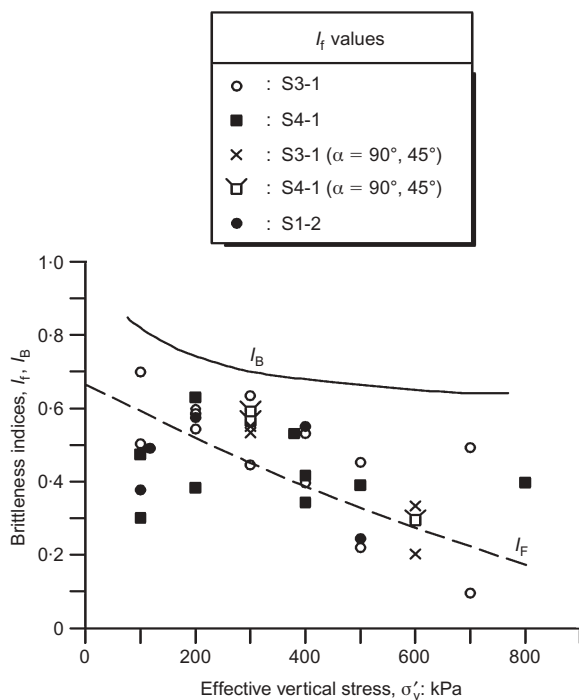
Fig. 39. Variation of brittleness indices I_B and I_f of Guadalquivir blue clay with effective vertical stress

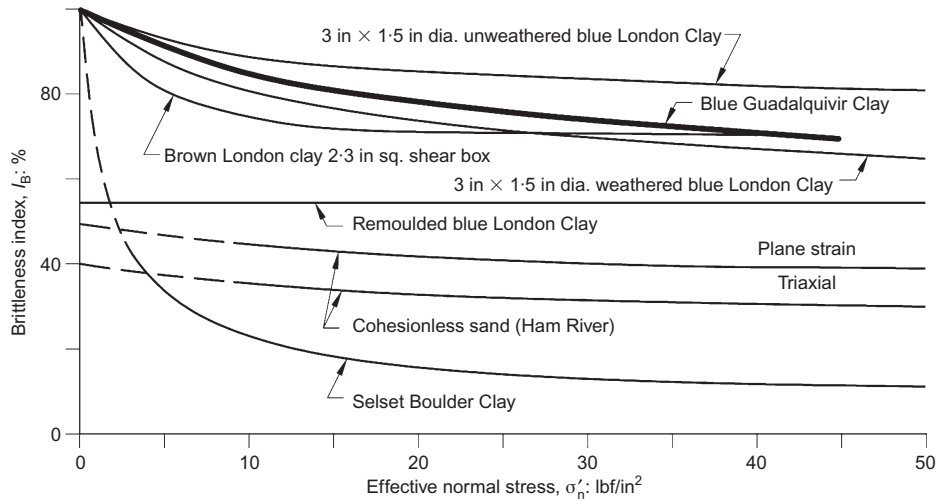
Fig. 40. Comparison of brittleness index I_B with other values reported by Bishop *et al.* (1971)

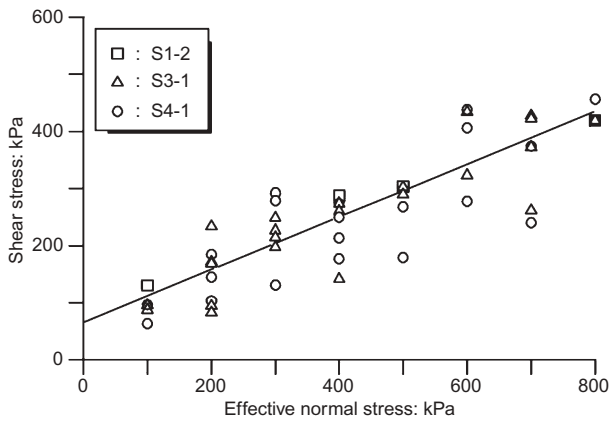
strength on horizontal planes corresponds to the clay matrix. Measured peak strengths are plotted in Fig. 41 in a Coulomb diagram. Some scatter is observed. Average peak strength values correspond to the drained parameters $c' = 65$ kPa, $\phi' = 24.1^\circ$. If the strengths measured at the end of the direct shear test (for displacements of 4–6 mm) are considered, an average limiting curve $c' = 0$ kPa, $\phi' = 20^\circ$ is obtained.

Fig. 41. Drained peak strength envelope for Guadalquivir blue clay

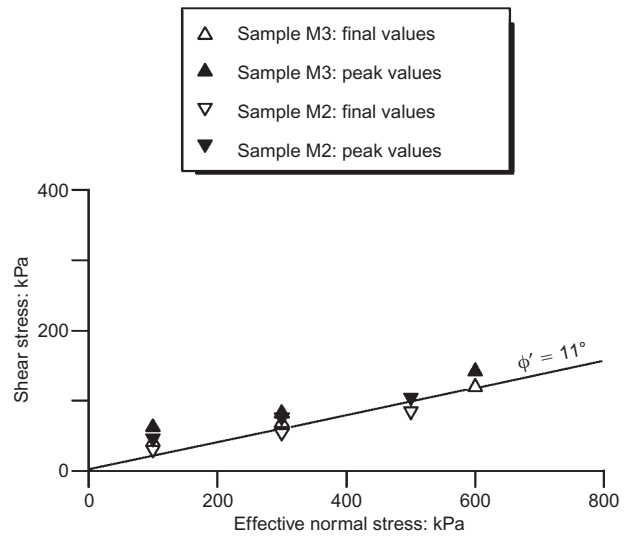
Natural joints found on the large clay blocks deposited by the mudflow (Fig. 12) were tested in the shear box. The discontinuity was aligned with the shearing plane of the box. Several reversing cycles were applied, and displacements in excess of 60 mm were achieved. For vertical stresses in the range 200–400 kPa a friction angle $\phi'_{res} = 11^\circ$ was found (Fig. 43).

Fig. 43. Summary of direct shear tests performed on two natural discontinuities of the clay

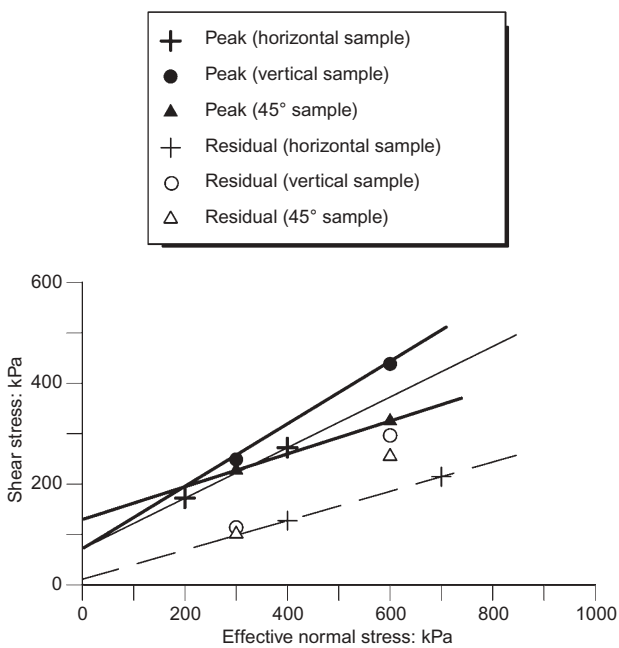
- (e) Several specimens were tested along planes inclined at 45° and 90° with respect to the horizontal. The results are collected in Fig. 42. No clear indication of anisotropy of the clay matrix was found, so it is possible that peak parameters determined for horizontal shearing may represent average peak strength.

Fig. 42. Shear strength measured in inclined samples of foundation clay

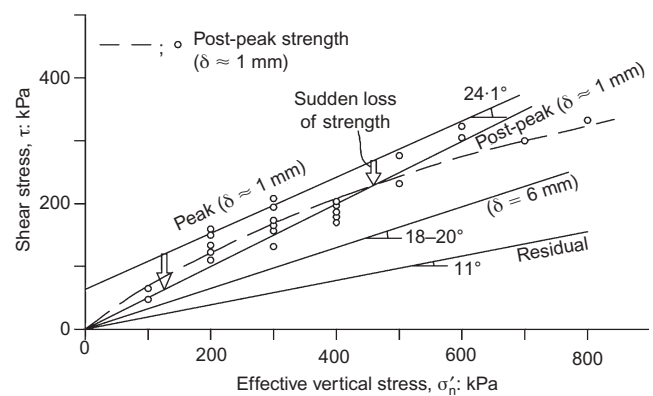
The results of all direct shear tests performed on horizontal planes are summarised in Fig. 44. The average peak strength is obtained for a shear displacement of 1 mm. The open symbols in the figure correspond to the strength measured immediately after the peak at essentially the same displacement. The curved strength envelope is a reasonable approximation to the measured values. A straight line is also fitted to the points. The important result is that the sudden loss of strength results in a destruction of the effective cohesion. An accumulation of shear displacements of 6 mm implies a drop of friction angle down to $18\text{--}20^\circ$. Finally, the residual friction envelope, associated with further additional displacements, is also plotted in the figure.

Fig. 44. Direct shear strength envelopes of foundation clay

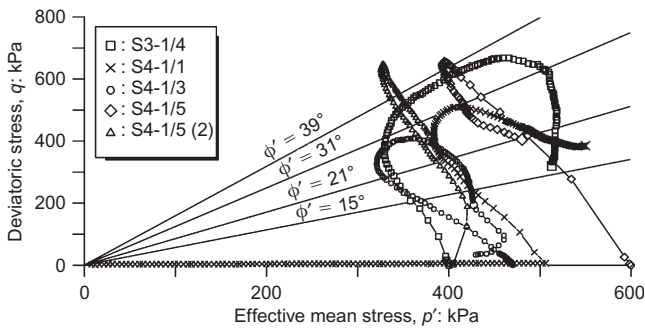
Several isotropically consolidated undrained tests were performed in a stress-path cell. Peak strengths correspond to friction angles in the range $\phi' = 31\text{--}39^\circ$ (Fig. 45). For the final conditions (vertical strains in excess of 20%), the friction angle drops to $15\text{--}21^\circ$. The maximum values of Skempton's A -coefficient ($A_{max} = 0.7; 0.45; 0.24; 0.49; 0.8$) reflect a moderate contractant behaviour before the onset of dilatancy. Near the peak some dilatancy develops, and the final A values indicate this change ($A_f = 0.6; 0.35; -0.03;$

0.20; 0.55). The 'elastic' value of $A = 0.33$ is probably a reasonable average value. Elastic moduli measured at relatively low strains ($\epsilon_z = < 2 \times 10^{-3}$) were in the range 55–115 MPa for confining stresses varying from 400 to 600 kPa.

Fig. 45. Stress paths measured in isotropic undrained triaxial tests
