# PICTURE THIS: A NEW PERSPECTIVE ON TENSILE MEMBRANE DEGRADATION

**Key words:** Biological Growth, Membrane Degradation, PET-PVC Coated Fabrics

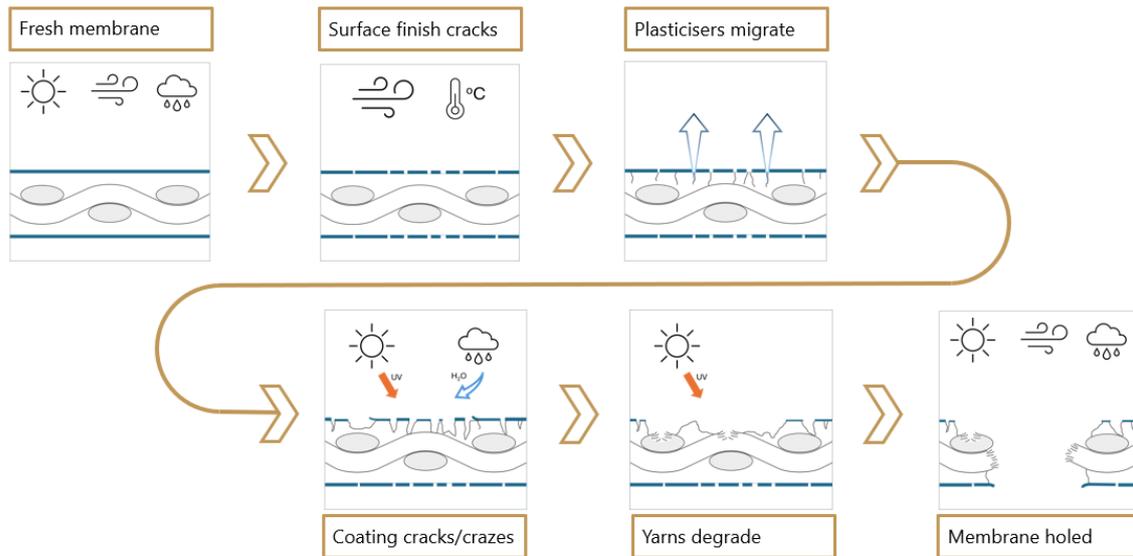
**Figure 5:** Weathering pathway: stages of degradation resulting from environmental conditions

The commonly accepted<sup>1,2,3</sup> degradation pathway results from the exposure to environmental conditions such as ultraviolet light, moisture, temperature, and loading (especially wind and snow) which leads to natural weathering degradation. The stages associated with this pathway are summarised in **Figure 5**. It begins with crazing and cracking in the finish layer associated

with membrane response to physical and thermal loading. These cracks accelerate plasticiser migration by diffusion, increasing brittleness and promoting further cracking and crazing of the PVC layer. As plasticiser loss progresses, the underlying PET yarns become exposed to UV radiation, resulting in photo-degradation, fibre fracture, and ultimately perforation of the membrane. This sequence builds on the well-established understanding that plasticiser loss drives PVC embrittlement, surface cracking, subsequent exposure and degradation of the load-bearing fibres and results in a loss of tensile strength capacity.

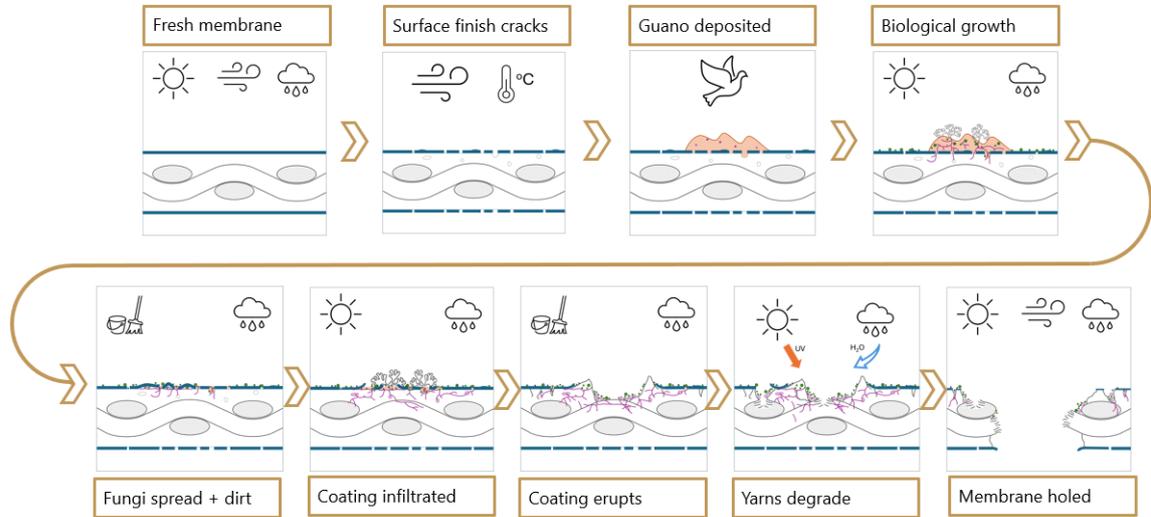
**Figure 8:** Biological action pathway: stages of degradation by lichen growth and proliferation

A new degradation pathway is identified from the analysis of the collated pictures. The hypothesised stages associated with this pathway are summarised in **Figure 8**. The initial stage echoes that of the weathering pathway, where the surface finish cracks and crazes, but even small pre-existing discontinuities could enable organic deposits such as guano to adhere and accumulate. These nutrient-rich sites promote biological colonization in the sunny, moist environment. Lichen rhizines penetrate beneath the coating, and although cleaning removes surface soiling, residual rhizines facilitate rapid recolonization from existing cracks and defects, undermining the bond between finish and coating. Progressive degradation of the coating and underlying layers exposes the PET yarns, which subsequently deteriorate under UV and

moisture, ultimately resulting in membrane perforation and hole formation.
