THE PLASTER CEILINGS OF BUCKINGHAM PALACE AND WINDSOR CASTLE: THEIR CONSTRUCTION, CONDITION AND CONSERVATION

Abstract. *Alan Conisbee & Associates and Richard Ireland were engaged by the Royal Household Property Section to inspect and assess the historic plaster ceilings and their supporting structure within Buckingham Palace and Windsor Castle. Following the partial collapse of the Apollo Theatre ceiling in London in 2013 great importance has been placed on the inspection and certification of all historic plaster ceilings throughout the United Kingdom. This paper presents the key challenges of the project included the facilitation of access to constrained spaces, asbestos removal and cleaning of delicate fabric, surveying, digital monitoring, structural and plaster defects. Furthermore we discuss the key project outcomes including lessons learnt and best practice methodologies and practicalities behind inspections of this kind. The paper concludes with an outline of significant discoveries and ongoing laboratory testing of undernailed historic timber connections.*

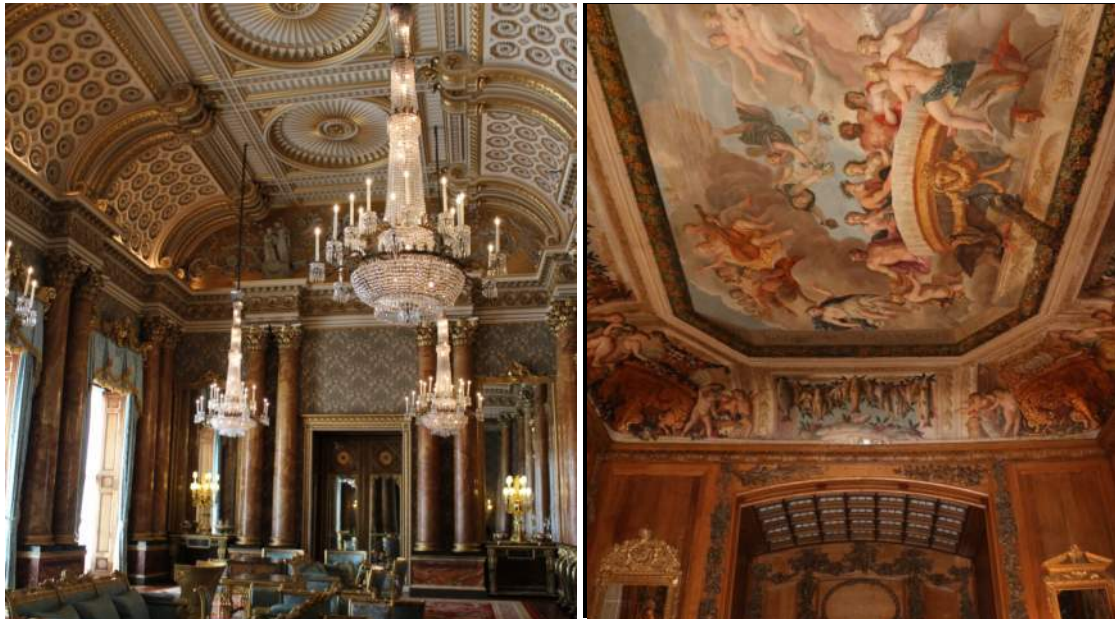
Figure 01: (Left) Interior view of the Blue Drawing Room 1830's highly enriched lath and plaster ceiling. (Right) KCIIDR baroque painted plaster ceiling by Antonio Verrio dated 1684 at Windsor Castle.

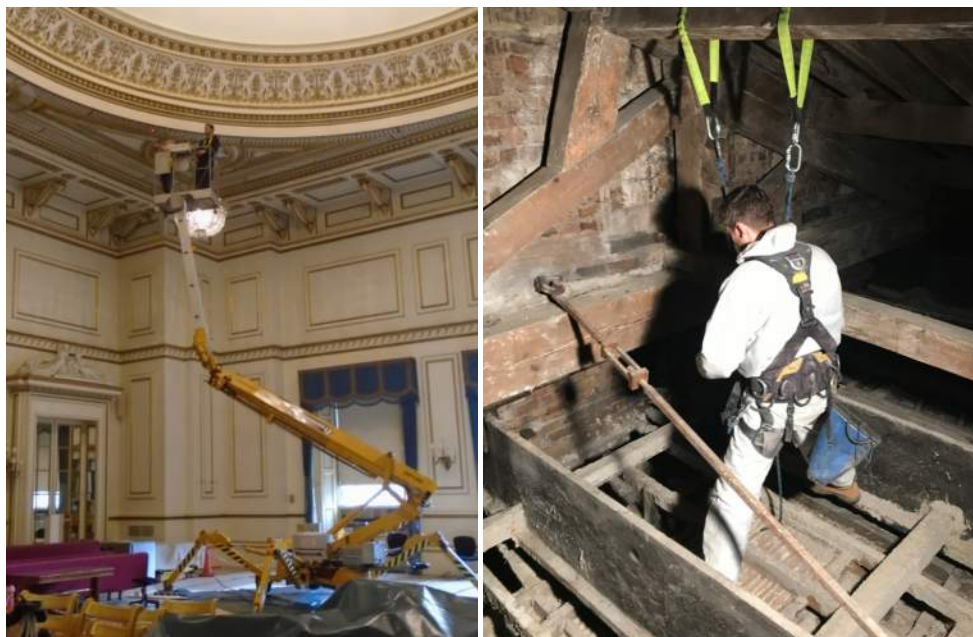
Figure 04: (Left) Ball Supper Room ceiling inspections via cherry picker. (Right) Inspection via rope access
