FAILURE ANALYSIS OF THE ARECIBO OBSERVATORY M4N AUXILIARY CABLE¹

Gregory J. Harrigan², Vinay K. Goyal³, Pavel F. Babuska⁴, Nathan Trepal⁵

ABSTRACT: Structural and forensic analysis concluded that the Arecibo Observatory M4N socket joint failure in August 2020 was due to a socket joint design with insufficient design criteria that did not explicitly consider socket constituent stress margins or time-dependent damage mechanisms. The socket attachment design was found to have an initially low structural margin with a finite service life, notably in the outer socket wires, which degraded primarily due to long-term zinc creep effects that were activated by long-term sustained loading and exacerbated by cyclic loading. Additionally, HAC and wire defects were found in a few outer wires that may also have contributed to initial outer wire failures. The design did not explicitly consider the time-dependent effects of creep and cyclic loading on design capability, account for a worst-case build condition traceable to in-service inspection of features (e.g., zinc creep/extrusion), specify an end-of-life capability requirement associated with service life degradation, or explicitly set servi

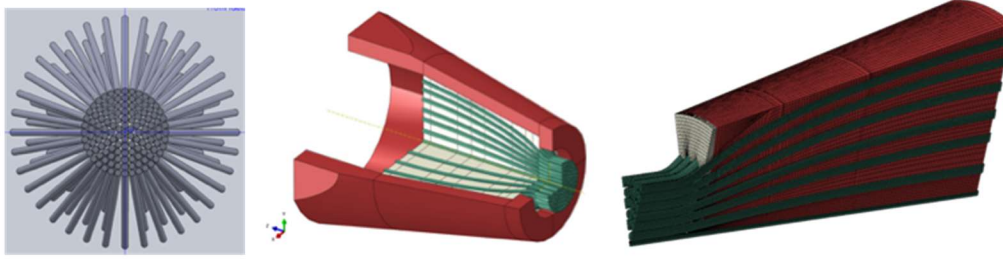
High-fidelity three-dimensional FE models of the cable termination into the M4N socket were developed using Abaqus to investigate the individual wire, zinc, and steel socket mechanics and to support the failure investigation. The models enabled sensitivity studies to understand the effects of various parameters including the degree of wire brooming, zinc material properties, and metallurgic examinations. Multiple model configurations were constructed, each containing varying levels of wire brooming, one of which represented the as-built/as-failed wire brooming specific to Aux M4N. The interfaces between the wires and zinc were modeled with a nearly infinite stiffness contact condition to enable extracting interface shear and pressure stresses. Contact modeling with friction was implemented between the zinc and the socket casing to allow for zinc “seating” within the socket. Material nonlinearity was included for the steel wires and the zinc spelter to predict the post-yield material response. Examples of the idealized wire brooming, simplified socket model, and wedge model mesh density are shown in Figure 3.

Figure 3: FE model included conical socket housing, cast zinc, and individual wires.
