# The Structural Strengthening of a Masonry Heritage Shop House using Glass Fibre Based Materials

**Abstract.** *A two-storey masonry pre-war shop house in Taiping, Malaysia was badly affected by construction being undertaken at an adjacent lot. The building was in a serious state of disrepair and on the verge of collapse at the time of the investigation and temporary propping and a stoppage of adjacent works had to be imposed. For the remedial intervention a rapid approach was critical with materials and methodologies selected to incur minimum additional impacts on the building in terms of physical works and with flexibility on site. Several innovative techniques developed for the structural intervention of masonry buildings was considered. In this case the masonry wall cracks were repaired by a stitching method using the glass fiber rod maperod g which was considered a suitable material due to the compatibility of modulus of elasticity (40,800N/mm<sup>2</sup>) to the lime mortar, having good tensile strength of 760 N/mm<sup>2</sup> to help bridge the cracks in case of further movement and is also corrosion resistant and will remain protected in future even though it is embedded

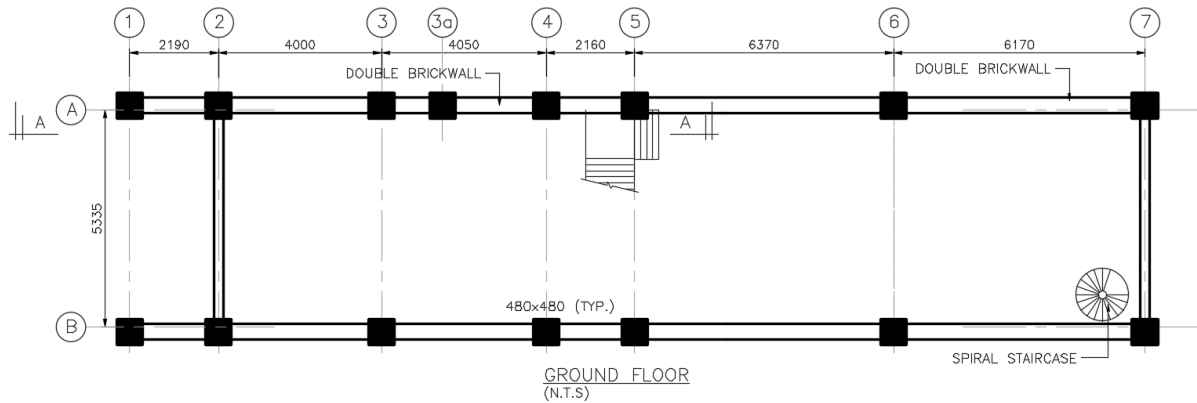
**Figure 1.** Plan View of Shop House.

The building is a 2 storey pre-war shop house with an overall layout plan as shown in Figure 1. The building housed a family business until adjacent construction activity forced the owners to move from the premises due to an eviction order imposed by the local authority arising from the dangerous state of the building. The actual construction details of the adjacent building was not made available but the site visit confirmed that the original 2 storey building next door had been torn down to make way for a 3 storey structure on piled foundations with a lift at the rear.
