## DOCUMENTATION AND STRUCTURAL APPRAISAL OF THE MEDIIEVAL MANOR OF POTAMIA, CYPRUS: AN INTERDISCIPLINARY APPROACH

**Keywords:** Historical Structure, Masonry, Monitoring, Non-Destructive Inspection

**Abstract.** *This paper aims to present, via a case study, an interdisciplinary approach towards the comprehensive analysis of historic constructions. The case study monument examined is the Medieval Manor of Potamia in Cyprus. The work hereby presented was based on a collaboration between scientists from the fields of archeology, architecture, materials science/conservation and structural engineering. A thorough review of historical sources was initially carried out in order to obtain data concerning the history and construction development of the Manor. Extensive field work was undertaken to study the architectural typology and construction detailing of the structures and to explicitly map the various agents of pathology. For the characterization of the historic fabric, masonry materials were sampled and studied at the laboratory. The accumulated data facilitated the development of a Finite Element (FE) model, which was used to numerically assess the structure's seismic response.*

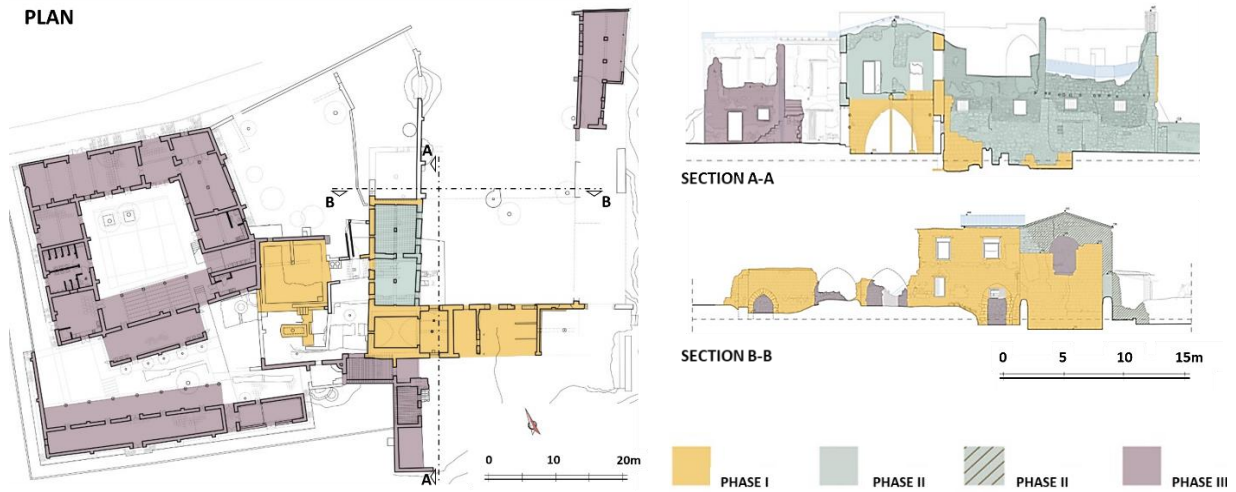
- Phase I (1380-1426): Medieval structures built before the destruction of the Manor by the Mamelukes. These include masonry sections composed of coursed ashlar stones.
- Phase II (1426-1570): Elements added/reconstructed during the Frankish and Venetian periods. These are stone masonry sections incorporating reused ashlar blocks.
- Phase III (1571-20<sup>th</sup> century): Additions/modifications made during the Ottoman period and up to the 20<sup>th</sup> century. Such structures are generally constructed of adobe masonry.

**Figure 1:** Plan drawing of the Potamia Manor complex and section drawings of the east part of the monument indicating the different building phases identified.

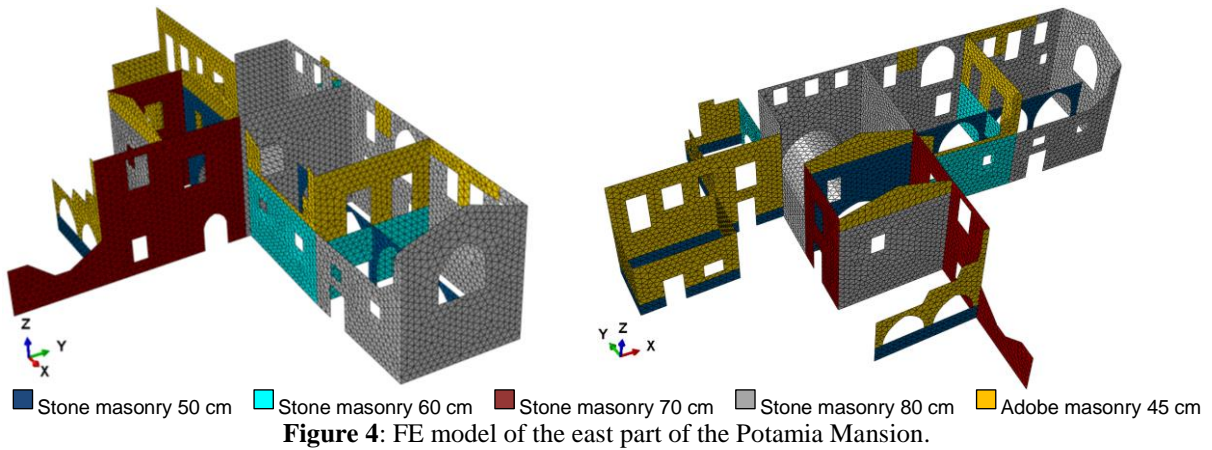
In order to assess the seismic vulnerability of the monument, a FE model was developed in Abaqus/CAE (Figure 4). The stone-mortar and adobe-mortar masonry composites were treated as homogenous continua and were modelled using an isotropic elasticity constitutive law. Plane stress failure measures were specified for identifying damage. The FE mesh consisted 3-noded shell elements with five integration points through the thickness and an average side length of 0.4 m. Pinned supports were defined along the walls' base.

**Figure 4:** FE model of the east part of the Potamia Mansion.
