Thermal segregation of asphalt material in road repair

Juliana Byzyka^{*}, Mujib Rahman, Denis Albert Chamberlain

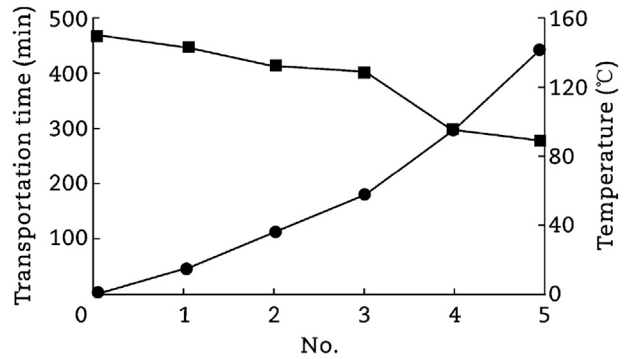
Fig. 3 – Asphalt temperature variation and transportation time between asphalt production facility and each repair site.

production facility. Improper insulation of the hot-fill material and long travel time, in combination with low ambient temperatures, impacted on the asphalt mix temperature causing significant temperature losses through the panels of the truck and the cover sheet (Fig. 2). Table 2 and Fig. 3 present the overall transportation time and temperature drop versus time respectively of the asphalt from the production plant to each repair site.

● Transportation time (min)					
0	50	115	180	295	445
■ Temperature (°C)					
150	143.5	132	128	95	90

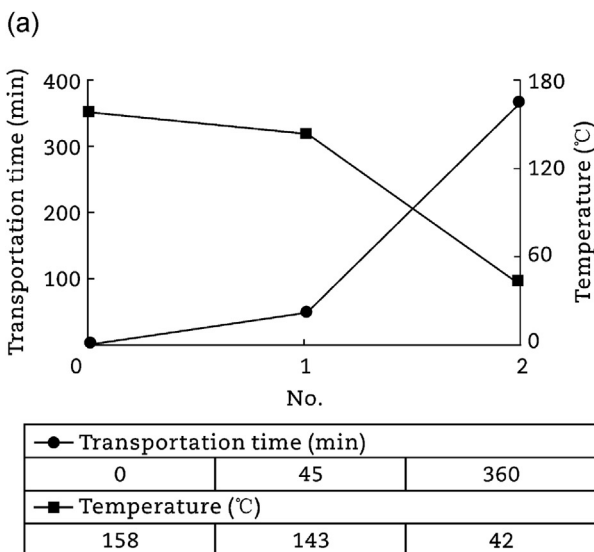
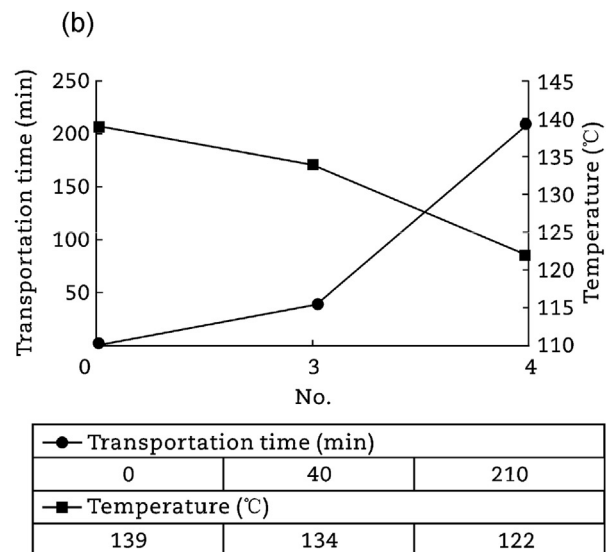
Fig. 7 – Temperature variation and transportation time of HMA between asphalt production facilities and each repair site. (a) Day 1 repair sites 7–8. (b) Day 2 repair sites 9–10.

The maximum temperature of asphalt, when gathered from the production plant at day 1, was approximately 158.3 °C (Fig. 5(b)). Thermal segregation had started to develop as observed with Contractors A and B. Heat loss from the truck panels and insulation cover was also observed, shown in Fig. 5(c). At day 2, the maximum temperature measured on the mat of the HMA was 138.5 °C with cold spots also seen throughout the asphalt mat as per all the repairs previously discussed Fig. 6(b). Further, Table 3 and Fig. 7 demonstrate transportation time and temperatures of the mix upon arrival at repair sites.

As the results show, during the transportation of the HMA at day 1 there was an overall dramatic decrease of asphalt mixture temperature of 116.6 °C. This heat loss is attributed to the travelling time and uncontrolled insulation of the hot material. At day 2, the overall maximum temperature drop was much less, reaching a difference between asphalt plant and last repair site of 16.5 °C.
