## STRUCTURAL RESTORATION AND RE-USE OF THE HISTORIC COAL MINE TOWER

**Abstract.** The coal mine is located in the town of Labin, Istria peninsula, Croatia. Restoration of the tower is a part of the project that includes thorough restoration and re-use of the Labin mining complex for cultural, tourist and educational purposes. The tower was built in 1938 by Italian authorities as part of the pre-war campaign. It is a 32.5 m high steel structure that once enveloped the elevator to a 200 m deep mine shaft. The structure is a built up Vierendeel truss with four columns / chords connected with horizontal moment resistant beams. Two large steel inclined struts were resisting elevator rope forces connected to the elevator machine building. The mine was shut down in 1988. The assessment of the tower consisted of geometry measurement, cross-section shape determination, steel quality determination, condition of members and connections (rivets and bolts), protective coating condition and underground supports condition. Two samples were taken to laboratory to determine the steel grade with tensile yield test. Structural model with existing members has also been analysed. Different loads were

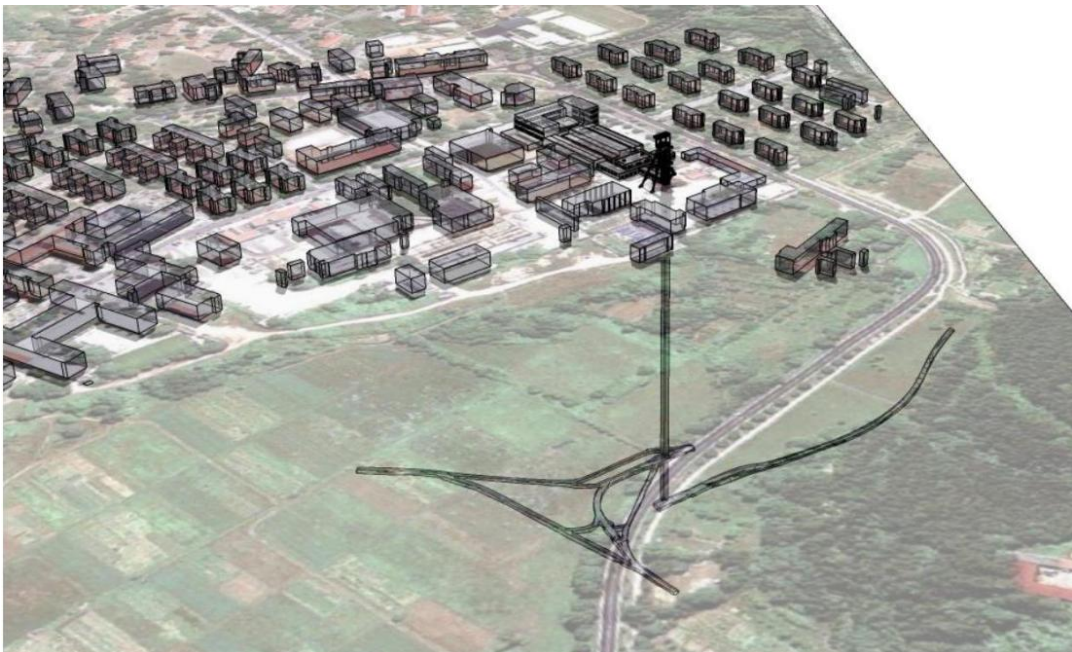
**Figure 1:** Mine shaft with nearby tunnels 200 m below the surface

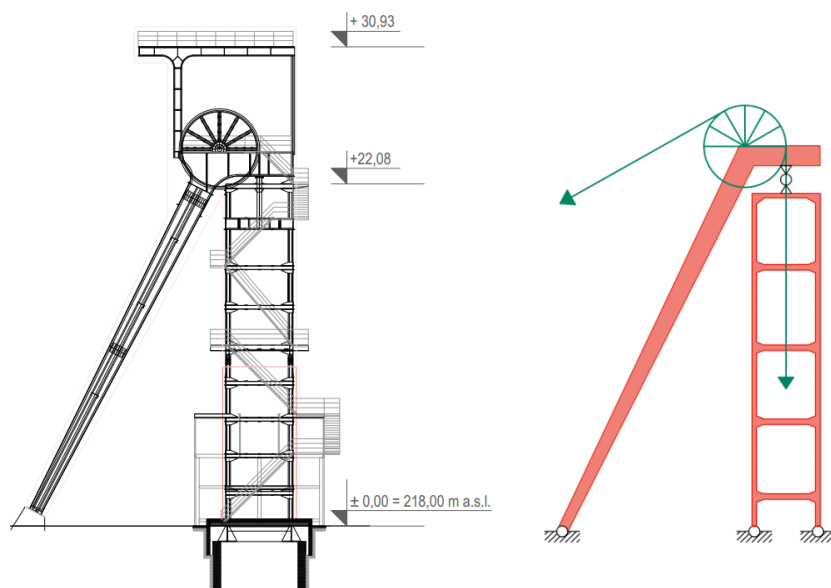
**Figure 3:** Mine tower drawing prior to restoration on the left, structural scheme with the forces imposed by the elevator mechanism on the right
