## INSPECTION, DIAGNOSIS AND MODELLING OF AZURARA CHURCH IN THE NORTH OF PORTUGAL

ESTEFANÍA A. CHAVES MORENO<sup>1\*</sup>, ELLEN T. KEY<sup>1</sup>, AMRUTA UPLEKAR<sup>1</sup>,  
OMAR PINO ACUÑA<sup>1</sup>, GRAÇA VASCONCELOS<sup>1</sup>, JAVIER ORTEGA<sup>1</sup>, ELISA  
POLETTI<sup>1</sup>

<sup>1</sup>University of Minho

**Abstract.** *Santa Maria de Azurara church is a XVI century church in Portugal, classified as a national monument since 1910. The building shows not only the influence of the Manueline architectural style (Portuguese late Gothic style), but also Baroque and Mannerism styles. Presently, the church presents some structural and non-structural problems, so an inspection and diagnosis of the main building pathologies was carried out. This process was assisted by non-destructive testing (NDT) techniques which included sonic tests, ground penetrating radar (GPR) and Schmidt hammer for masonry elements and Pilodyn and ultrasonic pulse velocity for the timber elements. In addition, scanning electron microscope and x-ray diffraction analysis were used for mortar and stone characterization. Furthermore, dynamic identification tests were performed. Numerical analysis

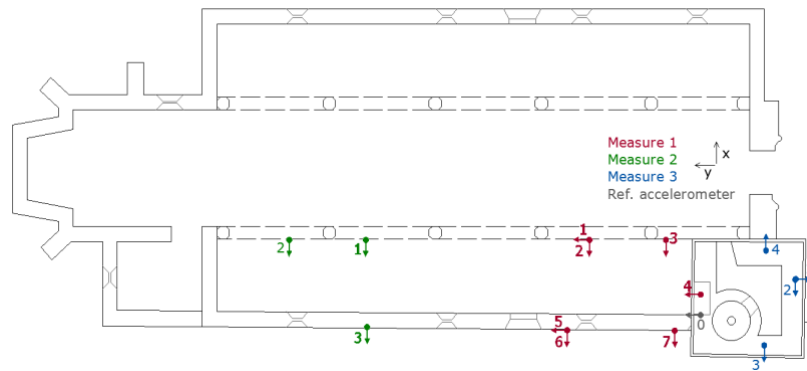
**Figure 5:** Accelerometer locations for OMA campaign

A representative part of the church was chosen for analysis; namely, the tower and the north walls connected to it. Twelve points of measurement were chosen: five in the bell tower, four in the clerestory wall and three in the external wall (Figure 5). The accelerometers measured the out-of-plane acceleration at every point and in-plane acceleration at one point of each structural element.

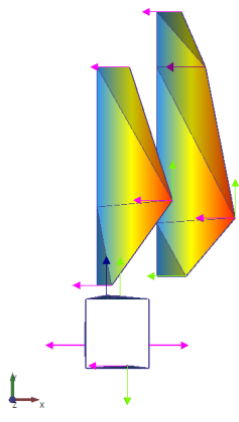
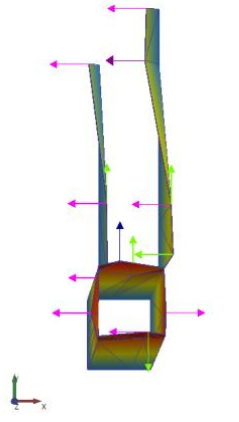
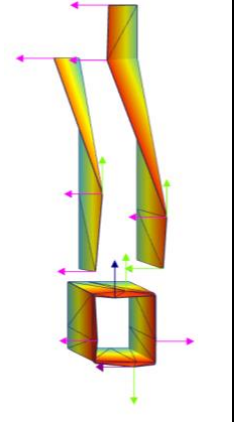
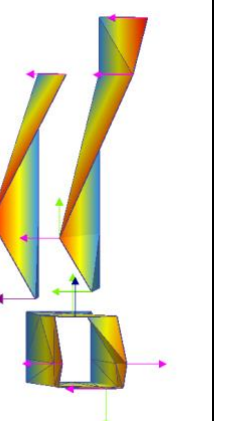
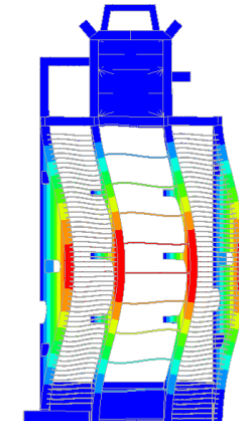
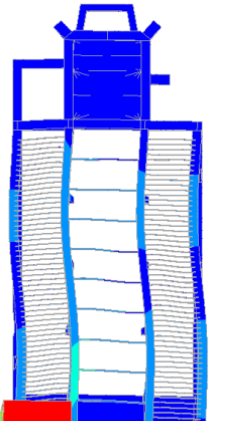
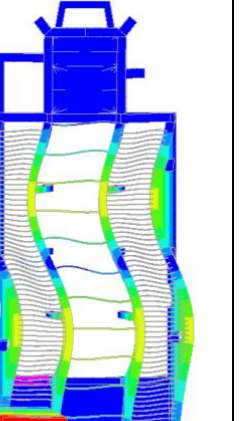
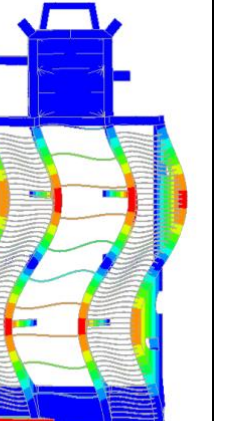
**Table 3:** Modal shapes and frequencies of the OMA (ARTEMIS) results and updated FEM

The elastic modulus of the masonry was modified in order to match the values of the frequencies and the modal shapes from the OMA campaign. Then, a MAC comparison was also used. The final properties are listed in Table 2 and the four selected mode shapes are provided in Table 3. Poisson ratio was taken as 0.2, tensile strength as 0.15 MPa, and tensile fracture energy 8 N/m.

OMA Mode 1: 1.73 Hz	OMA Mode 2: 2.68 Hz	OMA Mode 3: 2.83 Hz	OMA Mode 4: 3.18 Hz

FEM Mode 1: 1.73 Hz	FEM Mode 2: 2.68 Hz	FEM Mode 3: 2.89 Hz	FEM Mode 4: 3.04 Hz

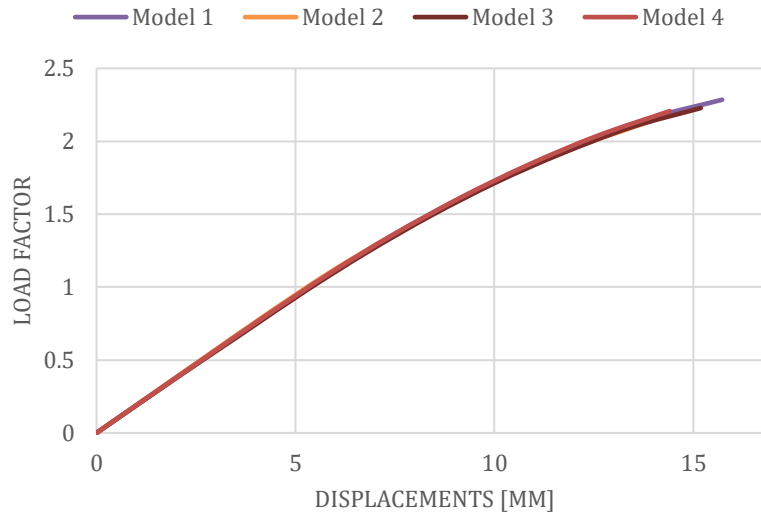
**Figure 6:** Capacity curve of the incremental vertical analysis

The first analysis was performed in the vertical direction in order to obtain the maximum load factor for the gravitational load that the structure can support. The capacity curve is shown in Figure 6. Different models were created with different values for the variables that define the nonlinear analysis. Three values for the tensile fracture energy were used, 8, 50 and 1000 N/m. A model without the slab of the choir was also analysed. Model 1 represents the original model whose material properties are defined in the previous section. For Model 2 the slab was removed. Model 3 and Model 4 present higher tensile fracture energy, 50 N/m and 1000 N/m respectively. The results are similar for all the cases, reaching a maximum value for the load factor of 2.3 for the original model. It can be observed that for the current state of loading, the

structure is in the linear range what means that no problems should appear in the structure related to the materials.

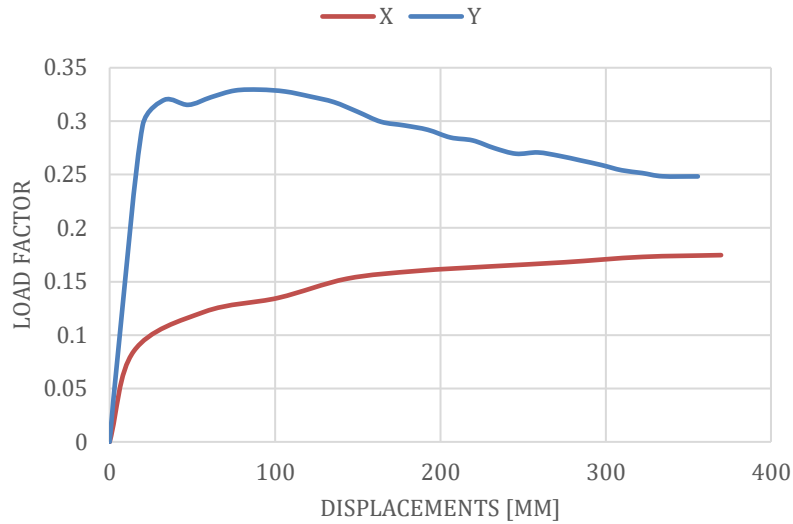
**Figure 8:** Capacity curves for horizontal pushover

For the horizontal pushover both the transversal and longitudinal axes were analyzed in one direction. In the case of the transversal direction (X) the church presents a load factor around 0.17 and the capacity curve presents hardening. As expected, in the longitudinal direction (Y) the structure presents higher capacity and the curve reaches a value of 0.3 with an elastic behavior. The nonlinear branch presents softening in this case.
