# TYPOLOGICAL CLASSIFICATION AND OBSERVED DAMAGE PATTERNS OF MASONRY CHURCHES AFTER THE 2016 CENTRAL ITALY EARTHQUAKE

G. CIANCHINO<sup>1</sup>, G. DE MATTEIS<sup>2</sup> AND G. BRANDO<sup>1\*</sup>

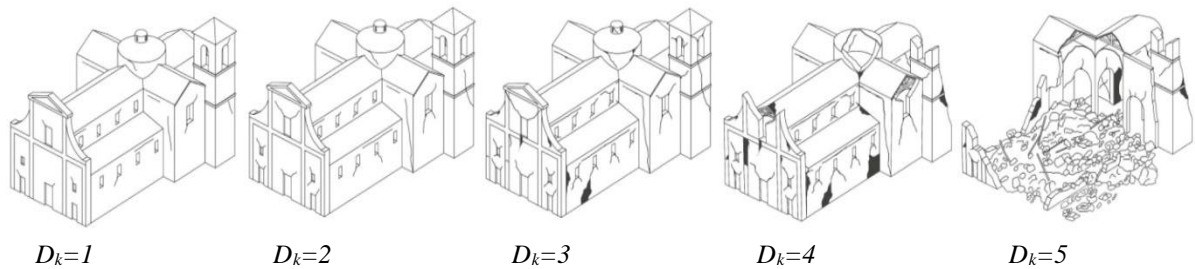
**Figure 5:** Limit states corresponding to the five damage levels  $D_k$

- $D_0$ : no damage
- $D_1$ : light damage
- $D_2$ : moderate damage
- $D_3$ : serious damage
- $D_4$ : very serious damage (partial collapses)
- $D_5$ : collapse

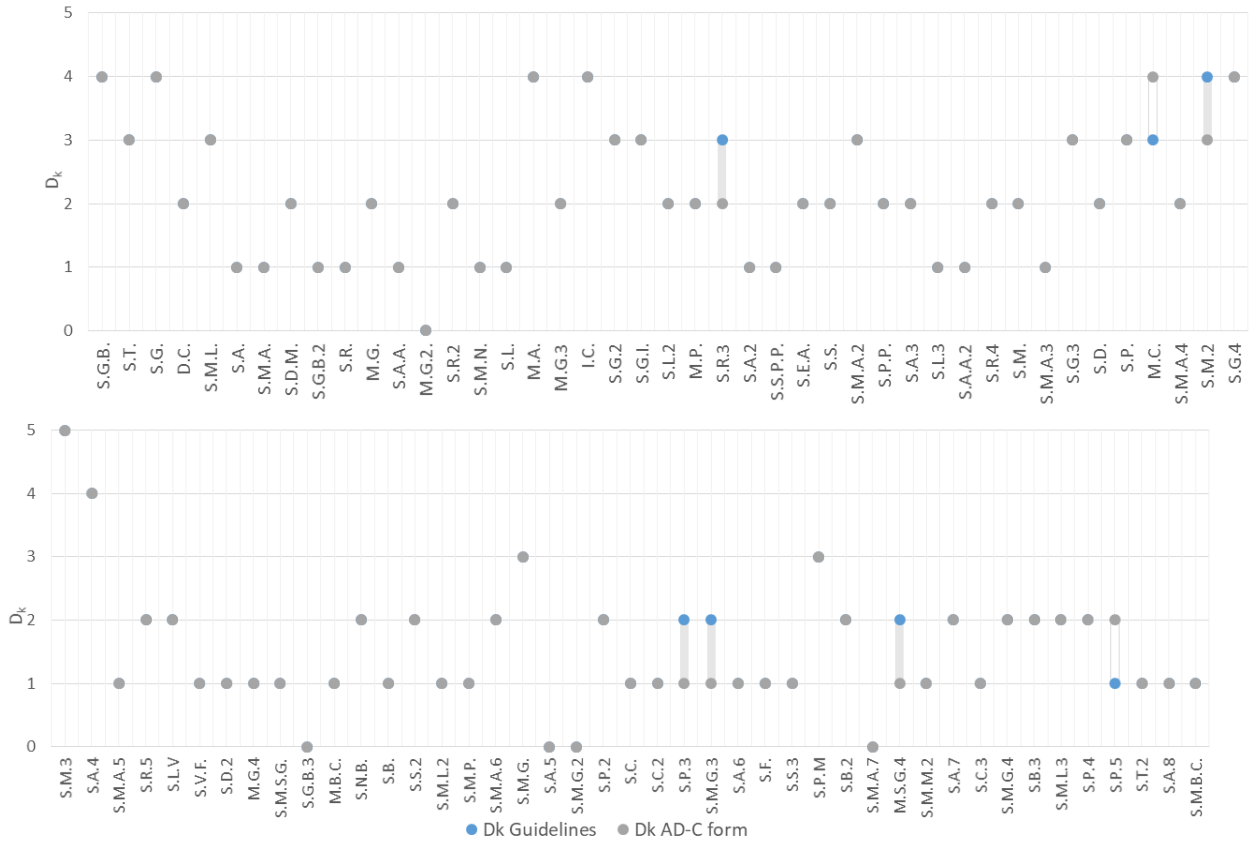
Figure 6: Damage levels ( $D_k$ ) for churches

The obtained  $D_k$ , obtained according to the two procedures discussed in Section 4.1 and 4.2, are reported in Figure 6 (organized in two graphs arranged on two rows). As it is possible to observe, the two procedures give almost the same results except for six cases.

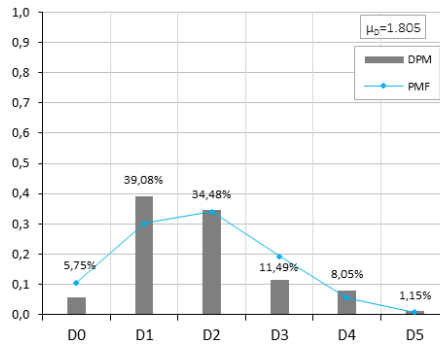
**Figure 7:** Damage Probability Matrix (DPM) of the analyzed churches

The elaboration of the frequencies of the obtained  $D_k$  evaluated for the studied 87 churches has allowed the definition of the so called Damage Probability Matrix (DPM), shown in Figure 7, which is as a useful tool for representing the occurred damage scenario.

Always in Figure 7, it is possible to observe that the gathered frequencies could have been predicted by applying the binomial probability distribution (DPF) provided in eq. (3), once that the mean damage  $\mu_D$  had been assessed.

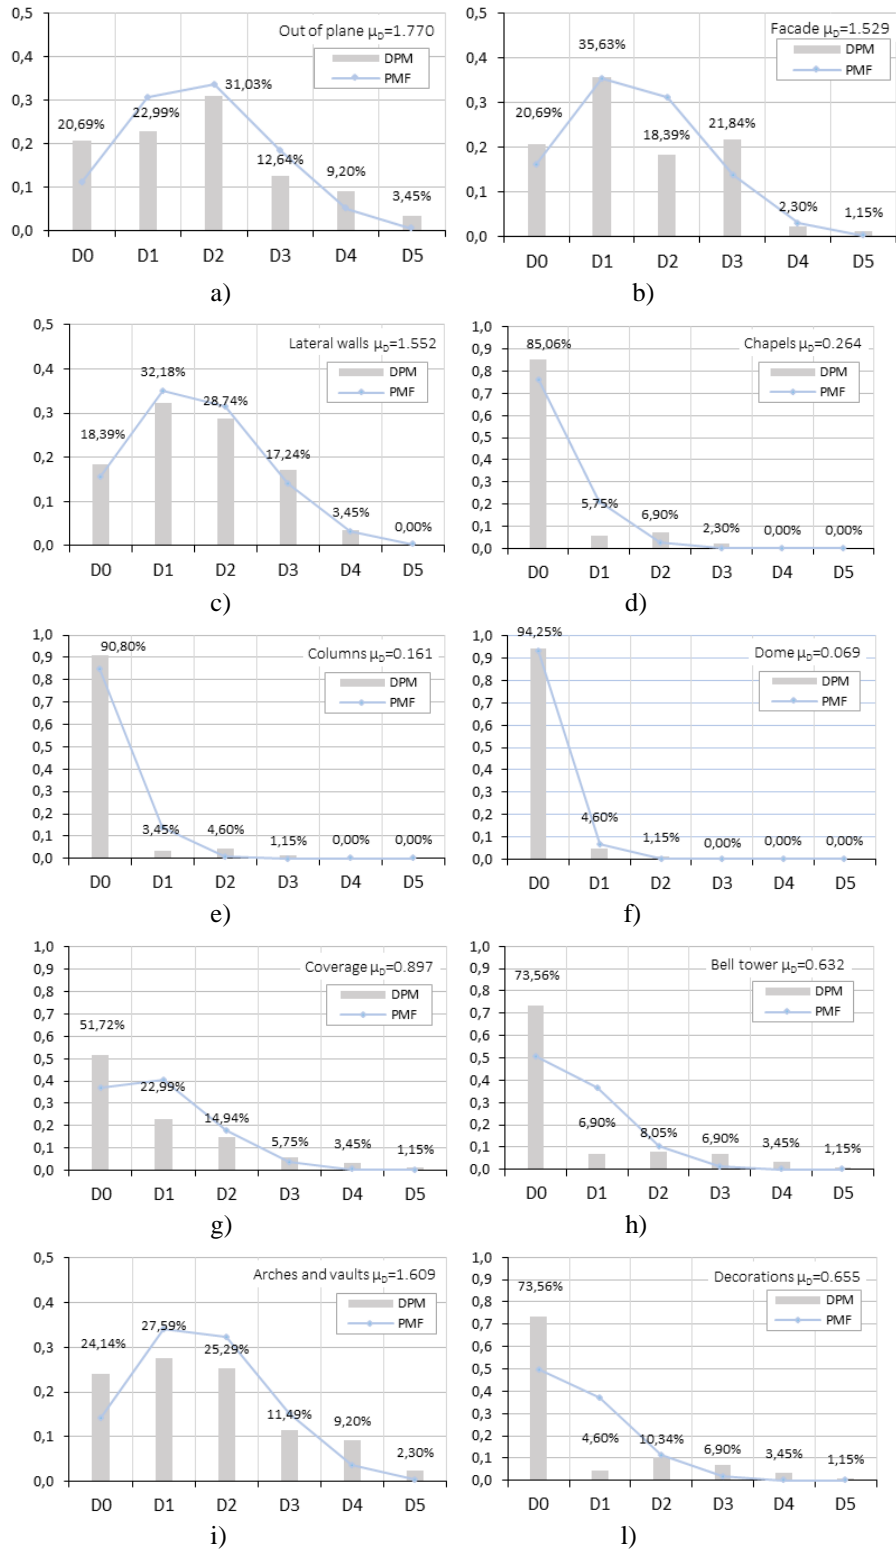
**Figure 11:** Statistical analysis of damage by macroelements with probabilistic interpretation according to binomial distribution (a) Out of plane, (b) Facade, (c) Lateral wall, (d) Chapels, (e) Column, (f) Dome, (g) Coverage, (h) Bell tower, (i) Arches and vaults, (l) Decorations.

The frequencies of the reported damage are shown in Figure 10. It is interesting to note that, also in this case, the associated damage levels can be well interpreted through the application of the binomial probability distribution that, therefore, can be intended as a predictive tool also when the prevision is carried out on the single mechanisms involving the single macroelements. This result confirm what was found in [12] by the Authors with reference to the churches in Abruzzi hit by the 2009 L'Aquila earthquake.
