# TYPOLOGICAL CLASSIFICATION AND OBSERVED DAMAGE PATTERNS OF MASONRY CHURCHES AFTER THE 2016 CENTRAL ITALY EARTHQUAKE

G. CIANCHINO<sup>1</sup>, G. DE MATTEIS<sup>2</sup> AND G. BRANDO<sup>1\*</sup>

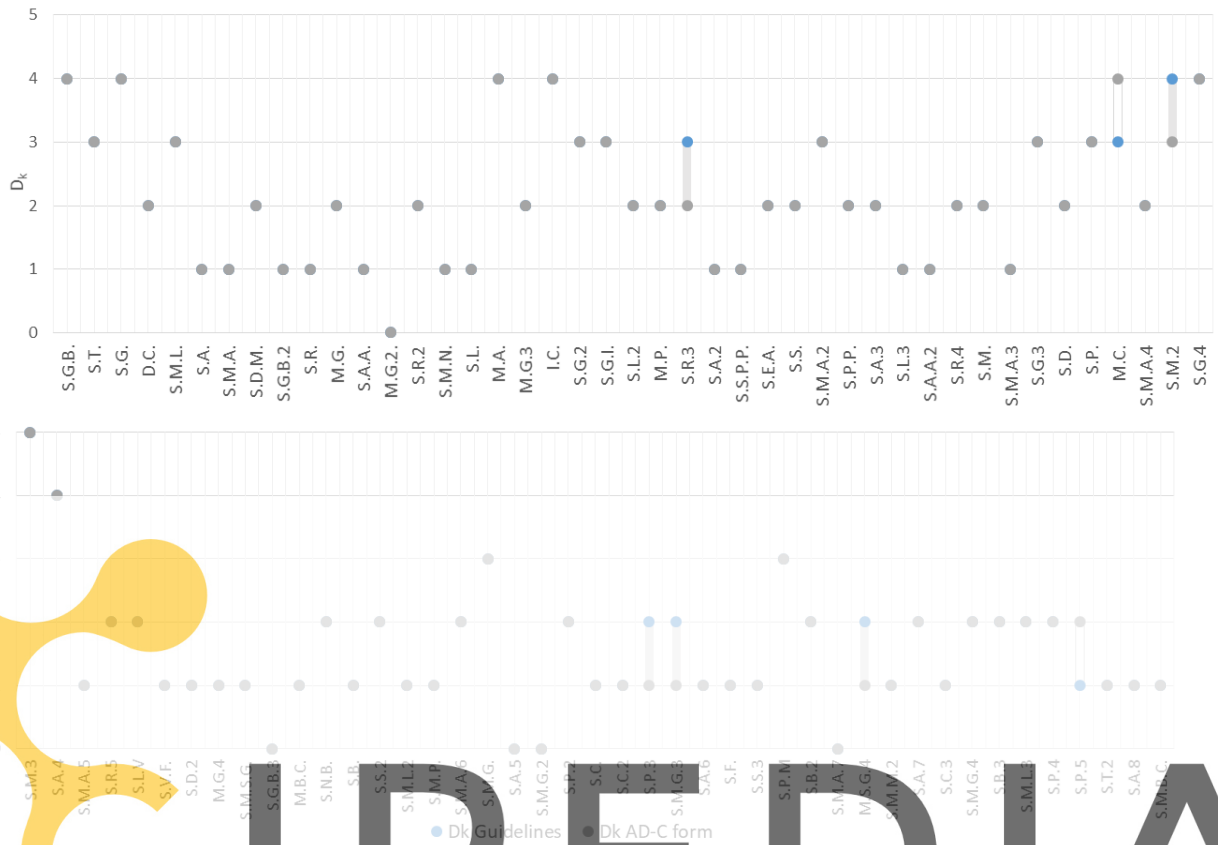
The obtained  $D_k$ , obtained according to the two procedures discussed in Section 4.1 and 4.2, are reported in Figure 6 (organized in two graphs arranged on two rows). As it is possible to observe, the two procedures give almost the same results except for six cases.

Figure 6: Damage levels ( $D_k$ ) for churches

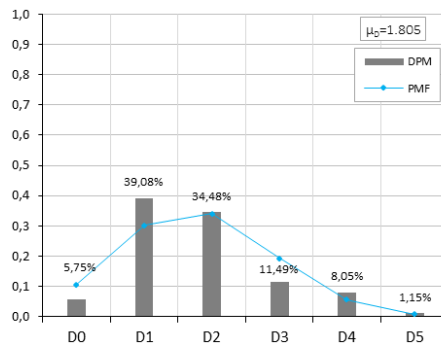
Always in Figure 7, it is possible to observe that the gathered frequencies could have been predicted by applying the binomial probability distribution (DPF) provided in eq. (3), once that the mean damage  $\mu_D$  had been assessed.

**Figure 7:** Damage Probability Matrix (DPM) of the analyzed churches

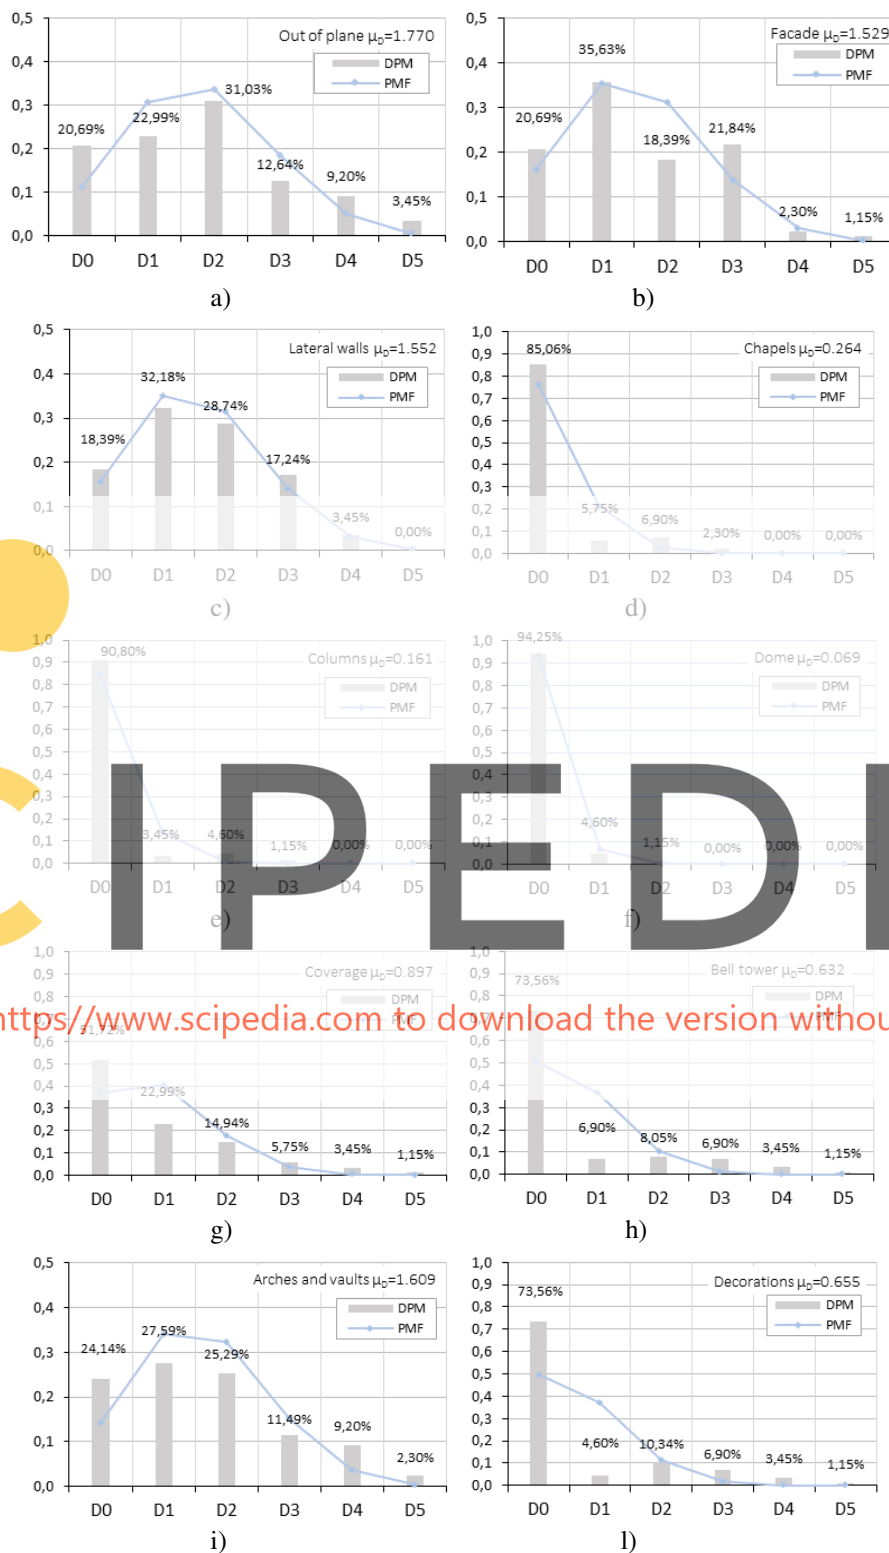
The frequencies of the reported damage are shown in Figure 10. It is interesting to note that, also in this case, the observed damage levels do not deviate from the prediction of the binomial probability distribution that, therefore, can be intended as a predictive tool also when the prevision is carried out on the single mechanisms involving the single macroelements. This result confirm what was found in [12] by the Authors with reference to the churches in Abruzzi hit by the 2009 L'Aquila earthquake.

**Figure 11:** Statistical analysis of damage by macroelements with probabilistic interpretation according to binomial distribution (a) Out of plane, (b) Facade, (c) Lateral wall, (d) Chapels, (e) Column, (f) Dome, (g) Coverage, (h) Bell tower, (i) Arches and vaults, (l) Decorations.
