FATIGUE ASSESSMENT OF OLD RIVETED RAILWAY BRIDGES: LABORATORY TESTING OF A REAL BRIDGE

JOSÉ M. ADAM*, PEDRO A. CALDERÓN¹, MANUEL BUITRAGO¹, ELISA
BERTOLESI¹, JUAN J. MORAGUES¹, SALVADOR IVORRA², BENJAMÍN
TORRES²

Abstract. *The bridge over the Quisi Ravine in Alicante Province (Spain), built between 1913 and 1915, consists of six 22-22-42-42-22-22 m long steel Pratt truss spans, the lateral spans being isostatic and the central spans continuous. All the joints between the steel elements are riveted. As the bridge has been carrying railway traffic for more than 100 years, its condition needed to be assessed before carrying out the necessary repairs-reinforcement to extend its service life. One of the most interesting tasks on the bridge involved a study of its fatigue behaviour to estimate its remaining useful life. Only a few kilometres away there happened to be another bridge with identical geometry over the Ferrandet Ravine, which had recently been dismantled and taken out of service and had carried the same railway traffic as the one over the Quisi Ravine. Advantage was therefore taken of this unique opportunity to test one of its isostatic spans in order to extrapolate the res

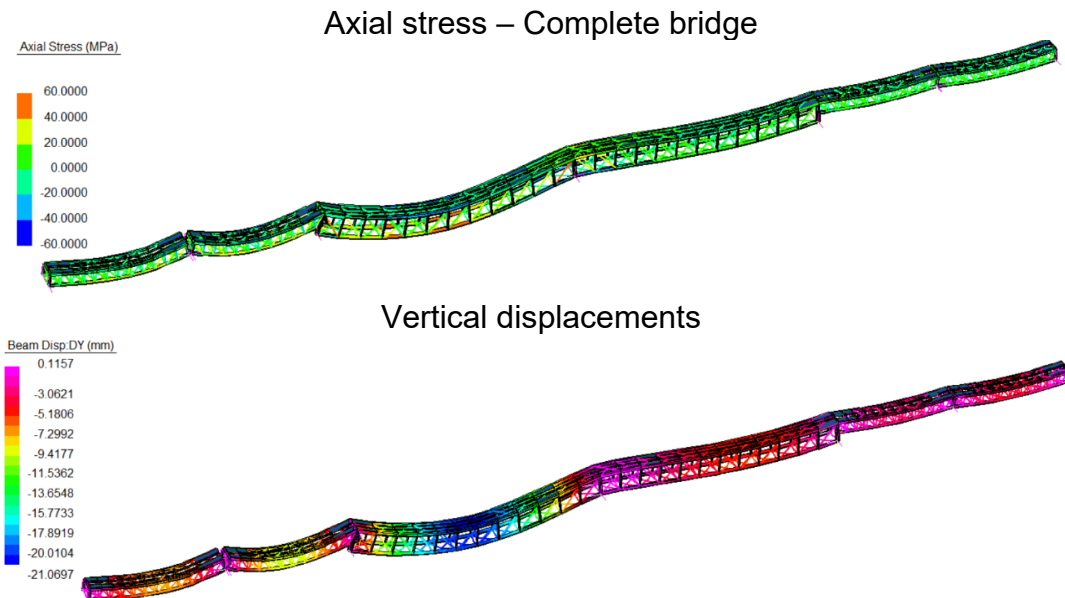
Figure 5. Axial stress and vertical displacements of the structure.

Results were obtained for the geometry of the different bridge elements and a linear-static analysis. For example, Figure 5 gives the axial stress structural response and the vertical displacements of the structure for a specific load hypothesis. As can be extracted from the structural response and as expected, the bridge behaviour consisted of a series of isostatic and continuous high-depth beams (trusses) mainly loaded with axial forces. However, certain components had a highly local behaviour and transmitted the train loads to the main trusses by means of a series of elements working with bending stresses. Figure 6 shows the stress values of one of these elements with local behaviour working under bending stresses.

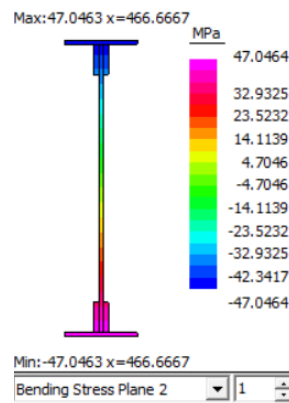
Figure 6. Stresses on an element with local behaviour.

It can be seen that train loads had different effects on the structure: a) a truss behaviour defined as the main general structural response of the structure, and b) a local behaviour of some elements under bending stresses. The study of the bridge's fatigue capacity and remaining service life was thus in two directions to evaluate both its local and general behaviour.

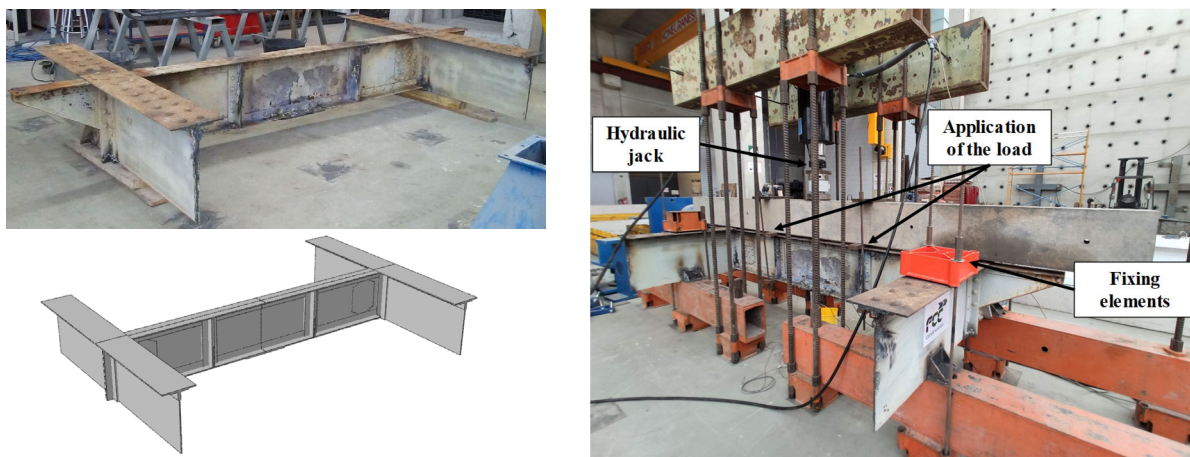
Figure 7. Element selected for testing (left) and test setup (right).

The test was on a lateral joint element with the top chord of the main truss of the bridge as shown in Figure 7, which shows the test setup.

In these conditions the element was subjected to local loads that reproduced similar bending and shear stresses to those in the bridge. The applied load was defined with the aid of computer models (see also Figure 7). Diverse situations were modelled under different loads. The highest stresses and lowest number of cycles before failure were obtained at the highest load levels. The load increment finally selected was 600kN. The Von Mises stresses in the constant bending moment zone at the centre of the element were expected to reach maximum values of 212.6 MPa, at which the number of estimated cycles before failure was 74,472, adopting a category detail of 71 [4] without considering a previous history of accumulated repetitive loads.

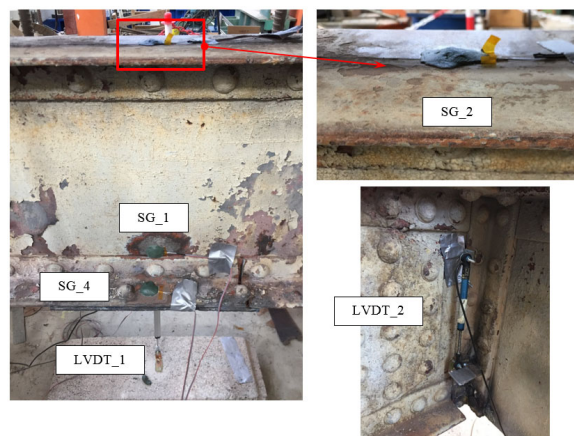
Figure 8. Position of the sensors.

The test was continually monitored by four strain gauges (SG) to measure deformations and two LVDTs to measure deflections and any slippage between the rivets and plates subjected to the highest shear stresses. The positions of the sensors can be seen in Figure 8.

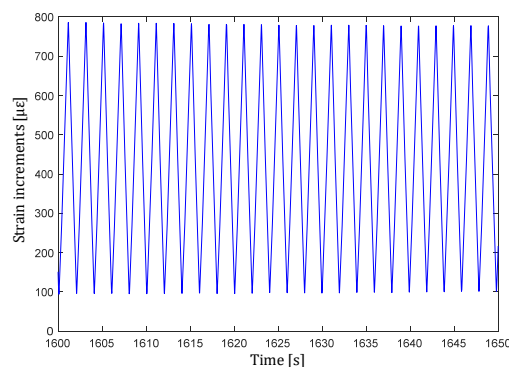
Figure 9. Example of strain measurements.

Figure 9 gives an example of the readings from a strain gauge in a short period of time and Figure 10 shows the evolution of the deformation increment measured in each cycle from the start until failure (cycle 31377). The element failed at normal stresses in cycle 31377. Figure 10 shows the fatigue crack that started at the bottom of the element (zone in tension) and propagated to the top of the beam element.

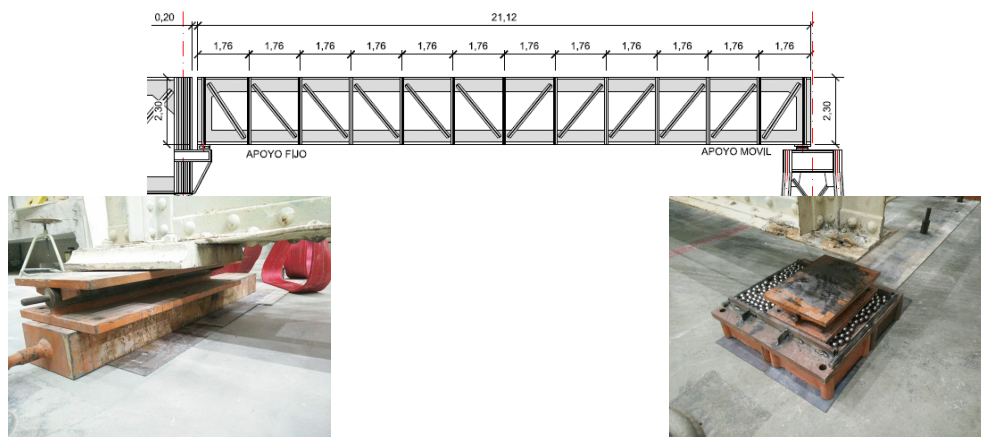
Figure 13. Support system used in the tests.

The system used to support the span in its original location was used in the lab tests: hinges that allowed rotation around an axis at each end and metal boxes containing steel ball bearings that allowed longitudinal movement at one end only. Figure 13 shows the supports used in the test setup, while Figure14 contains a view of the span at the *ICITECH* laboratories.

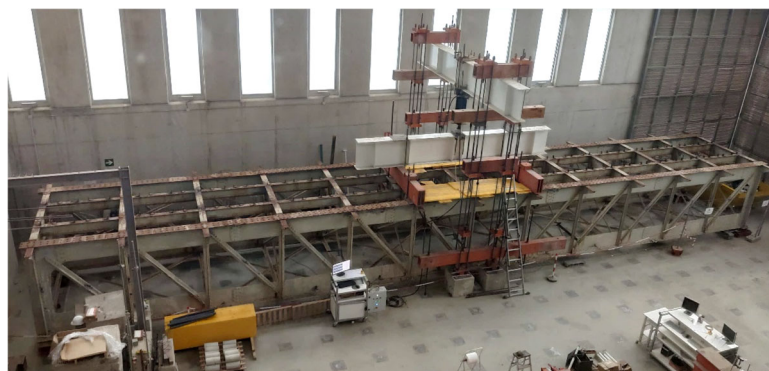
Figure14. General view of the bridge span at the *ICITECH* laboratories.

The tests revealed clearly elastic linear behaviour with no apparent damage, based on:

- Stresses clearly lower than the yield stress in the different elements.
- Similar deformation and stress patterns were found in the first and last cycle. Variations were less than 5% in all cases and below 2.5% in 85% of cases.
- Similar deflections and horizontal displacements were found during the entire test and all were below 3%.

The dynamic test gave a variation of 8.40Hz at the start and 8.05Hz in the first mode of vibration in the structure at the end of the cycle, which implies a frequency reduction of 4.2% and shows a slight increase in the bridge flexibility. Together with the variations obtained by the deformation and displacement sensors, this value shows the minimum variation in the general bridge behaviour after the intense fatigue test it had been subjected to. There were no signs of failure or weakness in any of the elements.
