Study on a Proper Repair Cycle of Finishing Materials in Condominiums

Abstract. *In this paper, we discussed the concept for appropriate repair period for finishing materials of reinforced concrete structures. We investigated the actual building repair cycle, the progress of carbonation of concrete, and the adhesion strength of various finishing coating. In addition, we carried out 10-years exposure test of concrete with various finishing to evaluate the progress of carbonation and the degree of deterioration of the finish coating material. From these results, we showed the possibility of extending beyond the current repair cycle.*

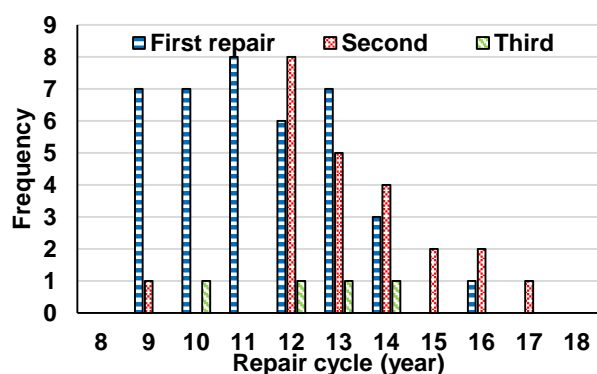
**Figure 1.** Cycle and number of exterior repairs.**Table 3.** Repair cycle for each finishing materials.

Figure 1 shows the cycle and number of exterior walls repair carried out in 222 condominiums that were analyzed in this study. The cycle was an average of 12 years, with a minimum of 9 years and a maximum of 17 years. More than 70% of the first repairs were done by the 12th year. Most of the second repairs were carried out after the 12th year, and the cycle was longer than the first repair. Among the targeted apartment houses, there were only a few them that over 30 years old and the third large-scale repair work was carried out.

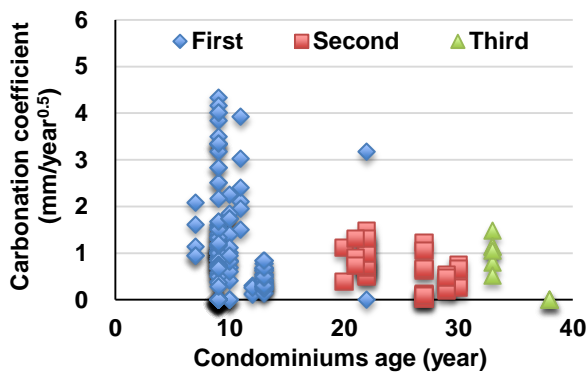
Figure 2. The carbonation speed coefficients for different ages.

Figure 2 shows the carbonation coefficient for condominiums with different ages. Although it shows a few relatively large numbers after approximately 10 years, most of numbers are less than 1.50 after 20-30 years. Previous studies have revealed the relationship between carbonation coefficient and compressive strength in unfinished concrete.⁵⁾ Assuming that the carbonation coefficient of targeted condominiums is estimated to be about $3.00 \text{ mm}/\text{years}^{0.5}$. Therefore, since the carbonation coefficient was kept low, the carbonation preventive effect has been maintained by repair work for more than 30 years.

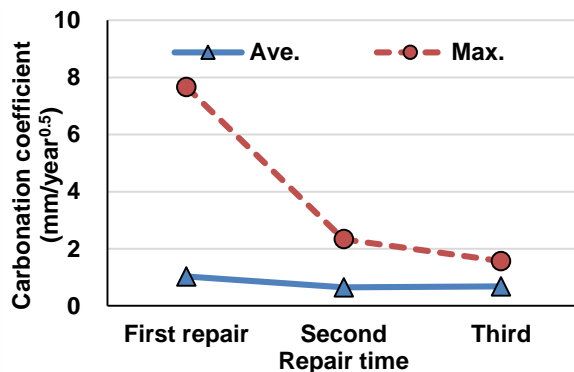
Figure 3. The carbonation coefficients for each repair time.

Figure 3 shows the carbonation coefficient for each time of repair work. The average carbonation coefficient is about 0.5 to $1.0 \text{ mm}/\text{year}^{0.5}$. On the other hand, the maximum value for the first repair can be confirmed similar value to that of the unfinished concrete. However, in both the second and third repair, the maximum value is significantly lower than the first repair. This is an effect of recoating that the defective part at the time of construction such as pinhole was repaired.

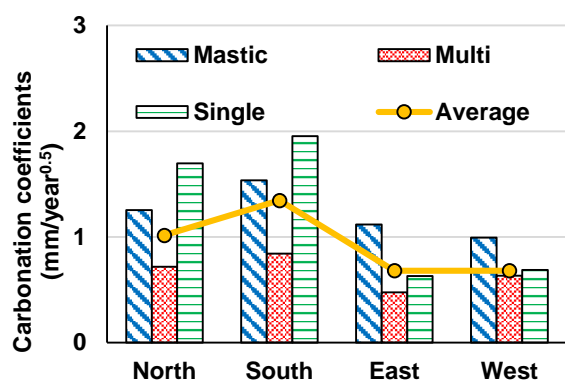
Figure 4. The carbonation coefficients for each direction.

Figure 4 shows the average of the carbonation speed coefficients for each orientation. The norther and southern sides show slightly larger values than the eastern and western surfaces, especially with thin coating materials. The southern surface has the highest amount of solar radiation, so it is possible that it is more susceptible to UV degradation than other surfaces. In addition, it is known that neutralization is more likely to proceed with dry concrete. In other words, the southern side was in an environment where it was easy to carbonate due to the prolonged dryness caused by solar radiation. According to this result, there is an orientation in

which the deterioration of the finishing material tends to proceed. On the other hand, the reason for the high numerical value on the north surface is unclear, so we analyzed further about relationship between carbonation and orientation in the exposure test conducted in 3.2.

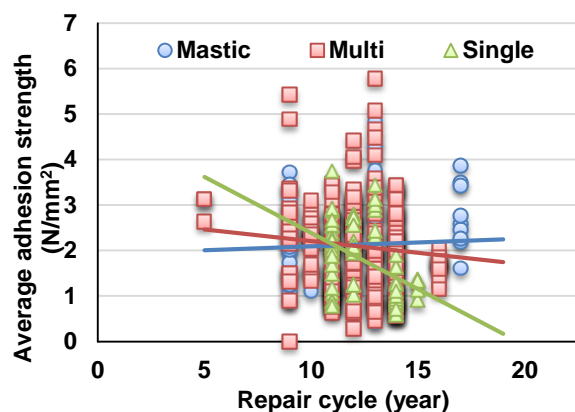
Figure 5. Adhesion strength for each repair times.

Figure 5 shows the average adhesion strength for repair cycle. Mastic and multi-layer adhesion strength almost did not deteriorate. However, single-layer coating strength deteriorate, and seem to decline below $0.3\text{--}0.5\text{ N/mm}^2$ that is established as quality standards of single-layer coating in Japanese Industrial Standards⁶⁾ after about 17 years. On the other hand, their strengths were maintained above quality standards in JIS until around 15 years.

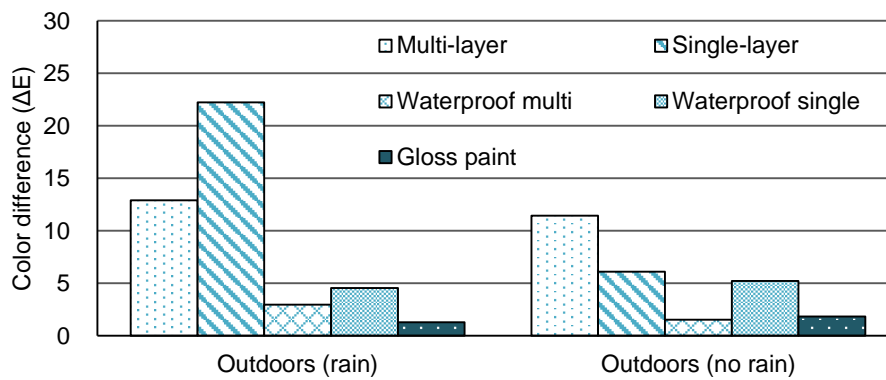
Figure 9. The color difference after 10 years (Coating material).

Figure 9 shows the color difference of coating material specimens exposed outdoors. In an environment with rain, the color difference is large overall, especially in the single-layer coating. In general, the evaluation standards of color difference, people cannot identify color difference when it is lower than 3.2, can recognize a color difference when it over 6.5 and can recognize as a different color when it over 13.0. In these results, the single and multi-layer in an environment with rain coating have deteriorated in design. On the other hand, all finishing materials under eaves were lower than 13.0. However, because the carbonation of single-layer coating progress in under eaves, the change in appearance did not necessarily match the carbonation preventive effect depending on the type of finishing materials or environment. We need to consider changes in appearance and carbonation preventive effects as separate factors.
