HISTORICAL AND TYPOLOGICAL CHARACTERIZATION OF CHURCHES IN THE HISTORICAL CENTRE OF CUSCO, PERU

This article presents a description of the architectural and structural typologies of the churches in the historic centre of Cusco and its relation to the most common failure mechanisms experienced by churches during earthquakes. To this end, this research carefully recreates typologies, geometry, materials and interventions carried on over centuries on these churches. It contributes to the seismic vulnerability knowledge of the studied churches and gives conclusions for decision-makers in future resilience plans.

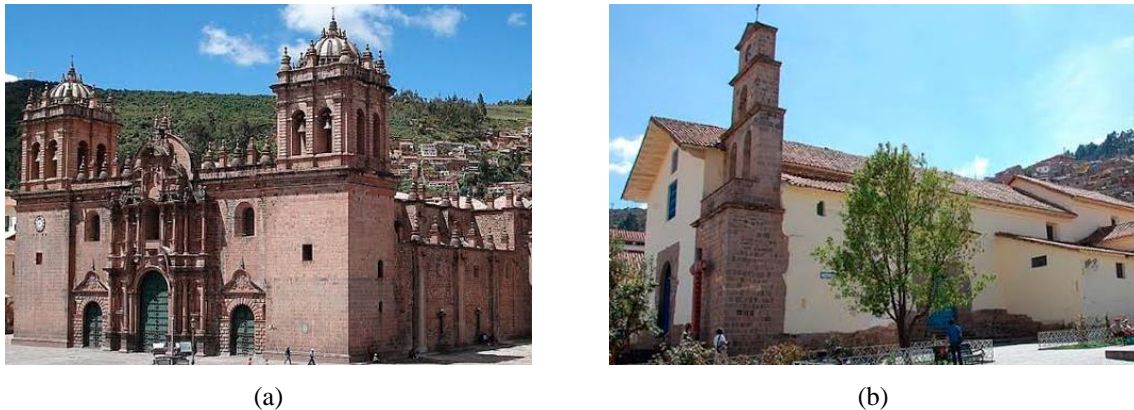
Figure 1: Materials used in Cusco churches a) Stone with lime mortar in the *Basilica de la Catedral* and, b) Adobe with mud mortar in the *Templo de San Blas*.

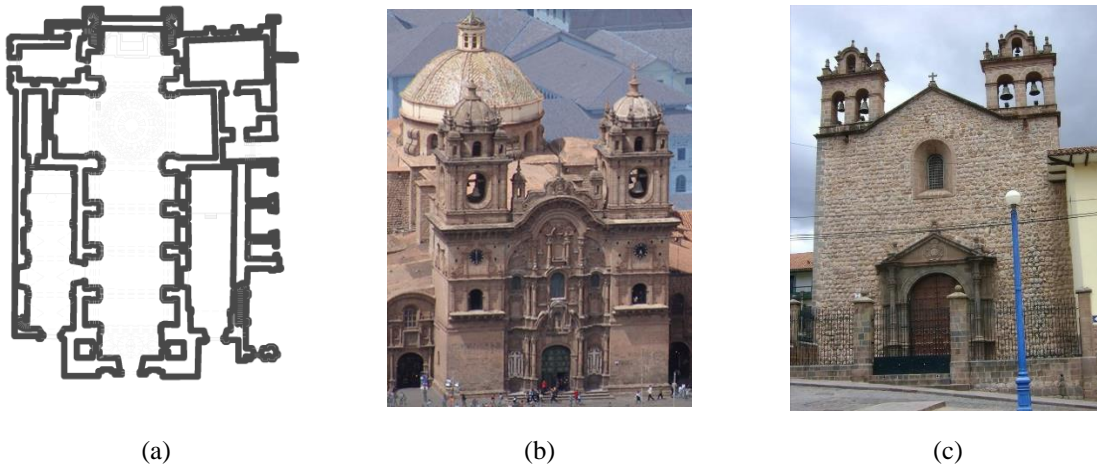
Figure 3: Classic architecture of Cusco churches, a) Latin cross shape plan view, b) façade with three bodies and columns and, c) façade with bell gable instead of bell tower.

The characteristics of most churches are a Latin cross plan view with one central dome (Figure 3a). Furthermore, almost all façades are two or three bodies in height (Figure 3b) with baroque pilasters close to the main entrance. In addition, they have at least one or two towers with round arches or bell gables (Figure 3c).

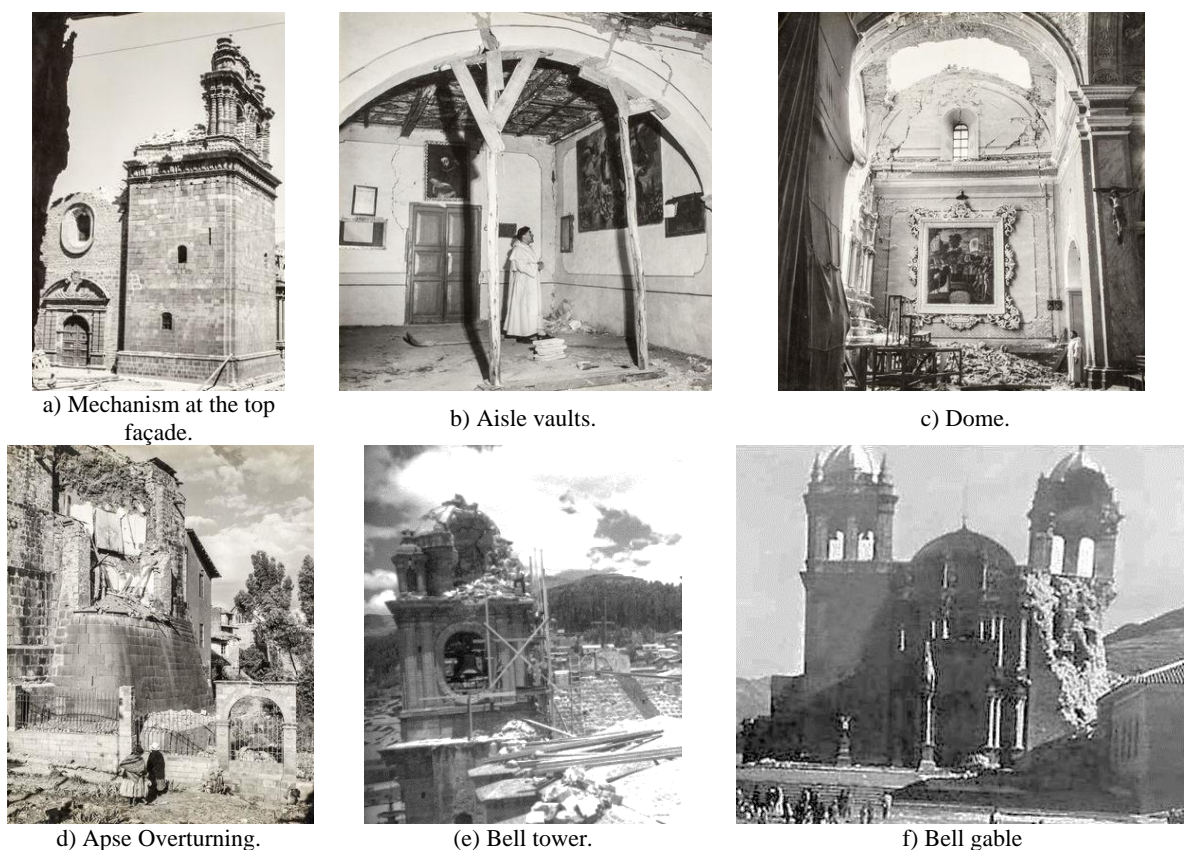
Figure 4: Common failure mechanism in churches of Cusco [7].

After the 1950 Cusco earthquake, six failure mechanisms were reported as the most common in churches [7]: at the façade top, aisle vaults, domes, apse overturning, bell tower fail, and bell gable fail (Figure 4).
