LAMB WAVE ANALYSIS AND DAMAGE DETECTION IN A SKIN-STRINGER COMPOSITE JOINT

Abstract. *Lamb wave qualitative analysis and impact damage detection in a bolted skin-stringer thermoplastic composite component were performed. The structure belongs to an aircraft structural part and represents a complicated structure from the Lamb wave mode identification perspective, especially when the joint is realized only by Hi-Lok fasteners. The sensor network for damage detection included 16 PZT disc transducers, however, additional sensors were exploited for supporting measurements. Two frequencies, representing A0 and S0 modes, were used to evaluate the propagation across the joint. Several impact damages were introduced to the stringer and skin parts of the structure. Suitable propagation mode and frequency for damage detection within the specific skin-stringer part were identified. Sensor configuration divided the test specimen into several sections and enabled measurements within a specific section with a specific frequency. The time delay of A0 mode at 50 kHz was exploited for impact damage detection within the skin part, and S0 mode at 180 kHz within the stringer part. The probabilistic al

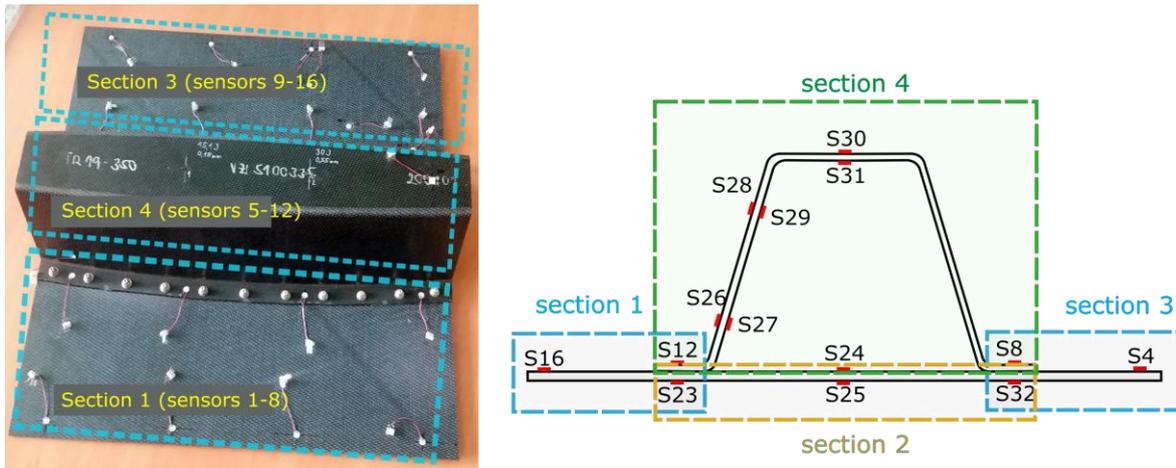
Sixteen PZT disc sensors (No. 1-16) by StemInc were mounted on the test specimens dividing the assembly into four subsections, according to Figure 1a. These sensors were used for damage detection. Sensors No. 23-32 were mounted additionally along the cross-section (Figure 1b) to evaluate Lamb wave propagation qualitatively.

Figure 1: Omega test specimen a) image, b) cross-section scheme

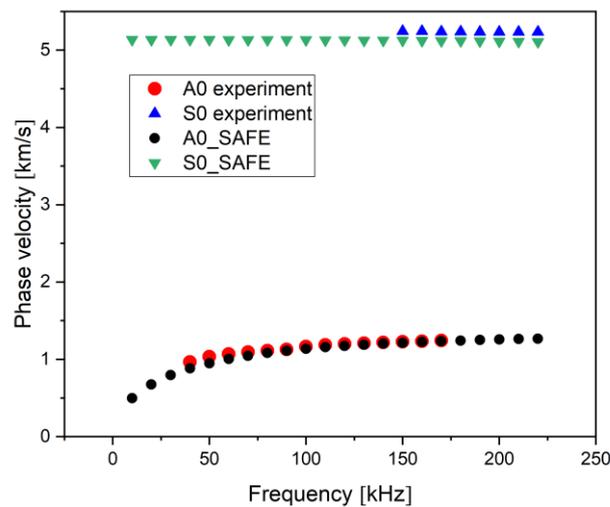
Segments of phase velocity dispersion curves were determined experimentally using the FFT (Fast Fourier transform) filtering method [12] and compared to the calculations using the GUIGUW SW [13]. GUIGUW is based on the SAFE (Semi-analytical finite element) method [9]. Material parameters were used the same as for the plates analyzed in the publication [12]. The skin-stringer assembly is manufactured from the same material.

Figure 2: A segment of a phase velocity dispersion curve – experimental and calculated values

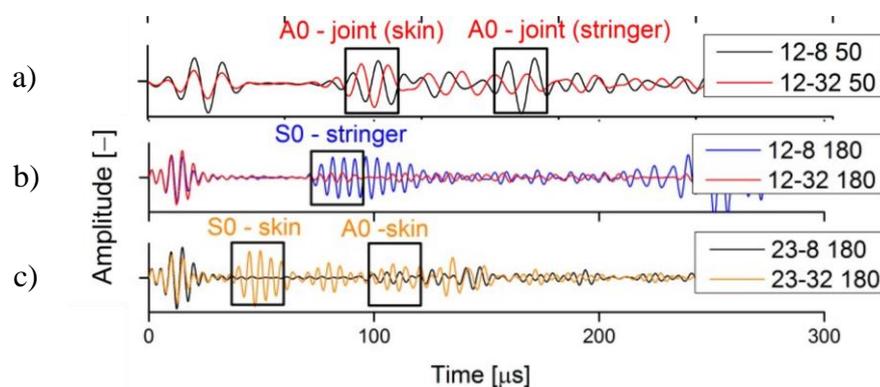
Signals were actuated from the joint at both surfaces (S12/S23). Wave propagation through the joint and the subsequent propagation to the stringer and/or to the skin, and finally to the joint on the other side was observed. The examples of some wave packets are shown in Figure 3 for the frequencies of 50 kHz and 180 kHz, representing A0 and S0 modes, respectively. Other waveforms detected along the whole cross-section are published in [13]. Figure 3a shows the signal actuated at the upper side of the first joint (S12) and detected at the second joint (S8 and S32). At the frequency of 50 kHz, the signals are out-of-phase, hence the propagating mode is A0. Based on the velocity dispersion curves and other waveforms along the cross-section of the stringer and the skin, the first detected wavepacket propagated along the skin (shorter distance) and the other wavepacket along the stringer. The attenuation by the joint is not significant for A0 mode. The same situation for the frequency of 180 kHz is presented in Figure 3b. S0 mode propagates along the stringer with significant attenuation at the joint. Therefore, there is a very low-amplitude signal detected at the bottom side of the joint (S32), and no wavepacket was determined as a wavepacket propagated along the skin. A completely different situation is when actuating at the bottom side of the joint (S23) – see Figure 3c. The wave S0 does not penetrate through the joint to the stringer and propagates only along the skin. The first detected wavepacket is identified as S0 mode and the third as A0 mode. This signal shows that S0 is much more attenuated by the joint than A0 mode.

Figure 3: Wave propagation actuated from the area of the joint at the frequency of a) 50 kHz and b, c) 180 kHz

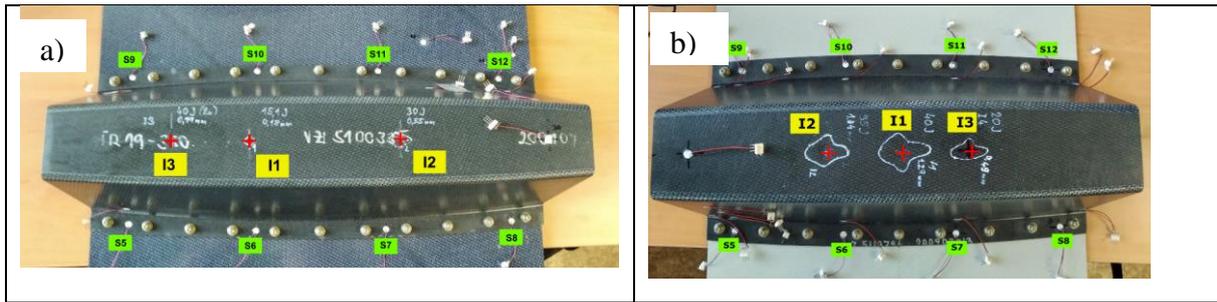
Seven impact damages in total were introduced to the test specimens Omega 1 and Omega 2. The locations are shown in Figure 4 and the impact boundaries are determined by means of ultrasonic A-scan. Parameters of individual impacts in terms of energy and depth are specified in Table 1. Six of them were introduced into the stringer part (section 4) and one to the skin part (section 1).

Figure 4 Test specimen a) Omega 1, b) Omega 2

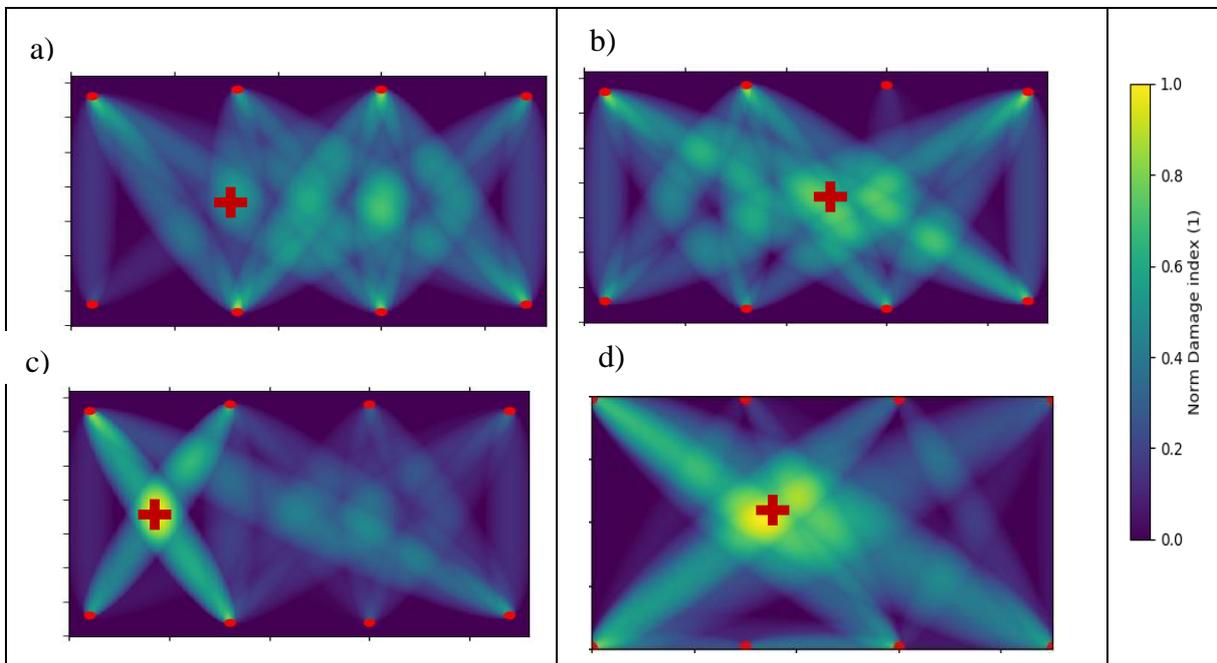
The RAPID visualisation algorithm realized through in-house RAPID GUI SW was used for the damage localization in both, the skin and the omega profile. Figure 5a-c shows results for Omega 1 test specimen. Impacts I1 and partly I2 introduced with the 16 mm impactor could not be localized clearly. On the other hand, the location of I3, which was introduced by a 1-inch impactor, was detected correctly. The impact damage area of I1 is significantly smaller than the rest of them. Impact damage performed to the skin part is seen in Figure 5d.

Figure 5: Omega 1 impact localization using RAPID a) I1, b) I2, c) I3, d) I4

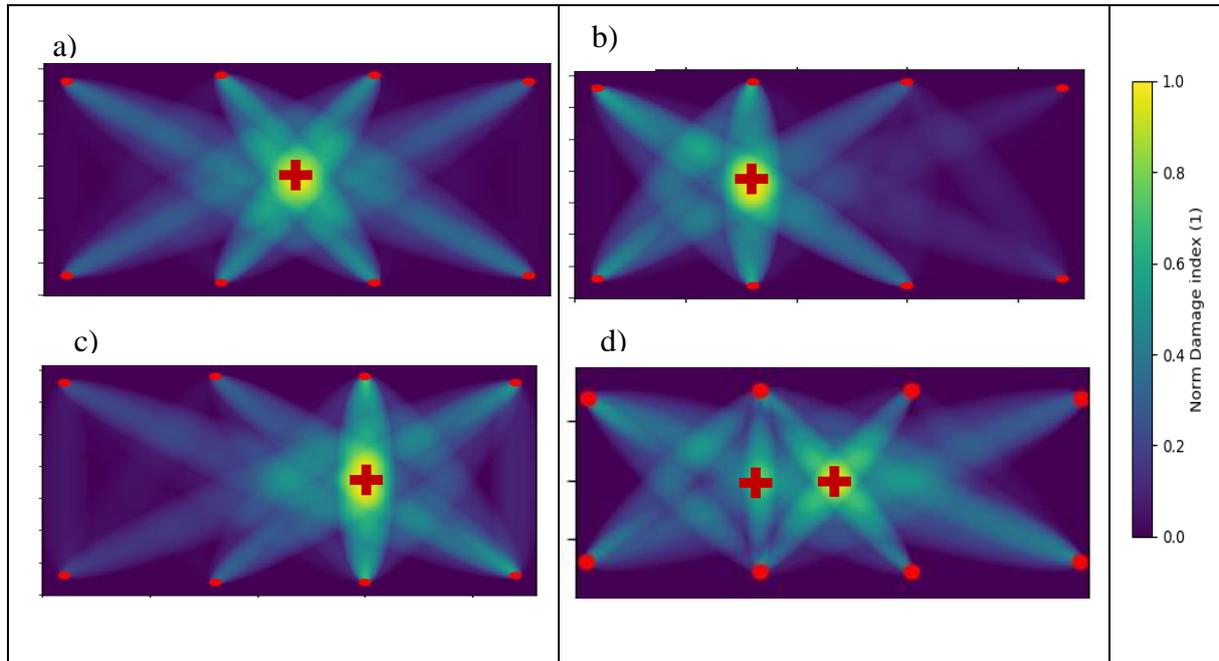
Impact damage areas at the test specimen Omega 2 are much larger than impact damage areas at the test specimen Omega 1. Figure 6a-c shows that all impacts (I1, I2, and I3) introduced by the 1-inch impactor were localized correctly. In addition, the evaluation of two impacts at once was performed correctly (Figure 6d).

Figure 6: Omega 2 impact localization using RAPID a) I1, b) I2, c) I3, d) I1+I2
