## “IRON CAGES.” TECHNICAL DISCUSSIONS AFTER THE 1906 VALPARAÍSO EARTHQUAKE AND RECONSTRUCTION WITH NEW TECHNIQUES AND MATERIALS

SANDRO MAINO<sup>1\*</sup>, KATHERINE CABEZAS<sup>2</sup> AND MARION KOCH<sup>2</sup>

**Keywords:** earthquake-resistant construction, Steel frame, Prefabrication, Factory Building, Chile

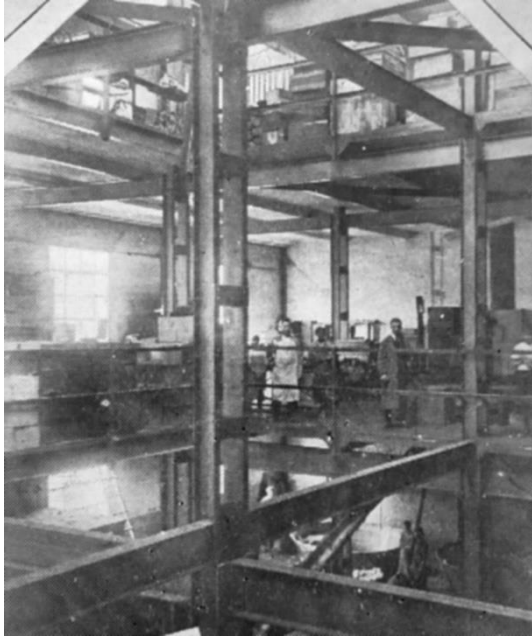
**Figure 11:** Interior of La Estrella soap factory (Source: German progress in America, 1924).

"La Estrella" factory is a rectangular-shaped volume with three blindsides and a façade facing the street, measuring 33 by 22 meters at the base and 19 meters high from its underground level (figure 11). Structurally, the building's interior is regularly divided into six bays on its longest side and four cross bays, while its height is made up of three open-plan floors plus a basement level, with the upper levels connected by a large central void that served as ventilation and natural lighting system (figure 12). The factory is structured by steel elements from the underground level to the roof, with reinforced concrete enclosures in the whole of its perimeter walls. Additionally, brick masonry is used as a lining for the metal elements located in the underground, as a strategy for protection against moisture and to provide greater strength. The metallic skeleton is made up of seven frames that cross the smaller side of the volume, composed of five pillars each and intersected in the same direction by main beams and a transversal framework of eleven secondary beams that tie up the set of structural elements. The perimeter of the building has stiffening elements, which in its smaller walls, are made up of V-shaped braces that intercalate their orientation between floors, from the basement to the roof (Figure 13). As for the larger walls, stiffening is based on the formation
