# AMAZONAS THEATER ARCHITECTURAL CONSTRUCTION AND RESTORATIONS HISTORY

MARIA S. M. SAMPAIO

**Keywords:** Amazonas Theater, Historical Structure, Construction History, Restoration

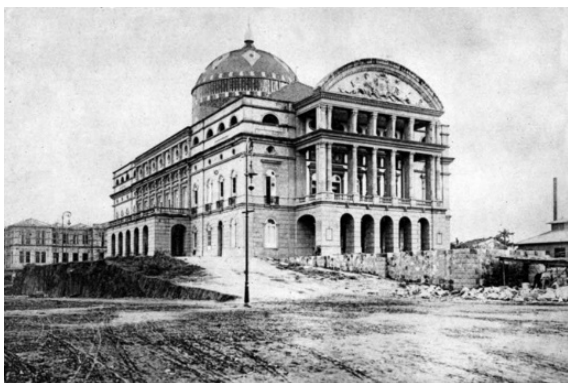
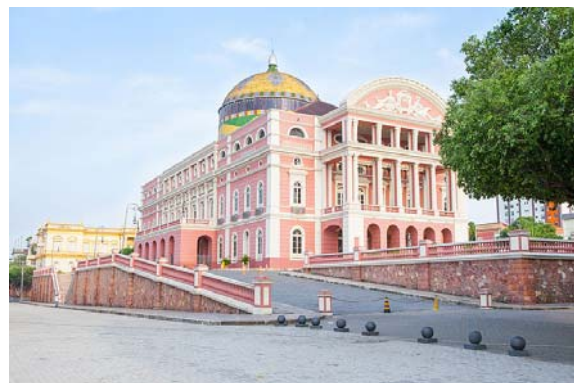
**Figure 1:** a) Amazonas Theater in construction [1,2]; b) Amazonas Theater in 2019.

Located in the middle of the Amazon forest in Manaus, Amazonas capital city, Brazil, the Amazonas Theater (Figure 1) took 17 years to be built from its conception until its opening in December 31, 1896. A place that would be frequented by the elite of *belle époque*, as it was called the period in which Manaus lived the golden age of rubber, Amazonas Theater became a symbol of a period of prosperity.

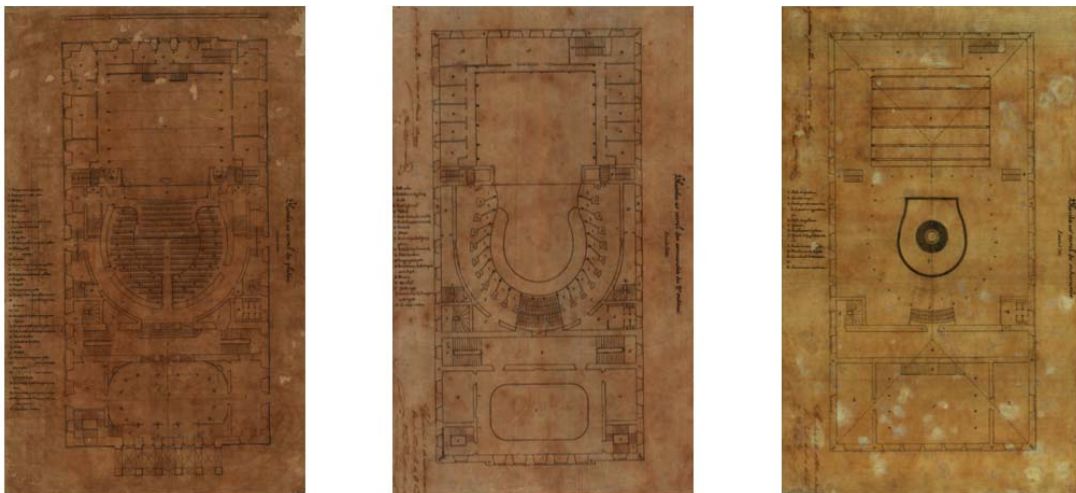
**Figure 2:** Original drawing of the Portuguese Office of Engineering and Architecture of Lisbon [16]: a) Ground floor plan [16]; b) 3th floor plan [16]; c) Attic plan [16].

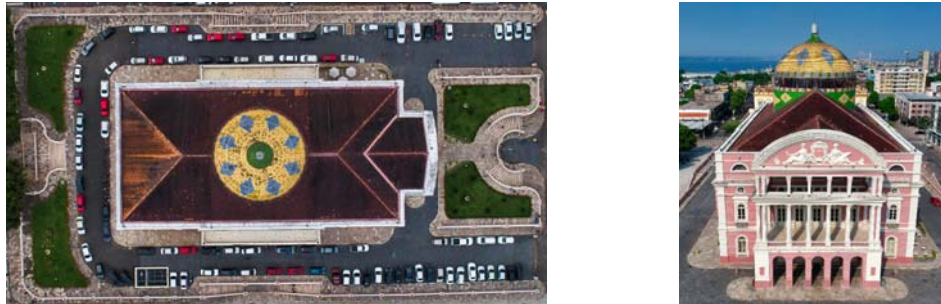
**Figure 3:** Amazonas Theater: a) Upper View; b) Frontal facade. Photo by Ivo Brasil Filho on June 4, 2019 [17].

When researched about the structural solutions and construction details of the Amazonas Theater, it can be easily seen that Amazonas Theater have a very simple patterns, including a simple dome above, and a very common roof solutions. The construction structure of the theater is quite conventional, adopting the traditional four-walled box format (Figure 3a).

The facade is divided into three bodies, the prominent central body consisting of a frame that, on the ground floor, has five arches supported by pillars. On the second floor of this frame, there is a balcony surrounded by balustrades interrupted by the bases of the eight Corinthian columns that camouflage the pillars and support the entablature; above it stands another set of pillars that support the base of the pediment, these pillars being disguised by eight small pillars with capitals decorated with feminine faces. On these elements stands the curved pediment which in its tympanum presents a relief set composed of two female figures, probably allegories to music and theater, among them a card engraved with the date 1896 (Figure 3b).

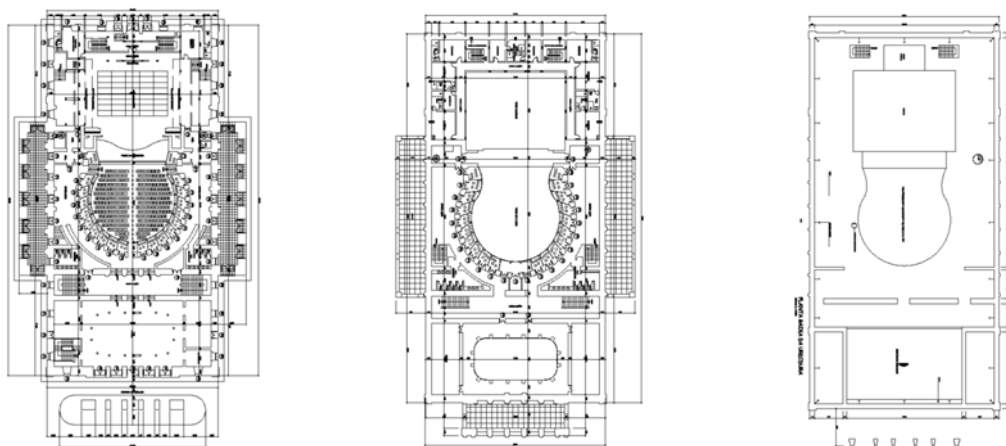
**Figure 4:** The plans of Amazonas Theater after renovation of 1972-1974: a) Ground floor plan; b) 3th floor plan; c) Attic plan. Filed in the Amazonas Theater Museum [18].

The Amazonas Theater has a ground floor, three floors and the Attic floor (Figure 4), being covered in masonry treated with continuous bossing, except for the floor corresponding to the Attic floor. The mains environments on the ground floor are the Foyer and the Concert Hall. The Noble Hall is located on the first floor. In the ground floor, the audience has 266 armchairs and 93 chairs distributed in 20 trimmings.

The 1st floor has 110 chairs distributed in 22 staterooms and the Governor's cabin. The 2nd floor has 125 chairs distributed in 25 cabins and finally, the 3rd floor has 95 chairs distributed in 19 staterooms. In according to the architectural ground plan, the Amazonas Theater has a plan with around 60.80 m x 30.80 m and a height of 35 meters considering the dome.

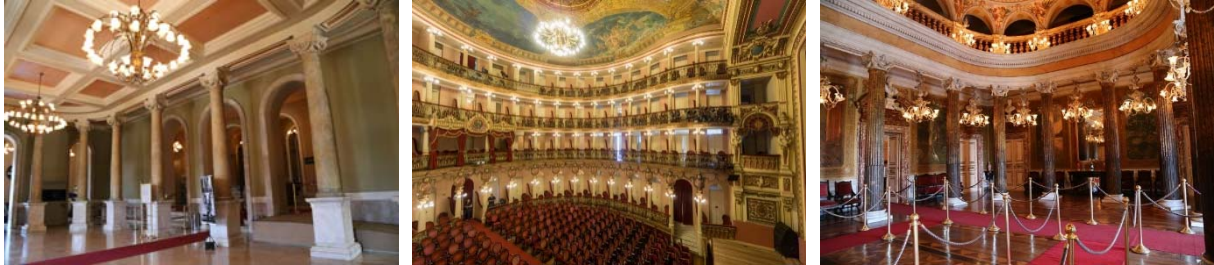
**Figure 6:** Amazonas Theater in 2019: a) Foyer; b) Concert Hall; c) Noble Hall. Filed in the Mário Ypiranga Library [19].

The Foyer has 16 iron columns from Glasgow lined with concrete supported by pedestals lined in marble (Figure 6a).

The Concert Hall has a floor plan in the shape of a lyre or horseshoe. Around this hall there are three floors of cabins or friezes. Between the friezes on the ground floor there are columns of the Ionian order. These concrete-coated iron columns extend to the third floor, the capitals are of the Corinthian order. There are a total of 22 iron columns from Glasgow (Figura 6b). The decoration of the Concert Hall is by Crispim do Amaral. The ceiling of the Amazonas Theater concert hall consists of a barrel vault, an arched roof, built in wood pieces that lean into each other, in order to support their own weight and external loads. The wood used are blonde lead

wood and black wood called “envira”. The barrel vault structure, all made of interlaced wood, forming a kind of the shell which is supported by a intricate system of levers and wood beams, attached to rods, to resist efforts, forces or stress, fixed to the iron frame of the ceiling.

The Noble Hall also has 16 columns. Although supported by Carrara marble, the shaft is covered in plaster in order to imitate marble. The floor of the Noble Hall is the most original part of the Amazonas Theater, composed of 12 thousand pieces of wood placed with a technique called marquetry, which consists of not using nails or glue, making the woods stay in the perfect fit position. between the pieces. It is important to highlight that the Noble Hall decoration work, performed by the Italian painter Domenico de Angelis, extended for a few years after the official opening in 1896 (Figure 6c).

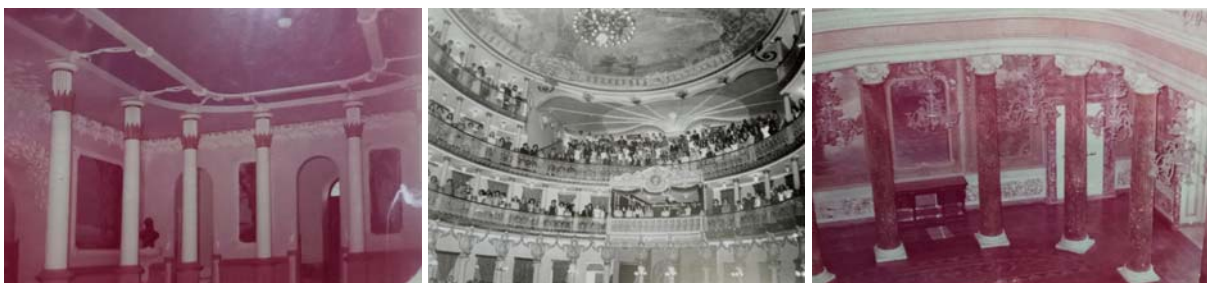
**Figure 7:** Amazonas Theater after renovation of 1926-1929: a) Foyer; b) Concert Hall; c) Noble Hall. Filed in the Mário Ypiranga Library [19].

In the Ephigênio Ferreira de Sales administration (1926-1929), the building underwent internal changes (Figure 7a,b). The seven front cabinets of the second order were removed and a grandstand topped by a large stylized shell was built there (Figure 7b). There was also suppression of internal walls, which separated two longitudinal and continuous corridors to the friezes of the first order. The orchestra venue was expanded and stucco and painting works were done in the hall and corridors [20,21,22]. The Foyer was decorated with *guaraná* leaves and half *pupunhas* changing the original design of the Theater (Figure 7a). No record of changes in the Noble Hall during this renovation was found (Figure 7c).

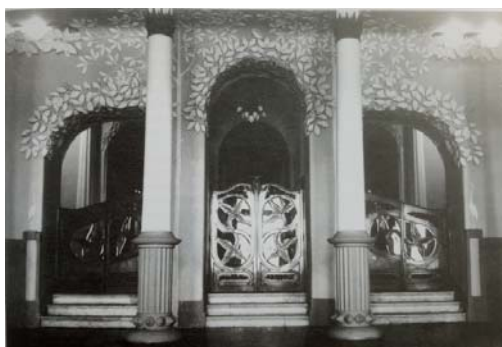
Figure 8 shows the branches of *guaraná* behind the columns. The columns with capitals alluding to the Amazonian flora have half *pupunhas* and simple half flutes on the plinth [19].

**Figure 8:** Foyer after renovation of 1926-1929. Filed in the Mário Ypiranga Library [19].

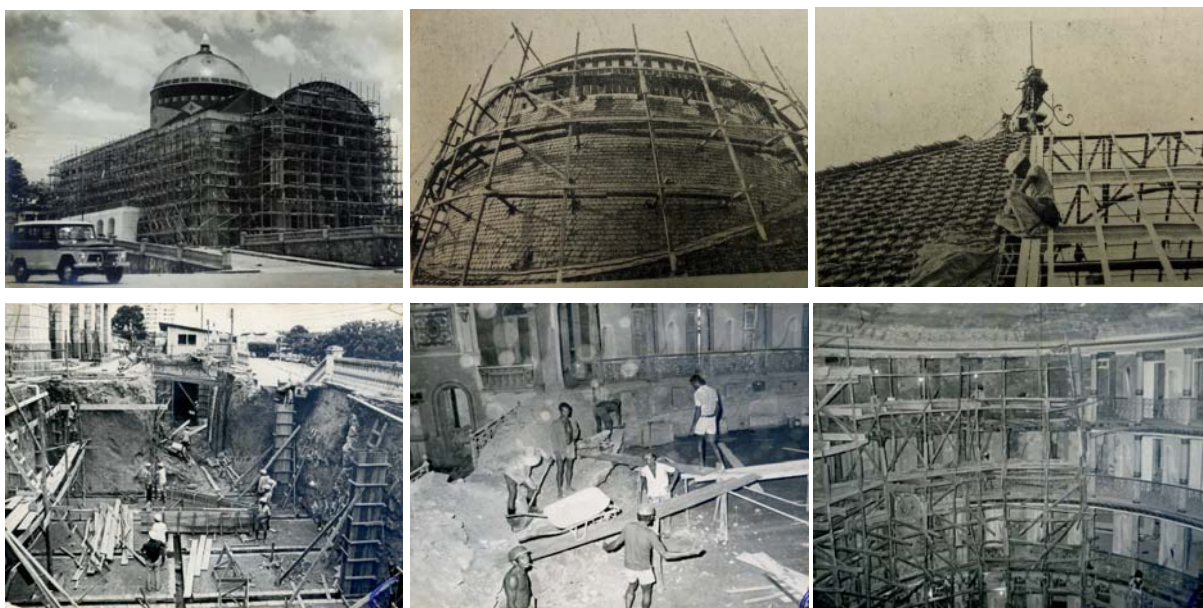
**Figure 9:** Amazonas Theater under renovation of 1972-1974: a) The facade [19]; b) The dome roof [19]; c) The roof [19]; d) Excavations for the construction of the air conditioning unit and generator room [18]; e) Internal works of the Concert Hall [18]; f) Renovation of the friezes of the Concert Hall [18].

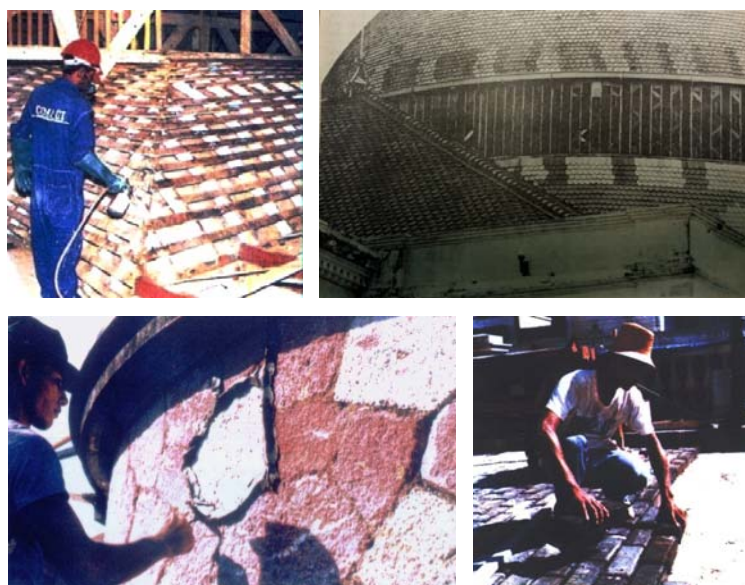
**Figure 10:** Amazonas Theater under renovation of 1987-1990: a) Treatment of the wooden structure of the Concert Hall plafond [18]; b) The dome roof [19]; c) Apparent surrounding wall restoration [18], d) The parallelepiped blocks restoration [18].

The woods underwent several types of treatment. Thousands of liters of immunizers were consumed. Even so, about 40 m<sup>3</sup> of wood totally damaged by the action of termites had to be removed. The new woods that were applied strictly followed the same specifications as the previous ones (Figure 10a).

The wall surrounding the theater was completely painted and grafted with cement and sand mortar imitating stone. As the research showed the wall was originally apparent, all the suspicious material found was removed and other stones with the same characteristics were cut and placed in the necessary places (Figure 10c).

The imported stones on the external sidewalks and staircases that had defects were reconstituted. The parallelepiped blocks of the external street were analyzed and 74 thousand pieces with the same characteristics and resistance as the originals were produced and laid (Figure 10d).

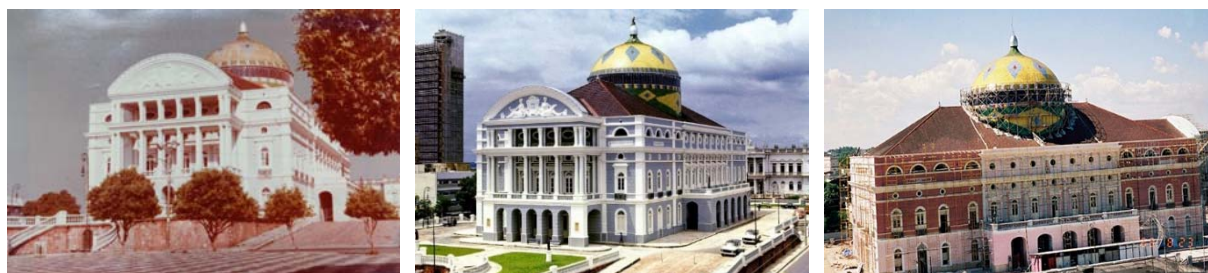
**Figure 11:** a) Before restoration of 1972-1974 painted in gray [19]; b) Under renovation of 1972-1974, painted in bluish gray [19]; c) Under renovation of 1987-1990, when it was painted in imperial rose, its current color [19].

During its renovations, the Amazon Theater had the colors imperial rose, bluish gray, and gray. Currently, Amazonas Theater is back to being imperial rose (Figure 11).
