Experiments and Fragility Analyses of Piping Systems Connected by Grooved Fit Joints With Large Deformability

Keywords: piping system, grooved fit joints, large deformability, quasi-static test, leakage limit state

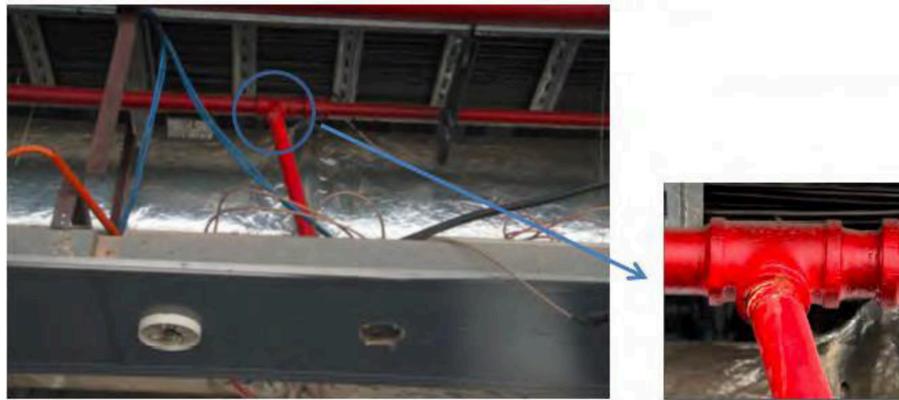
FIGURE 1 | Fractured piping tee joint at the Santiago Airport after the 2010 Chile earthquake.

non-structural components such as suspended ceilings, light fixtures, and fire sprinkler piping systems. The two largest airports in Chile were closed as well because of non-structural damages and flooding from failed sprinkler piping systems (Ju, 2011; Miranda et al., 2012; Tian et al., 2014). One typical fracture failure of the piping tee joints at the Santiago Airport is shown in **Figure 1**, which resulted in significant water leakage and further mitigated the functionality of the airport. **Figure 2** shows the percentages of damaged piping systems over all investigated piping systems in previous earthquakes (Steinbrugge, 1982; McKevitt et al., 1995; Fleming, 1998; Global, 2001; Dillingham and Goel, 2002; LeGrone, 2004; Chock, 2006; Miranda et al., 2012). In the 2011 Tohoku Earthquake, about 8% of the investigated piping systems suffered damages, among which pipelines dominated with 49% of economic loss of the entire

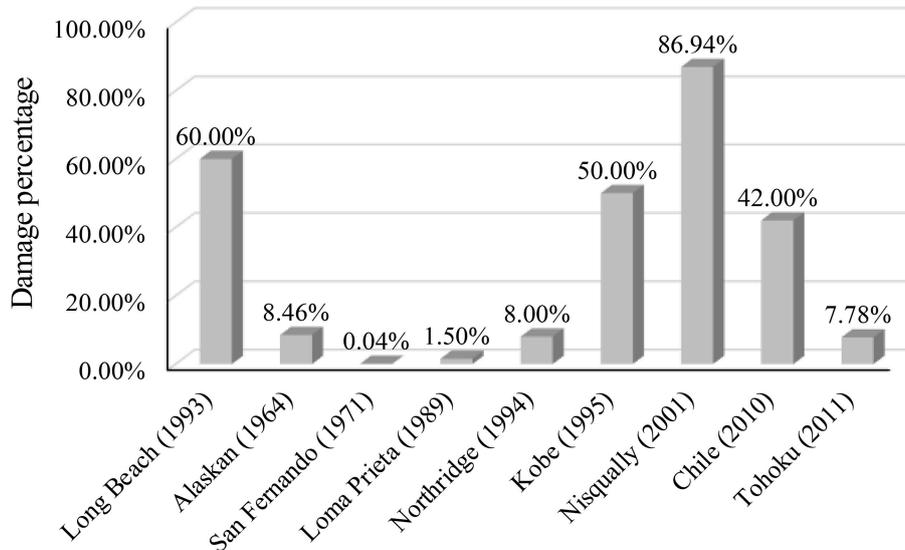
FIGURE 2 | Statistics of the damaged piping systems over all investigated piping systems.

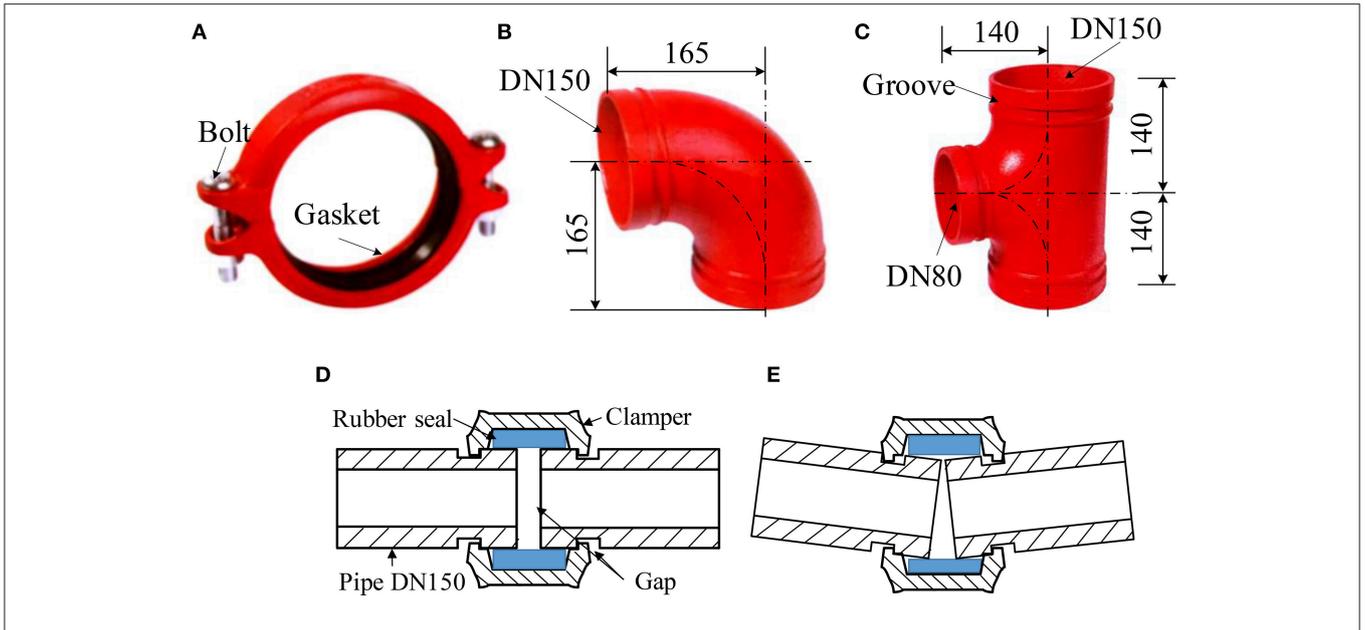
FIGURE 4 | Sketches of grooved fit joints (A) Lathedog-plumbings (B) 90° Elbow joint (C) Tee joint (D) Before deformation (E) During deformation (Unit: mm).

Grooved fit joints, as shown in **Figure 4**, are a relatively new piping construction product that has gained popularity in earthquake prone areas because of the improved flexibility they provide to fire sprinkler piping systems. The grooved fit joint is composed of pipes with grooves, lathedog-plumbings, rubber gasket and bolts. Dimensions of 90° Elbow joint and Tee joint are presented in **Figures 4B,C**. Nominal size of 90° Elbow joint is 150 mm while the actual size is 165 mm. Nominal size of Tee joint is 150 × 80 mm while the actual size is 160 × 90 mm. **Figures 4D,E** present the deformation mechanism of the grooved fit joint. The gaps in the grooves and between the pipes make it possible to accommodate earthquake induced rotations. The lathedog-plumbings and pipe joints are made of cast iron and the water pipes are galvanized steel pipes. Detailed information of the materials and components can be found in Meide (2016).

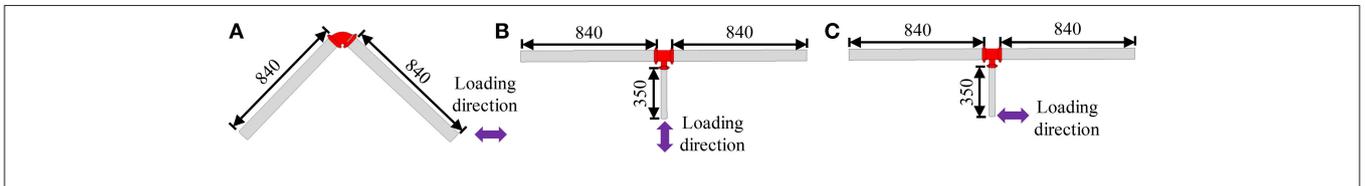
FIGURE 5 | Dimensions of specimens (A) Elbow joint (B) Tee joint (DN150) (C) Tee joint (DN80) (Unit: mm).

Although this type of joint is massively used in piping construction in China, there's no sufficient investigation on its mechanical behavior, deformation capability, and failure mode. This study conducted three sets of quasi-static tests to examine the seismic performance of two types of grooved fit joints. The elbow joint employs a 90° elbow joint connected with two DN150 pipes, as shown in **Figure 5A**. The length of each pipe is 840 mm. The Tee joint uses a triplet connecting to two DN150 pipes and one DN80 pipe. The length of DN150 pipes is 840 mm, while the DN80 is 350 mm. Eight Tee joints are divided into two groups. One tests the rotation of DN150 pipes and the other tests the behavior of DN80, as shown in **Figures 5B,C**, respectively. In each group, there are one monotonic loading test and three cyclic loading tests.

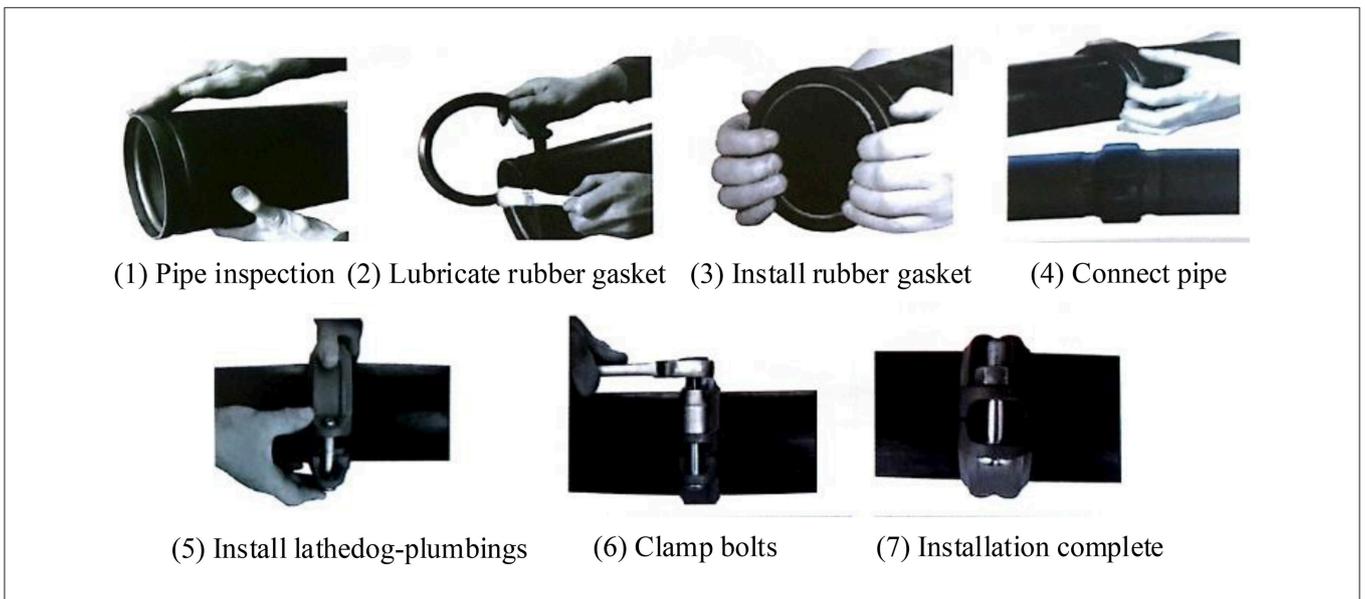
FIGURE 6 | Installation procedure of grooved fit joints.

Installation procedure of grooved fit joints is presented in **Figure 6**. Before the installation, lubricants are applied to the surface of rubber gasket. It is necessary to ensure that there is no gap between pipe end and joint. When tightening the bolts, take turns on both sides until the torque meets the installation requirements (60 Nm) and then the installation is completed.

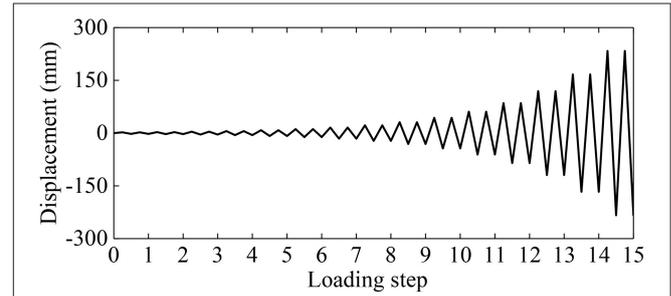
FIGURE 9 | Loading protocol for cyclic tests suggested by FEMA 461 (2007).

The specimens were subjected to a cyclic loading following loading protocol suggested by FEMA 461 (2007), as shown in **Figure 9**. This protocol is commonly used for the seismic performance assessment of non-structural components and equipment, as it allows all damage states to be quantified to develop the corresponding fragility models. The loading protocol consists of repeated cycles with an amplitude that steadily increases by 1.4 times at each step. Two cycles of loading are conducted at each amplitude level. At least six cycles must be performed before any damage can be observed.

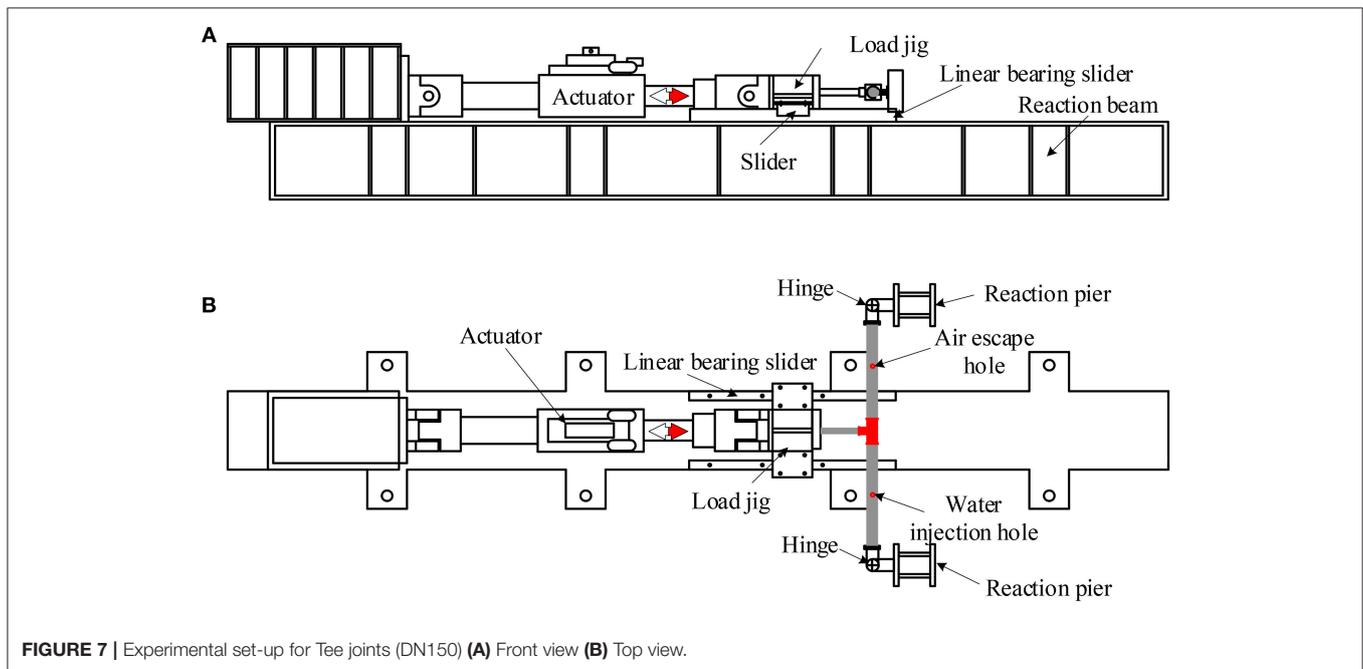
FIGURE 7 | Experimental set-up for Tee joints (DN150) (A) Front view (B) Top view.

the other testing the capacity of the triplet to the DN80 pipe, as shown in **Figures 8B,C**, respectively. The test setup for Tee joints (DN150) is shown in **Figure 7**. One hydraulic-servo actuator is employed to realize the quasi-static tests at a low loading speed of 0.5 mm/s. One end of the actuator is fixed on the reaction beam which is securely fixed on the strong floor. The other end is attached to a load jig which is bolted on two linear bearing

sliders. The sliders restrain the movement of the load jig in the axial direction only. The end of each DN150 pipe is pinned to one reaction pier fixed on the strong floor, while the end of DN80 is connected to the load jig along the loading direction (see **Figures 7, 8B**). Similar set-ups are used to test the Tee joints (DN80) and the elbow joints. When testing the DN80 connection of the Tee joints, the DN80 pipe is pinned to the load jig perpendicular to the loading direction (see **Figure 8C**). It is worth noting that the load jig is lengthened using a steel component as shown in **Figure 8C**. The elbow joints are pinned to the load jig at one end and to the reaction beam at the other, as shown in **Figure 8A**. The axes of the initial positions of the two DN150 pipes of the specimen are 45 degrees from the horizontal line. More details of the test setup are presented in Shang et al. (2018).

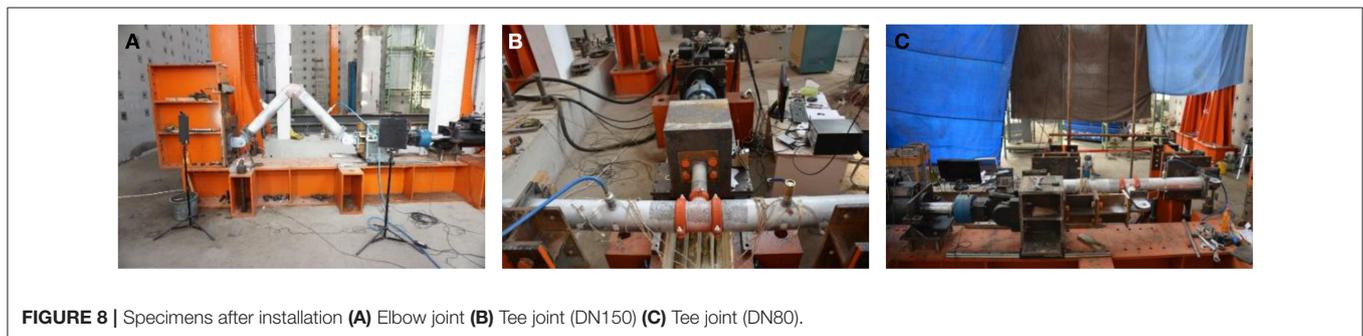
FIGURE 8 | Specimens after installation (A) Elbow joint (B) Tee joint (DN150) (C) Tee joint (DN80).

The Tee joints are to be tested in two patterns, one examining the rotation capacity of the triplet connected to DN150 pipes,

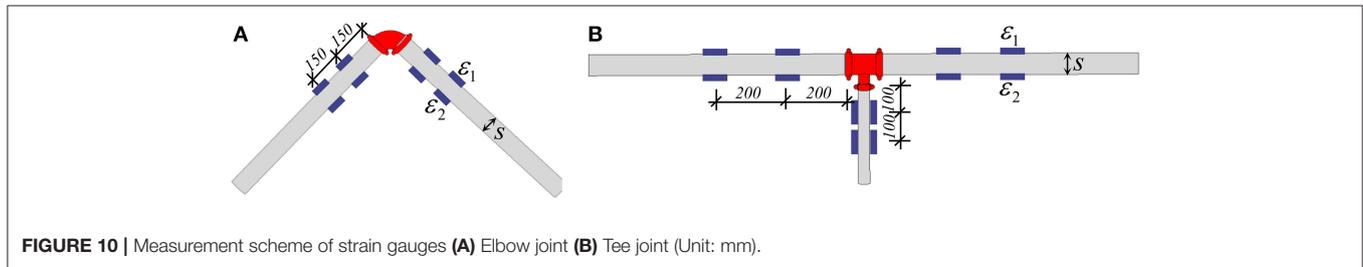
FIGURE 10 | Measurement scheme of strain gauges **(A)** Elbow joint **(B)** Tee joint (Unit: mm).

Meanwhile, four strain gauges are pasted on each pipe of the specimen, as shown in Figure 10. The curvature of each section is measured by two strain gauges respectively attached to the top and bottom of the pipes, as formulated in Equation

(2), where, κ represents the curvature of the measured section, ε_1 and ε_2 are the strains measured from the strain gauges, and s is the interval between two strain gauges (pipe diameter in this study). The moment M of the section is then calculated with Equation (3), where E is the young's modulus, and I is the moment of inertia of the concerned section. The distribution of bending moment along the pipe is assumed to be linear. The calculated bending moments of the two measuring points on the failure side are used to obtain that at the pipe joint section by linear assumption. The data measured from strain gauges will be used to calibrate the optical measurement and compared with the bending moment calculated using the method of Equation (1).

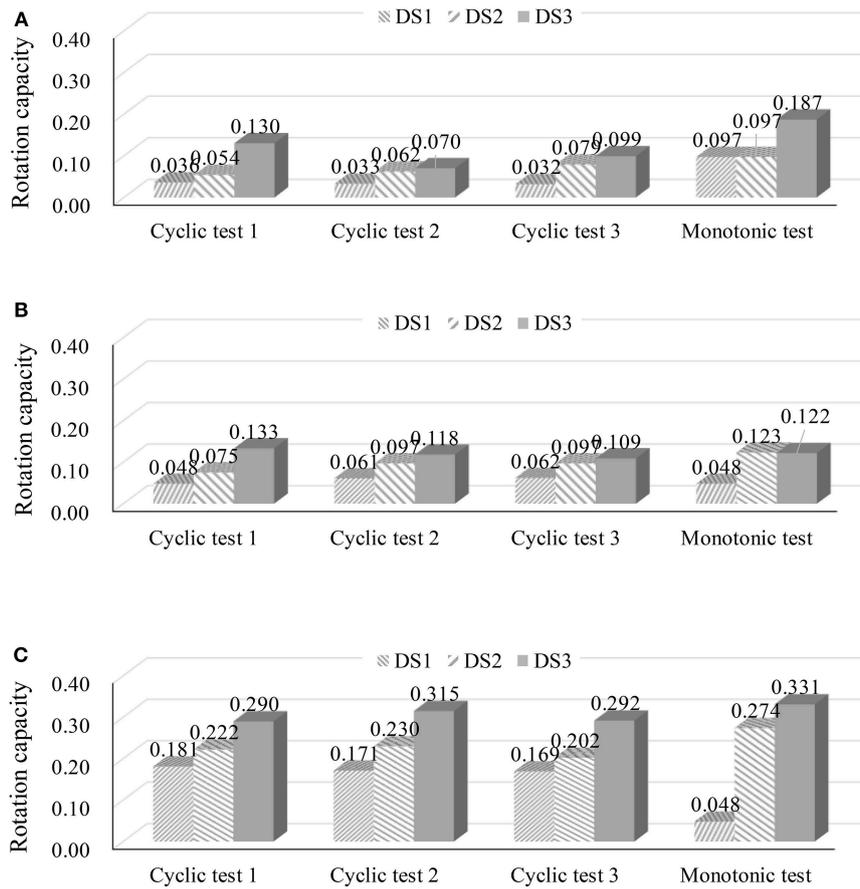
FIGURE 11 | Measured rotations for all specimens (A) Elbow joint (B) Tee joint (DN150) (C) Tee joint (DN80) (Unit: rad).

Three damage states (DS) of grooved fit joints are defined based on the test results. DS₁ represents the case in which pressure in the pipe drops to 85%, DS₂ represents massive leakage when the water pressure drops to 0 MPa, and DS₃ represents complete damage of the joints, including the resistance force dropping to 85% of the peak force, visible cracks, and the pipe pull-out. The rotations corresponding to different

damage states for each specimen are compared in **Figure 11**, both monotonic and cyclic test results are given. All types of joints exhibit large rotational capacities ranging from 0.054 to 0.274 rad before massive leakage. Rotational capacity of the DN80 Tee joint is much larger than that of the DN150 Tee joint and the Elbow joint. The monotonic rotational capacities of massive leakage (DS₂) are larger than their corresponding cyclic rotational capacities. This result is consistent with the results of Tian et al. (2014).

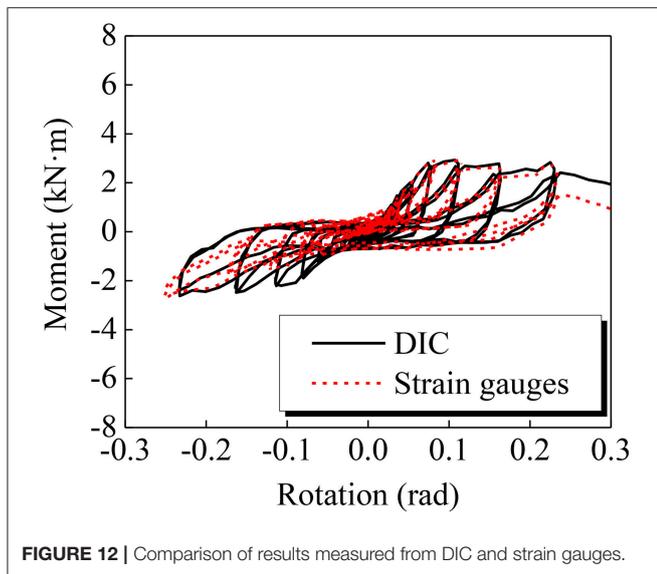
FIGURE 12 | Comparison of results measured from DIC and strain gauges.

The measurement scheme provides two methods to obtain the bending moment of the concerned sections. **Figure 12** shows the measured hysteretic curves from DIC and strain gauges, respectively. The moment of DIC curve is calculated using the

method of Equation (1), while that of strain gauge is calculated using the method of Equations (2, 3). They measured generally well. And in the following discussion, the data measured from DIC will be used. Typical moment vs. rotation hysteretic curve of each type of grooved fit joint is shown **Figure 13**. The occurrence of massive leakage (DS₂) is indicated by a solid red dot on each plot. After massive leakage, the tests were continued up to complete damage (DS₃) of the test specimens. It can be observed from the hysteretic loops that the moment values would keep increasing even at a large rotation around 0.1 rad. And a pinching effect was introduced by the gaps in the improved

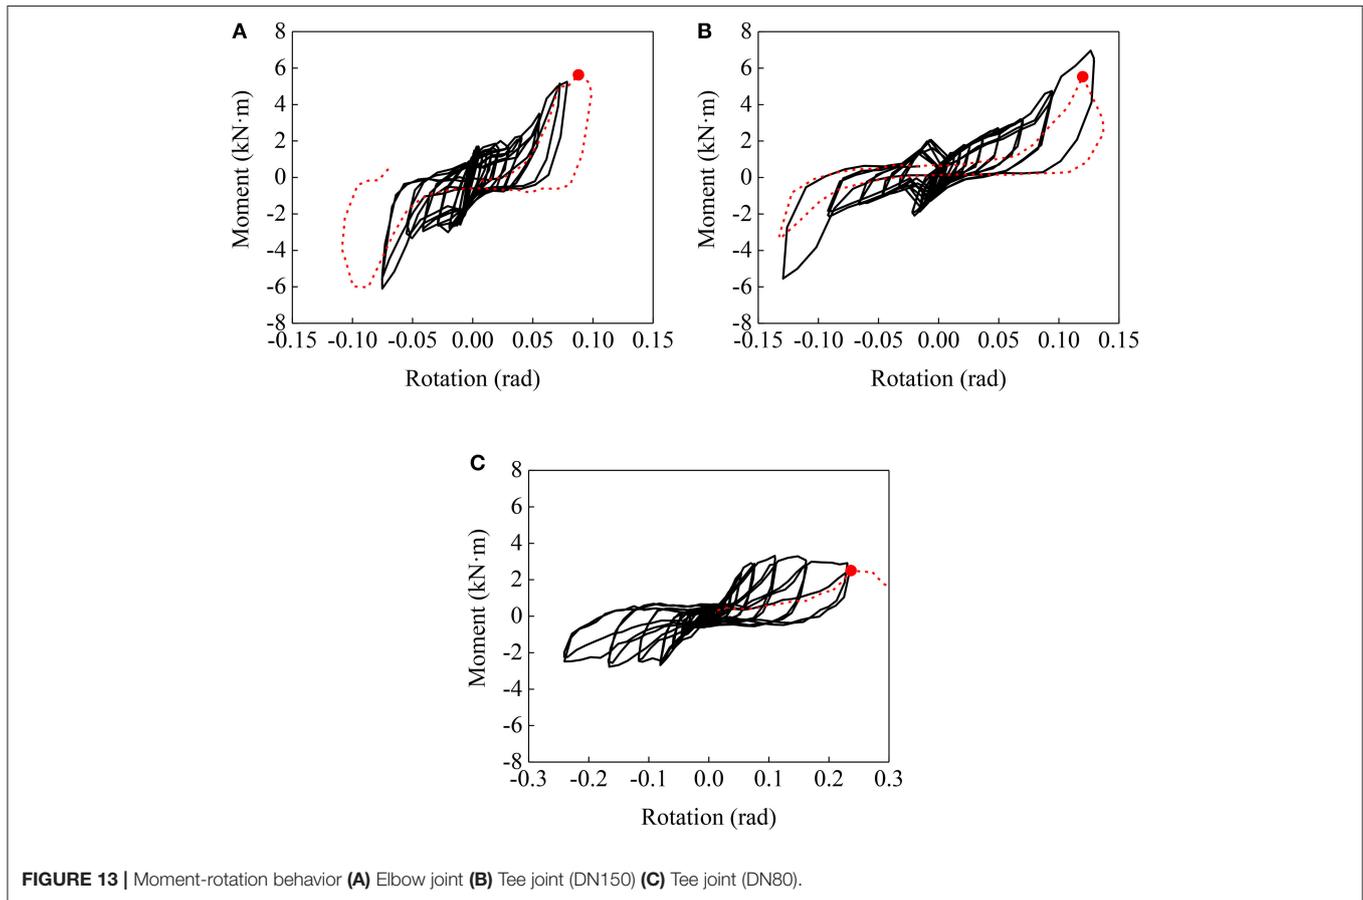
FIGURE 13 | Moment-rotation behavior (A) Elbow joint (B) Tee joint (DN150) (C) Tee joint (DN80).

configuration. As soon as the load intensity was increased, during the load-inversion phase, the gap generated caused relative rotations with near-zero force variation. Furthermore, reduction of the reloading stiffness can be observed after each loading step because the response could be highly influenced by the cumulative damage.

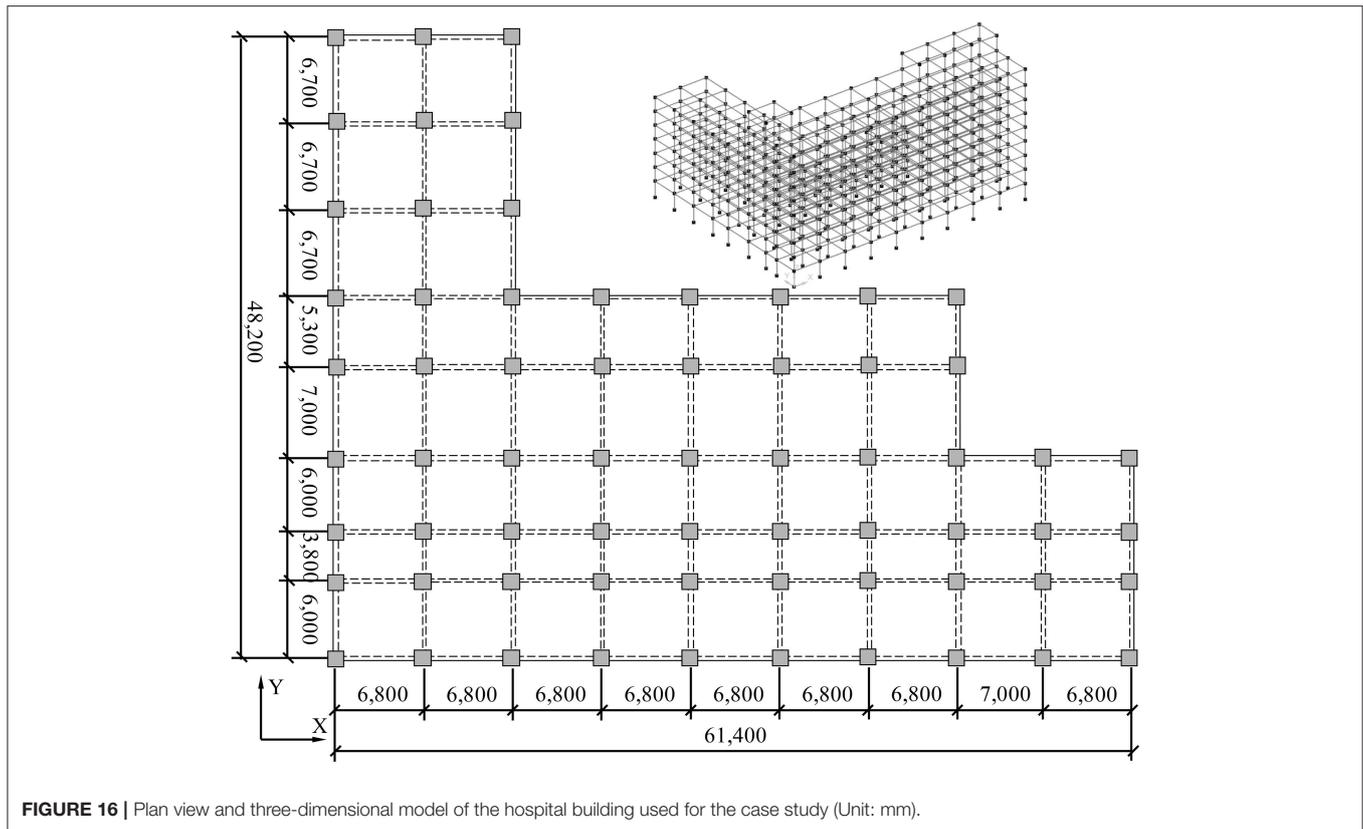
FIGURE 16 | Plan view and three-dimensional model of the hospital building used for the case study (Unit: mm).

A 10-story reinforced concrete (RC) frame was used for the case study of grooved fit piping joints. The story heights for the first two stories are 3.8 and 3.95 m, respectively, while the height of the penthouse is 3.9 m. The height of the remaining stories is 3.45 m. Uniformly distributed dead and live loads on each floor were 3.0 and 2.0 kN/m², respectively and those for the roof were 4.0 and 0.5 kN/m², respectively. It was designed following the Chinese Code for Seismic Design of Buildings (GB 50011-2010, 2010). The PGA of the design-basis earthquake ground motion was 0.2 g. The site was classified as type II and the design characteristic period was 0.35 s. The layout of the building was significantly irregular as shown in **Figure 16**. The concrete was C30 with a standard compressive strength of 20.1 MPa and the steel rebars were HRB400 with a yielding strength of 360 MPa.

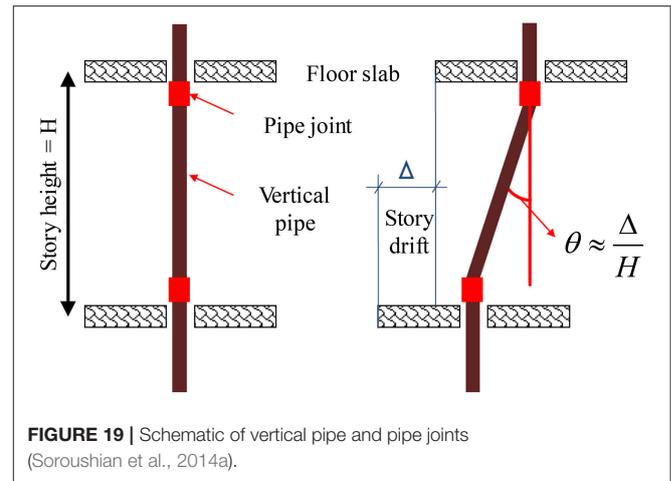
FIGURE 19 | Schematic of vertical pipe and pipe joints (Soroushian et al., 2014a).

It is assumed that the pipe joints of vertical pipes are installed at the ends of the pipe, nearly at the same level of the floor slab, as presented in **Figure 19**. We assumed that the rotation on vertical pipes imposed by building deformation (drift) is only concentrated at end joint rotations, so that the joint rotation is equal to the interstory drift ratio (IDR) (Soroushian et al., 2014a). The following assumptions have been made in this study:

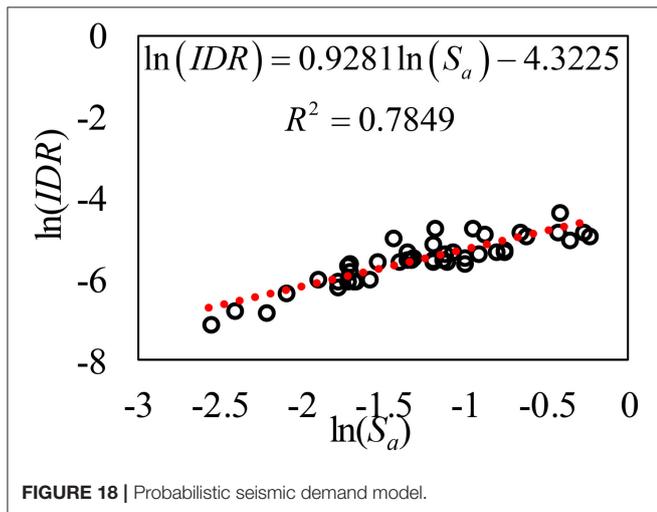
FIGURE 18 | Probabilistic seismic demand model.

where N is the number of simulations and d_i is the calculated maximum interstory drift ratio. **Figure 18** shows the result of the probabilistic seismic demand analysis for first floor of the 10-story building. R^2 is the coefficient of determination which can be used to indicate the robustness of the regression. Parameters used to define the probabilistic seismic demand model of the case study building are given in **Table 3**.

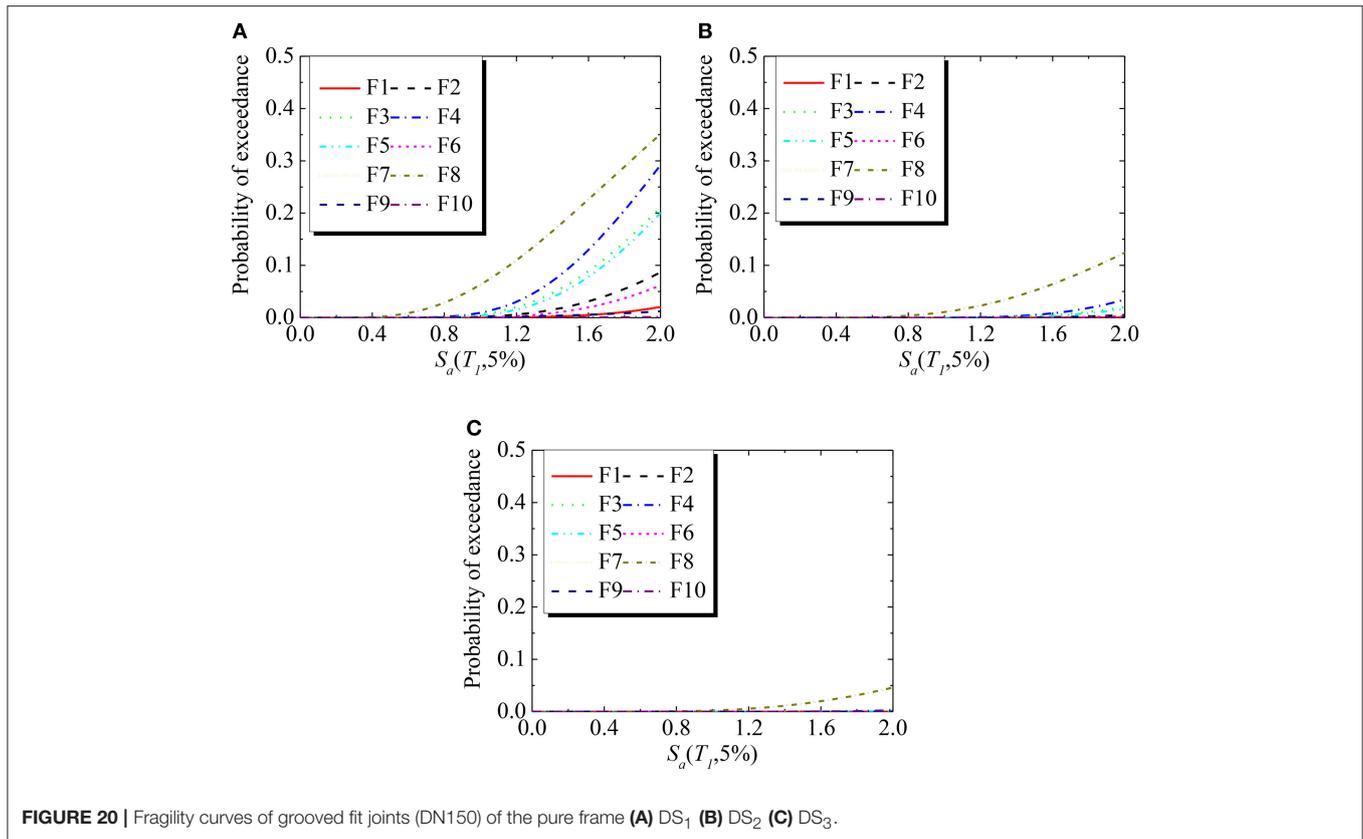
FIGURE 20 | Fragility curves of grooved fit joints (DN150) of the pure frame **(A)** DS₁ **(B)** DS₂ **(C)** DS₃.

Figure 20 shows fragility curves of grooved fit joints (DN150) used for vertical pipes using $S_a(T_1)$ as an intensity measure, where F_i ($i = 1, 2, \dots, 10$) represents the fragility curve of i -th floor. The damage probability of grooved fit joints (DN150) used for the vertical pipe under 0.07, 0.20 and 0.40 g [corresponding $S_a(T_1)$ are 0.0498, 0.1424, and 0.2847 g] corresponding to the service level earthquake (SLE), design-basis earthquake (DBE),
