Stability Assessment of Historic Plaster Ceilings on Wood Lath

Helena M. Currie, Matthew B. Bronski, and Rachel M. Lynde

Simpson Gumpertz & Heger, Inc. (SGH), 480 Totten Pond Road, Waltham, Massachusetts 02451,
United States of America, HMCurrie@sgh.com, MBBronski@sgh.com, RMLynde@sgh.com

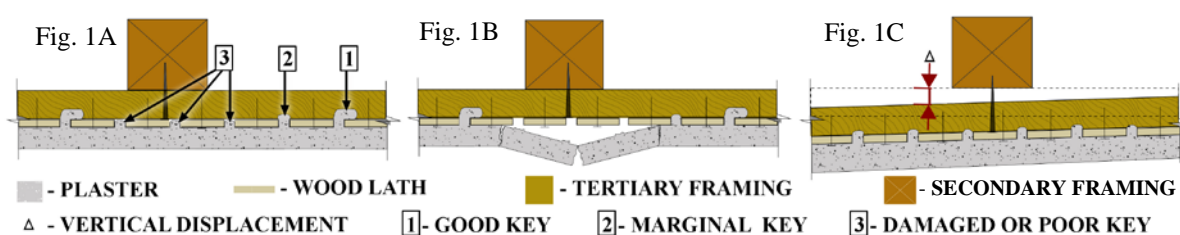
Figure 1. Typical historic plaster ceiling construction on wood lath (Fig. 1A) and two primary failure modes: plaster key failure (Fig. 1B) and fastener “pull-out” (tensile) failure of supporting framing connections (Fig.1C).

Historic examples in the USA survive from as early as the mid-18th century, and were typically constructed of lime-based plaster with animal hair fibers (Fig. 1A), similar to earlier European examples; however, closely spaced wood members are lath (long slender wood pieces) rather than dried reeds. Prior to the early 19th century, the wood lath was typically riven (*i.e.*, hand-split), and from the early 19th to the early 20th century, the wood lath was typically sawn. In both cases, pieces of the wood lath were approximately 6 mm thick by 60 mm wide, with gaps approximately 6 mm wide between the long edges in sawn lath, and approximately 2-6 mm wide between the long edges of riven lath. The lath is secured to the overlying structural wood framing (*e.g.*, the floor framing of the roof or attic above) by smooth shank nails, installed from the underside. Prior to the late 19th century, the nails were either hand-forged wrought nails or cut nails, which both have a wedge-shaped profile, tapering from head to tip. After the late 19th century, the nails are typically wire nails, which have a uniform cylindrical shank and a point only at the tip.

Failures of these historic plaster ceilings in the US typically fall into one of two primary failure modes: 1) failure of plaster keys (Fig. 1B), or 2) tensile failure or “pull-out” of the nailed connections of the lath to the overlying wood framing (Fig. 1C).

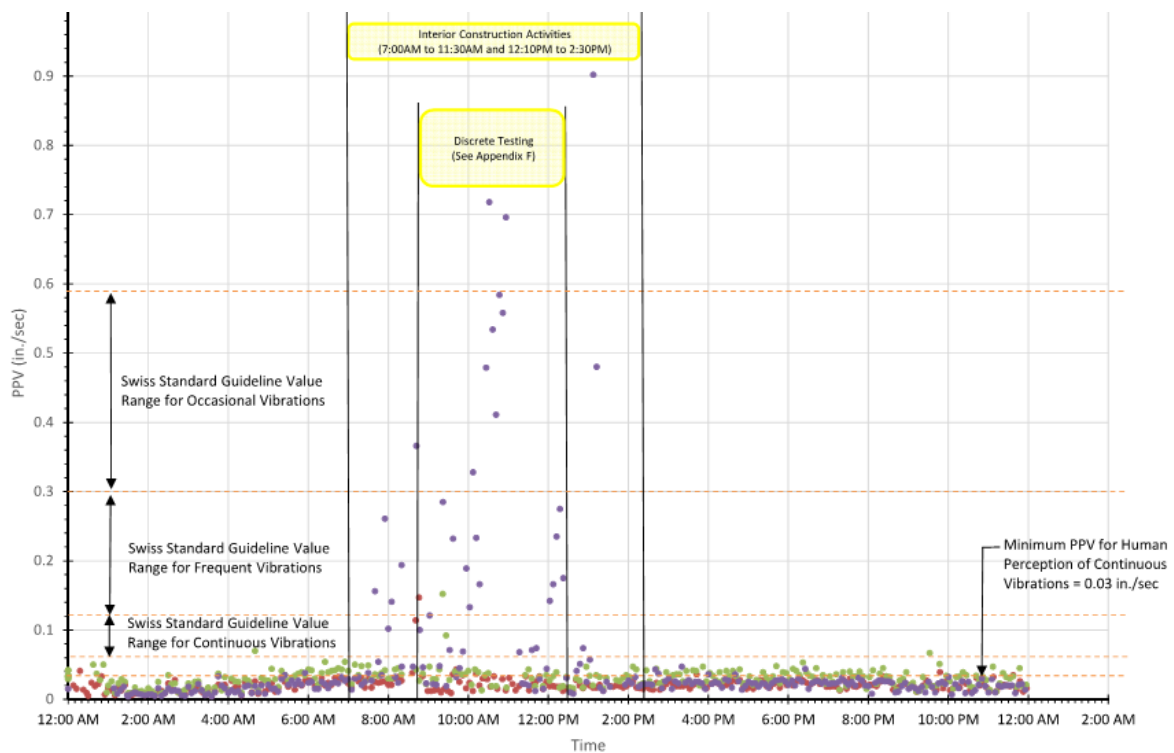
Figure 2. Example of vibration measurements collected at the topside of a plaster ceiling (where plaster damage was concentrated adjacent to attic walkways) during targeted vibration monitoring of an historic plaster ceiling.

All potential vibration sources identified during continuous monitoring as exceeding the ambient or industry-standard threshold should be further assessed by discrete vibration testing of those specific sources, isolated to the greatest extent possible. Consider vibration monitoring information jointly with the plaster condition assessment to determine whether any of the plaster damage is likely associated with suspect vibrations sources. For example, where damaged plaster keys are highly concentrated adjacent to walkways at the topside of the ceiling, vibration monitoring can help to evaluate whether the damage is from accidental direct impact (*e.g.*, individuals bumping into the plaster) or transferred vibrations (*e.g.*, from footsteps on the walkway transmitted through rigid connections to the ceiling framing) (Fig. 2).
