Various Factors of Water Entry and Penetration Through Water Proofing Layer in Wooden Wall Assembly

Abstract. *Rainwater entry and penetration through a waterproofing layer, such as external finishing and sheathing membrane, should be avoided to prevent moisture damage to a wooden wall assembly. However, housing warranty insurance organizations in Japan have reported that deterioration in some wall assemblies was caused by rain penetration, and severely damaged walls were detected in airtight and insulated building envelopes. This paper presents various factors of water entry and penetration of the waterproofing layers in wooden wall assemblies in terms of practical situations, as a part of a research project to reveal the risk of water and moisture accumulation in collaboration with government and industries in Japan. Several experimental works using mock-up specimens replicating a part of the wall assembly were carried out. As for external finishing, the water intrusion was observed not only at the joints but also at the bottom of vented cavities. Although these minor defects must be prevented by proper design and site work, it is difficult to avoid them completely through the c

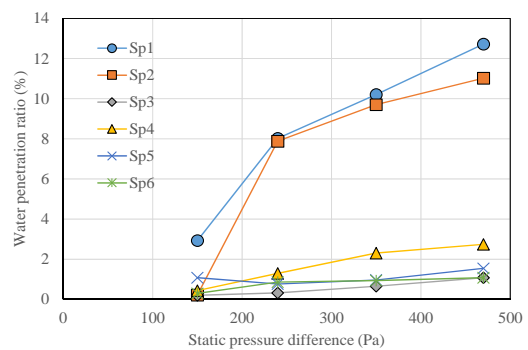
Figure 6. Water penetration ratio in Case 1.

The quantity of penetrating water and the water penetration ratio in Case 1 are shown in Figure 5 and Figure 6, respectively. The water penetration ratio means the ratio of the penetrating water and sprayed water. The quantity of the penetrating water in Sp1 and Sp2 exceeded 0.3 L/min m² in the range beyond 240 Pa. This value is approximately equivalent to 8% of the water penetration ratio in Figure 6. These values of the other specimens were less than 0.1 L/min m² and 3%. Figure 7 shows the water penetration ratio in dynamic pressure conditions (Case 2, Case 3). Although the values in Case 2 are less than in Case1, in the event of an equivalent average pressure difference, those in Case 3 are larger than in Case 1. It is speculated that accumulated water in the shiplap joint played a role in stopping the water when the sprayed water was 4 L/min m².

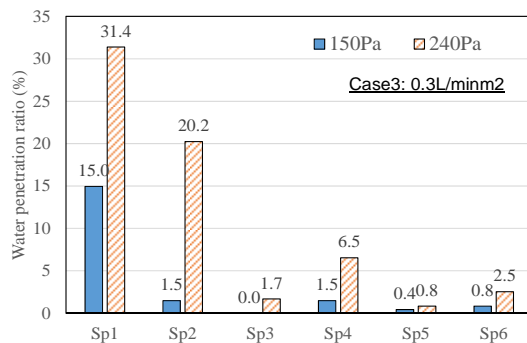
Figure 7. Water penetration ratio in dynamic test (left: Case2, Right: Case3).

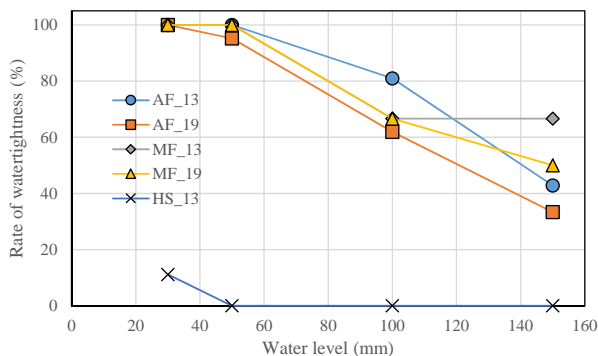
Figure 12. Rate of fastener interface securing watertightness in Case 1.

Figure 12 shows the relationship between the rate of the fastener interface securing watertightness and the water level. Water leakage was observed at 30 mm of the water level in HS, and all points of HS allowed water penetration through the fastener interface. Contrarily, AF and MF indicated higher performance for watertightness. However, water leakage in AF and MF was detected from 50 mm of water level, and half of the test spots allowed water penetration at 150 mm. Although this experiment in Case 1 showed the vulnerability of HS, it could not indicate a difference between AF and MF in terms of seal performance at fastener interface.
