Environmental Deterioration Factors in Metal Claddings and GFRC Panels Implemented on Facades: An Assessment through Two Cases in Istanbul

Keywords: *Environmental Deterioration Factors, Building Façade Failures, Metal Claddings, Glass Fibre Reinforced Concrete Façade.*

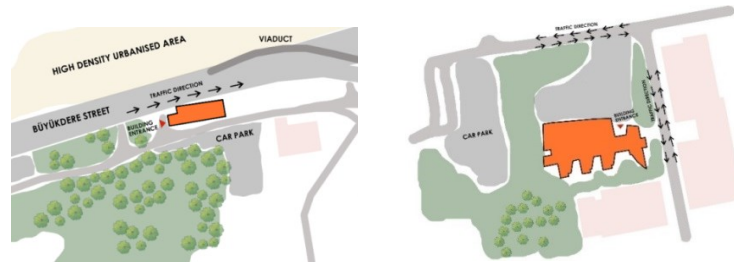
Figure 1. Site plans of the first and second case buildings.

In the second case building, traffic direction is in North and East face. There is also a parking lot in the West side. The site plans of the case buildings are given in Figure 1:

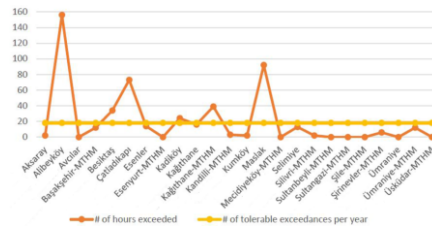
Figure 3. Frequency of hours the NO₂ limit was exceeded in 2017.

The recent measurements performed by Ministry of Environment and Urbanization show that PM_{10} and NO_2 values are comparatively increasing in the rush hours as a probable consequence of Buyukdere Street (SİM Project n.d.). Also, a report which has been prepared in 2018 by the Netherlands Enterprise Agency shows the existing situation within the context of air pollution in İstanbul. According to the European Directive, the number of permitted exceedances per year is 18. Figure 3 shows that NO_2 limit is exceeded more than 18 times in 6 stations in 2017 and Maslak district has the third highest exceedance level (Standards-Air Quality-Environment-European Commission, n.d.). As understood, the selected buildings are located in a highly urbanized area and air pollution in the district is quite a lot. Therefore, the selection of appropriate material for the building envelope is a critical issue.
