A. Rodríguez-Bellido<sup>a</sup>, I. Nieto-León<sup>b</sup>, M. P. Muñoz-López<sup>c</sup><sup>a</sup> Department of Composite Technology, Materials and Processes, AIRBUS Operations SL, Paseo John Lennon s/n, 28906 Getafe, Spain [ana.rodriquez@airbus.com](mailto:ana.rodriquez@airbus.com)<sup>b</sup> Department of Methods & Processes: Generic Technologies, AIRBUS Operations SL, Av. de las Naciones 37, 45200 Illescas, Spain [ines.nieto-leon@airbus.com](mailto:ines.nieto-leon@airbus.com)<sup>c</sup> Department of Manufacturing Engineering Technologies, R&D Engineer, AIRBUS Operations SL, Av. de las Naciones 37, 45200 Illescas, Spain [pilar.munoz@airbus.com](mailto:pilar.munoz@airbus.com)

## Reparaciones encoladas fuera de autoclave y su implementación en estructuras aeronáuticas fabricadas en material compuesto

## Out of autoclave bonded repair process and implementation for aircraft composite structures

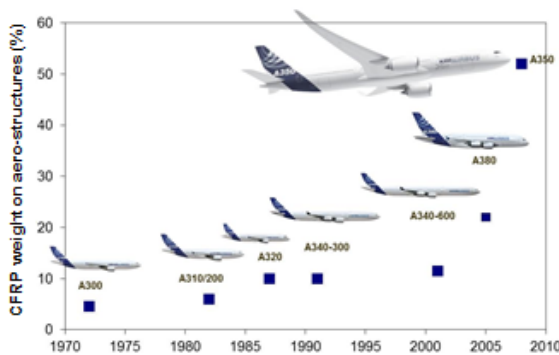
**Figure 1** Percentage of CFRP weight in Airbus aircraft

For the new A350 XWB Airbus went one step beyond, using carbon fiber reinforced polymers (CFRP) for the manufacture of the wing boxes and the fuselage achieving more than 50% of the structure in terms of weight made with composite materials, (see Figure 1, [1]).

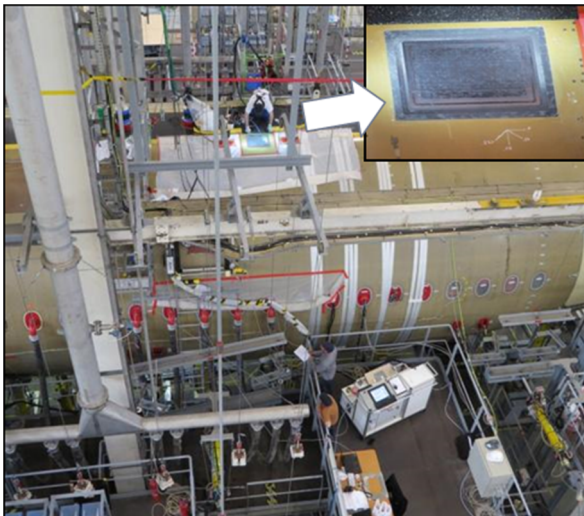
**Figure 2** Implementation of bonded repairs in A350 XWB test cells

Various types of repairs were done in four different full scale test cells (refer to Figure 2), representing damages such as severe lightning strikes, aircraft operating events and accidental impacts produced during manufacturing or maintenance operations. Actually the following types of damages were considered:

- Fuselage skin damage without perforation
- Fuselage skin perforation with internal structure damage
- Fuselage skin damage in double curvature areas
- Fuselage skin damage in the passenger door surrounding area
- Wing skin damage

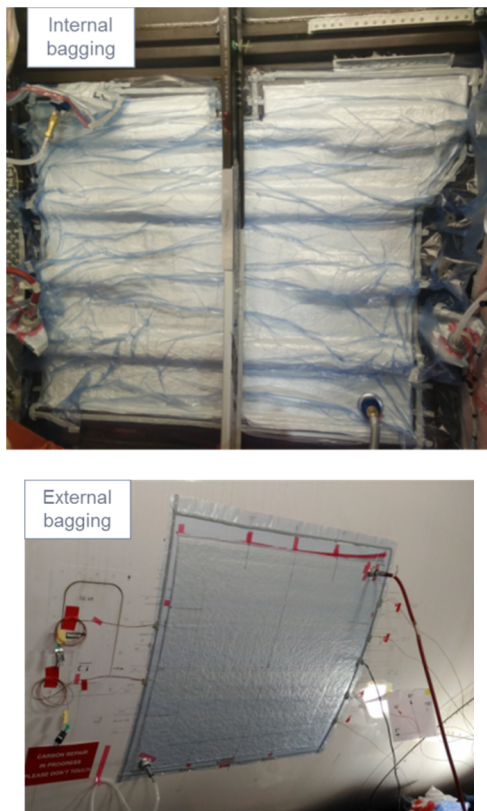
**Figure 3** Internal and external bagging applied during the cure of a repair of a perforating damage in the fuselage skin

Guidance for the proper installation of insulation schemes, which depend on the specific location of the repair were included in the in-house and in-service repair documentation to facilitate the management of heat application in the repair area. In Figure 3 the vacuum bags installed in the inner and outer sides of the fuselage skin for the curing of a repair patch are shown. A mandatory thermal profile is also part of the repair instructions. The number of thermal profiles is limited in terms of maximum time and maximum temperature so that the original component is not damaged.

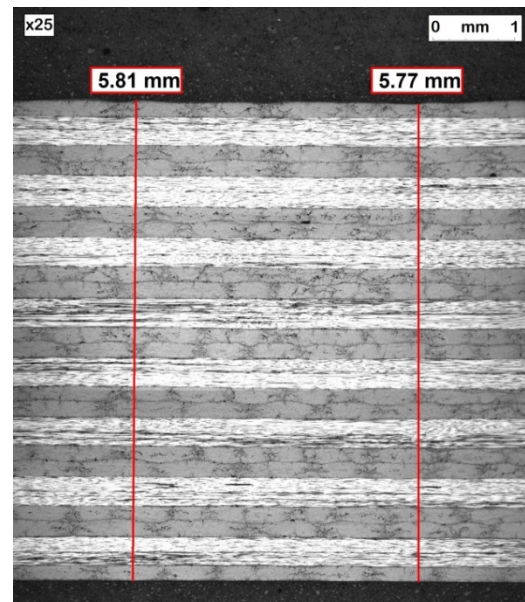
**Figure 4** Microscopic inspection of a repair laminate cured under vacuum

The repair materials are cured only under vacuum and their quality is highly dependent on the type of auxiliary materials used in the bag, the bag configuration, the debulking parameters and the vacuum application. These were studied as a function of the repair size and repair thickness to optimize the process and to define the feasible repair limits. Non-destructive and microscopic inspections were performed to check the bond line and repair patch quality. If the vacuum parameters are well controlled, thick repair laminates of very high quality can be produced (see Figure 4).

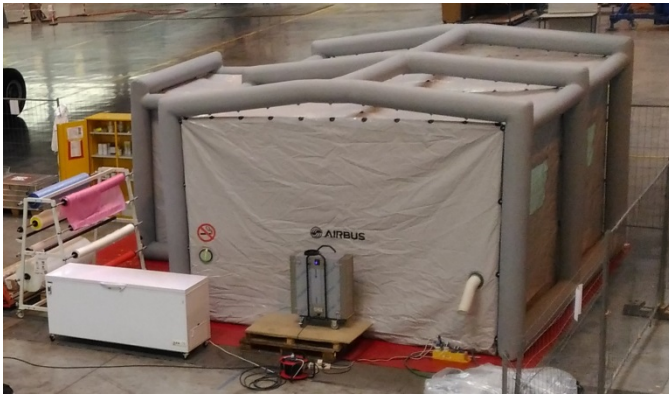
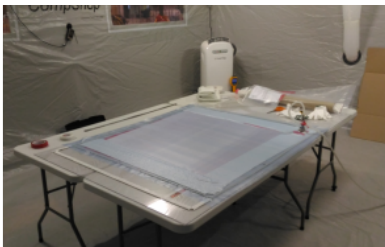
**Figure 5** Portable clean room with controlled temperature, humidity and particle concentration

repair cure, because the clean area conditions of the manufacture plants are not available at many in-service repair shops. On one hand, dedicated test campaigns were launched to evaluate the effect of exposure to temperature (up to 30°C) and humidity (up to 75%RH) on the material properties. On the other hand, repair instructions were completed with detailed instructions for the material preparation steps, material application and handling until cure. The material preparation steps are still required to be accomplished in clean area conditions, which can be made available by using portable devices as the one shown in Figure 5.

Environmental conditions for the application of materials in the repair area in the aircraft were restricted to a maximum of 30°C and 75% RH. If these cannot be reached a portable diving bell attached to the aircraft has to be used. Strict requirements regarding cleanliness and exposure to UV were also defined.

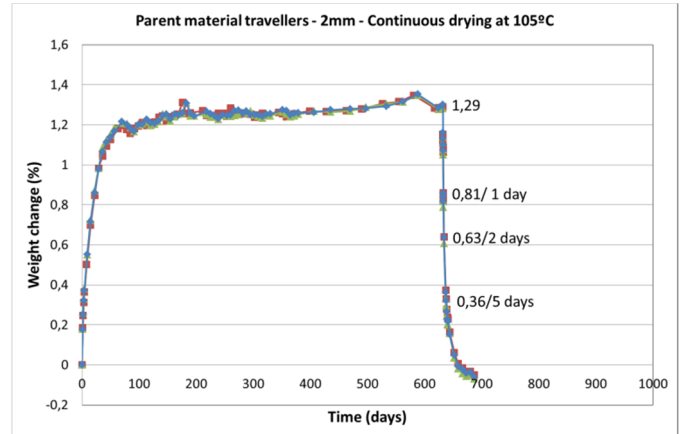
**Figure 6** Continuous drying at 105°C of parent material travellers

The mechanical performance of bonded composite repairs depends on the moisture content of the adherents. Eventually, the parent structure to be repaired in service might be fully saturated with moisture and drying it takes long times as can be seen in Figure 6 for 2 mm thick parent material travellers. It took 5 days of continuing drying at 105°C in an oven to reduce substantially the moisture content. Similar results were found for other epoxy composite materials of the same type.

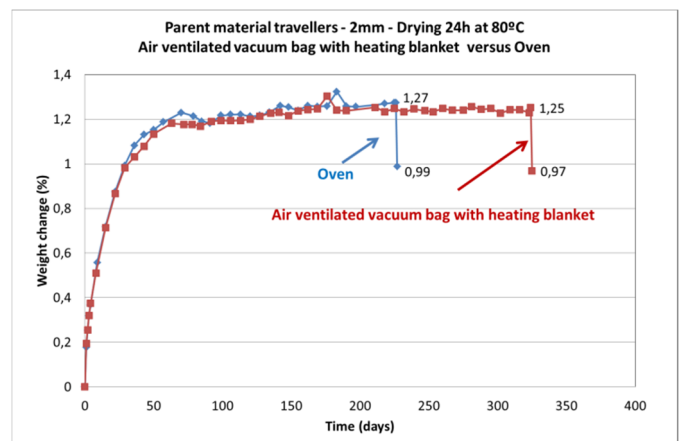
**Figure 7** Comparison of drying procedures

Alternative drying procedures were tried in order to see if shorter drying times could be achieved. Namely, air ventilated vacuum bags and standard vacuum bags, both with heating blankets, were tested and results compared with the ones obtained with the oven. No relevant difference was found among the different drying methods. Figure 7 shows the comparison of the air ventilated vacuum bag with heating blanket and the oven results.

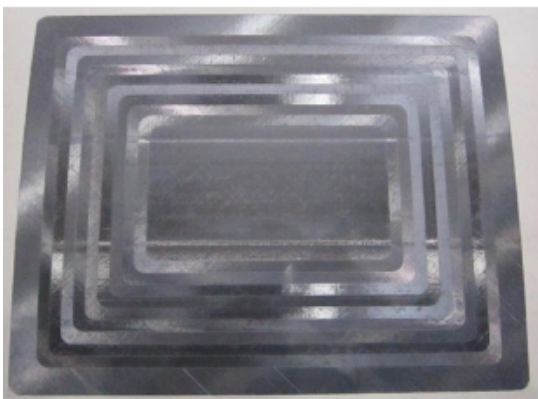
**Figure 8** Manual ply removal

Ply removal in stepped and scarfed bonded repairs is an essential operation, which must produce a bonding surface matching the repair drawing and fulfilling tight dimensional tolerances for an effective load transfer. When performed manually, it is a time consuming and challenging process which requires very skilled technicians. With adequate training and practice results can be however remarkably good (see Figure 8 and Figure 9). The automation of the process presents clear advantages, but whatever the system used for automatic ply removal, it requires qualification prior to use. As an example, Figure 10 shows a typical microscopic inspection carried out during the qualification of automated abrasive water jet for ply removal.

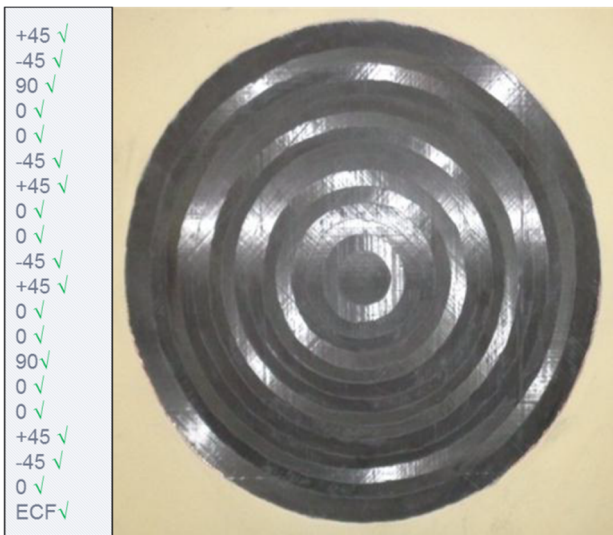
**Figure 9** Manual ply removal

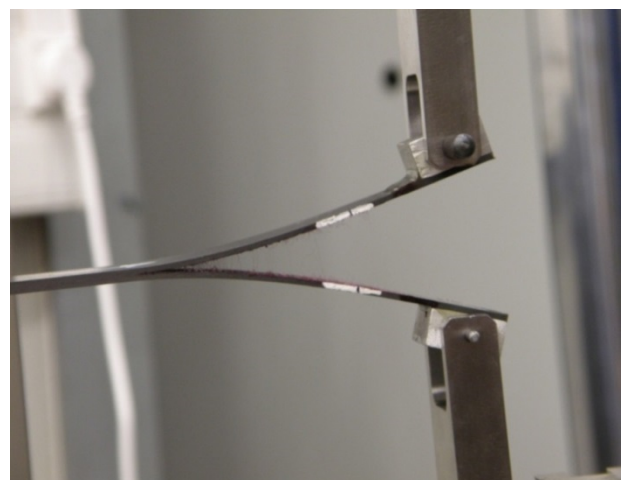
**Figure 11** Fracture toughness Mode I specimen

The chemical and mechanical compatibility of the repair materials with each other and with the parent materials in the original components was also carefully studied. Bond line tests were performed on bonded specimens prepared with the defined repair process (same surface preparation, same cure cycle, same vacuum bag). Pre-bond moisture may influence the results in terms of strength and failure mode. Therefore, the preparation of the parent semi-panels prior to bond was controlled carefully and the pre-bond moisture monitored precisely. The test matrix included the operating conditions and the environmental aging to discard incompatibility issues which may arise at temperatures other than room temperature or after ageing. The intended application drove the selection of the most appropriate configuration and test. Fracture toughness mode I test (see Figure 11) was a fundamental part of the testing as it is very sensitive to incompatibility issues.
