EVALUATION OF INVASIVE RETROFITTING INTERVENTIONS ON AN UNREINFORCED MASONRY HERIRAGE BUILDING

A.SCUPIN^{1*}, R.VĂCĂREANU¹ AND F.PAVEL¹

Keywords: Historical Structure, Geology Museum, Unreinforced Masonry, Invasive retrofitting

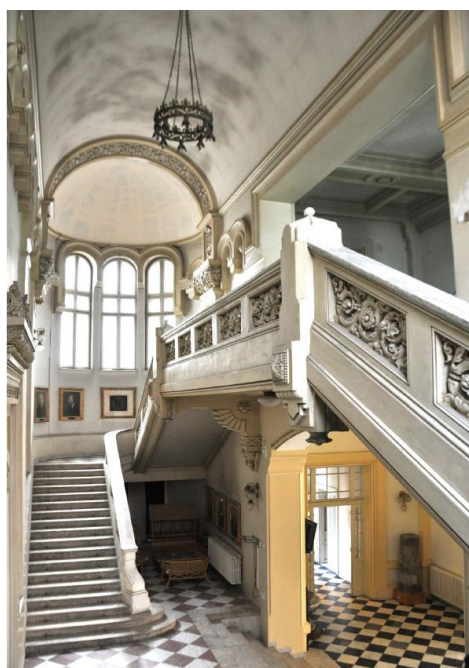
though not separated through seismic joints. The main wing has a U-shape layout composed of a semi-basement of 4.40 m height, a ground floor of 6.80 m and a first floor of 5.60 m. The secondary wing is located on the backside of the building and hosts the main staircase shown in Figure 1, as well as the exhibition hall with more than 12 m clear height. The connection between the two wings is done only through the circular walls of the hallway and through the stair landings. The lack of appropriate separation joints between the two wings with different stiffnesses represents one of the major structural deficiencies.

Figure 1: Main stairway linking the principal wing and the exhibition hall

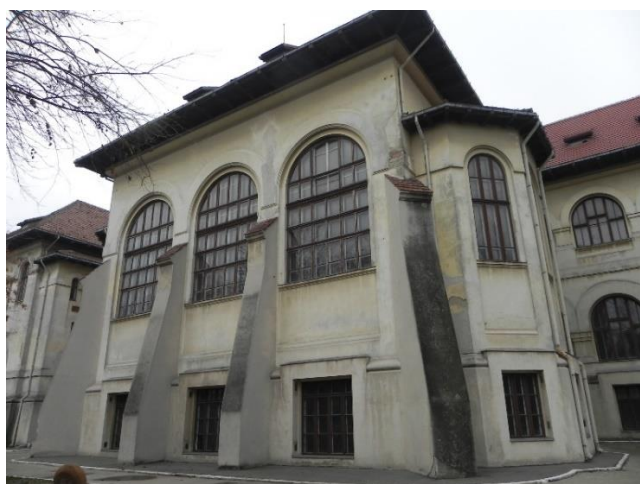
Both exterior and interior walls are made of clay brick masonry and lime mortar with variable thicknesses along the height of the building. Reductions of the walls' thickness range from 25% up to 55%, thus creating major differences of wall's areas for each floor. In most of the cases, the masonry walls are continuous along the entire height, following the proportions of structural elements specific for the time of construction. Even though increased story height favors the creation of high horizontal coupling elements above openings of about 2 m, the openings of the main façades do not follow this layout. The uneven placement of windows on the principal façade, as well as the reduced height of the spandrels from the first floor creates considerable stiffness differences in between exterior and interior walls. Similarly, the openings on the walls of the back façade present an irregular alignment. These deficiencies led most probably to the creation of buttresses to support the walls of the secondary wing, as it can be observed in Figure 2

Figure 2: View of the back facade of the National Geological Museum (secondary wing)

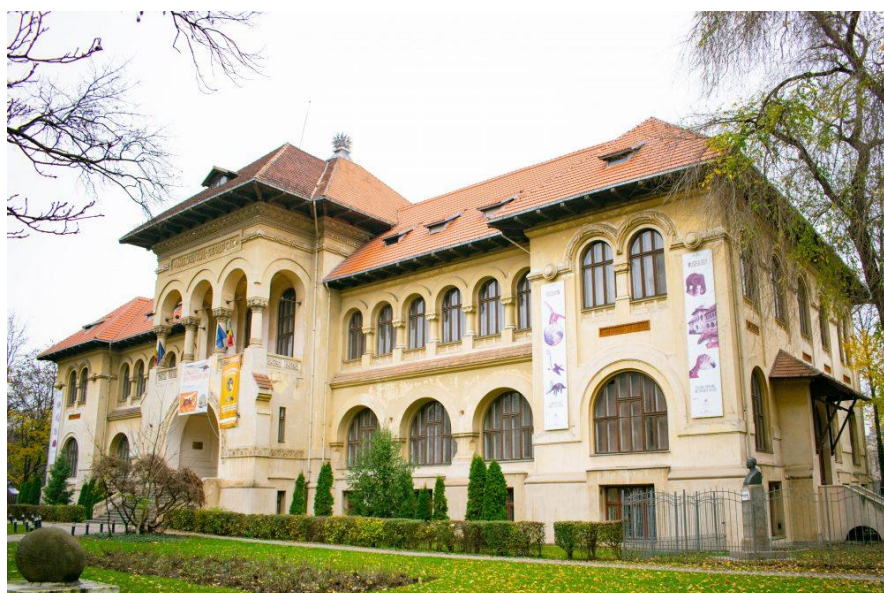
Apart from uneven placement of openings, the front façade also has an important discontinuity at the upper level of the balcony. The area situated above the main entrance is composed of columns and arches that support the upper level of the attic, as pictured in Figure 3.

Figure 3: Main facade of the National Geological Museum

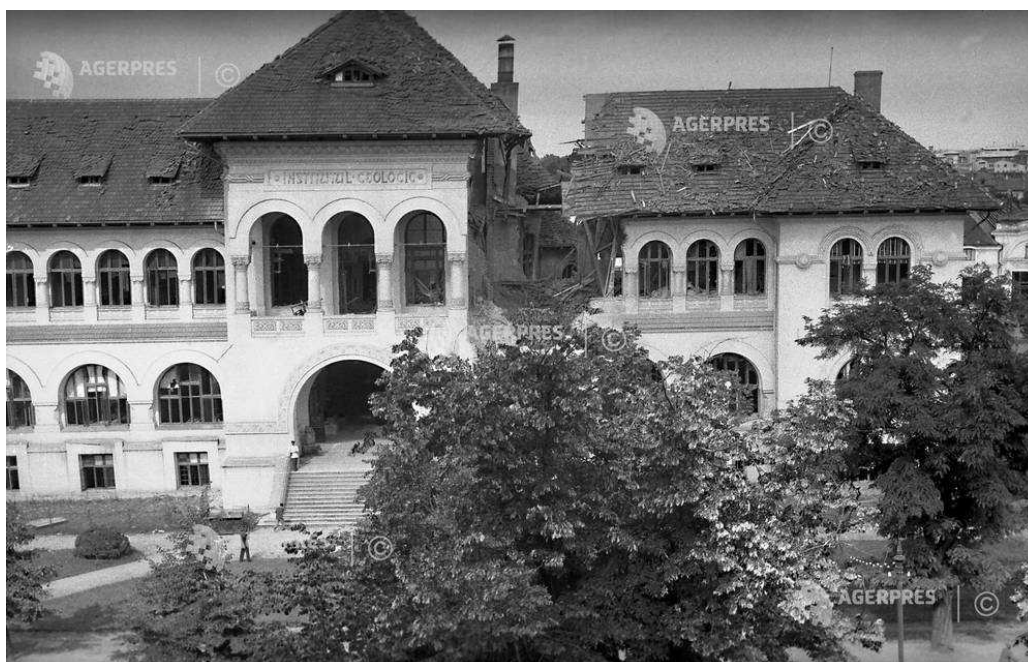
The museum was strongly affected by strong earthquakes which happened during the 20th century in Romania (1940, 1977, 1986 and 1990) and also by the World War II bombing in Bucharest (1944). Severe local damages were caused in the 1944, as it can be seen in Figure 4. According to past damage assessments [1], the earthquake from 1940 caused “significant degradations of the structural walls” that were not repaired not strengthened. Therefore, the strong ground motion from 1977 acted on a structure already damaged. Some of the damages observed after this seismic event range from cracking and debonding up to local collapse of nonstructural parts. The failure mechanisms consisted mainly in diagonal cracking (step-wise) and bending failure in the case of slender piers, such as the ones from the main façade of the building. The global behavior was governed by “walls with small openings” due to the increased width of spandrels, which remained undamaged. The most affected area was the portico of the front façade, due to uneven layout of transversal walls from the interior, with respect to the marginal walls of the balcony. This led to partial detachments of the portico from the main façade. Moreover, the asynchronous movement of the two wings caused significant damages to the curves walls that link the exhibition hall to the main building. At the last level, nonstructural walls improperly linked collapsed on top of the vault above the stairway and caused its destruction.

Figure 4: The National Geological Institute after the bombing from 1944, 23rd August (Agerpres Archive – foto no. 7646690)

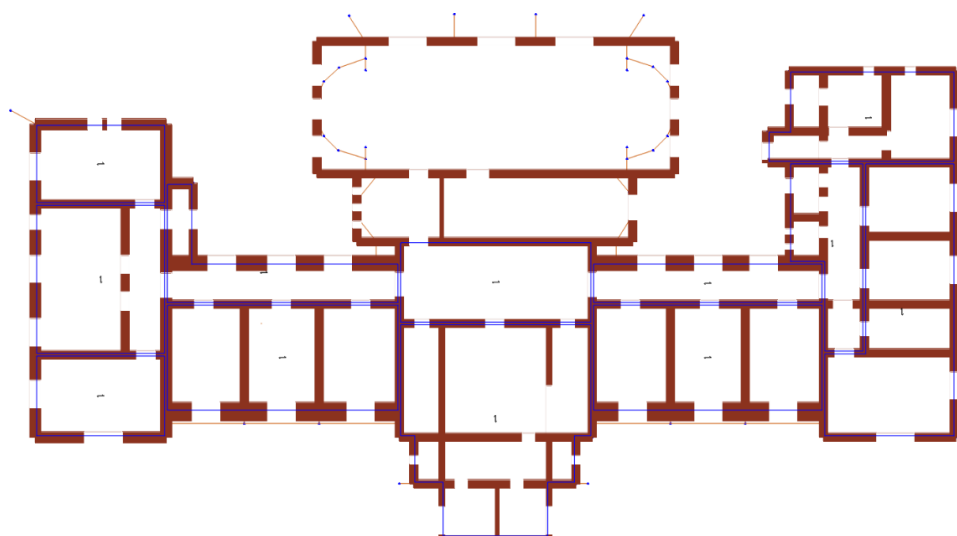
Starting from the damage assessment previously presented and also based on previous research related to material behavior of clay bricks used in the beginning of the 20th century, a numerical model of the buildings was calibrated. The software used was Tremuri [2] due to its ability to model masonry walls as assemblages of deformable macro-elements (piers and spandrels) linked by rigid nodes. The layout of the structure was slightly simplified in order to adapt to the modeling strategy of the software. Accordingly, the curved walls were approximated by orthogonal walls and the roof structures was not modeled explicitly. The final layout of the building modelled in Tremuri is shown in Figure 5.

Figure 5: Structural layout of the building (Tremuri)

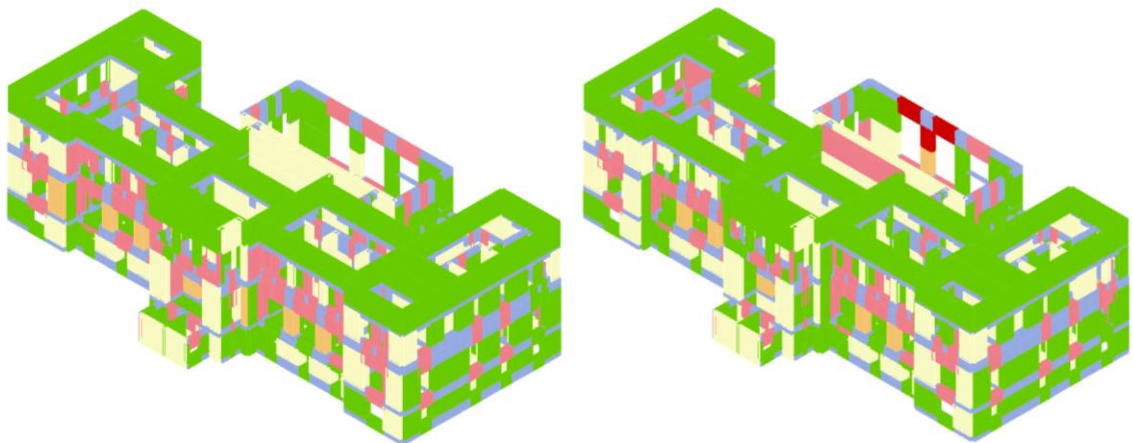
Figure 7 illustrates the elements' damage state recorded at the last step of the Pushover analysis on X direction of loading. The most affected elements are found on the front façade of the building due to shear damage (light yellow) in case of spandrels from the first floor and bending damage of the slender piers from the upper floors. The piers facing shear failure are colored in orange and they correspond to the level where changes in openings position appear (ground floor – first floor). Comparing these damages stages with the ones recorded on the retrofitted model on the left, it can be observed that bending failure (red colored elements) appear on top of the back-façade walls. The lack of proper separation between the two wings was not solved through the retrofitting interventions carried out in 1982-1984. Moreover, since jacketing measures were taken for walls of the main wing, even greater difference in terms of stiffness tend to appear in between the two building parts.

Figure 7: Comparative results for the Static Pushover: initial structure (left) and retrofitted structure (right) – longitudinal loading direction (X)

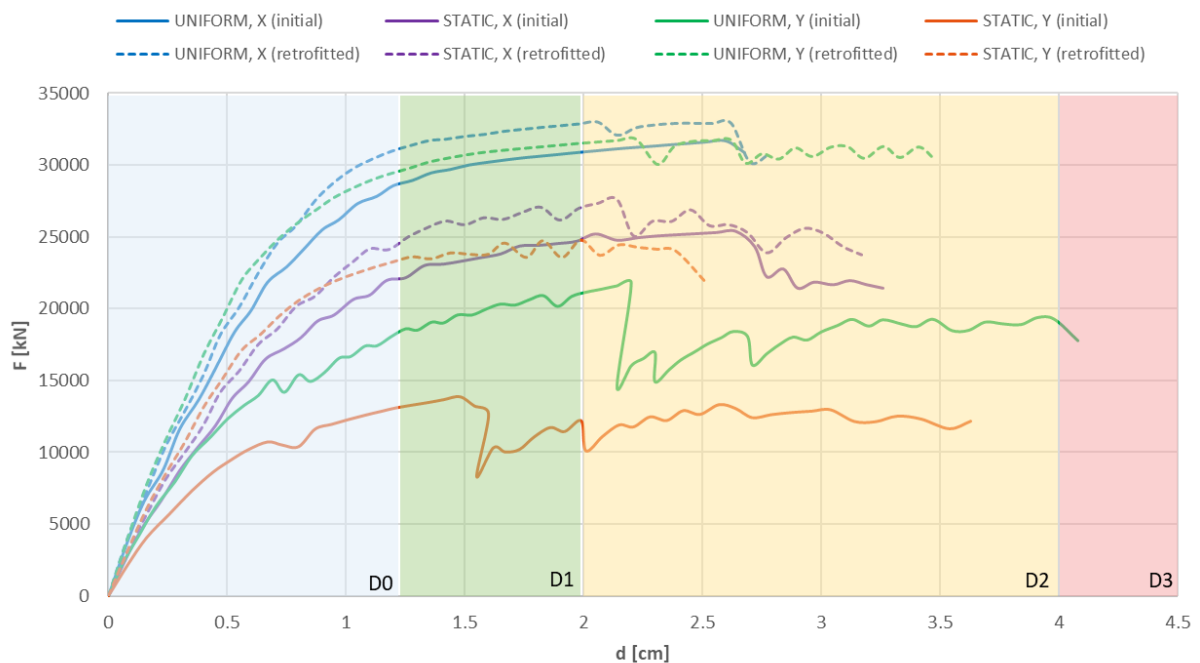
Pushover curves were obtained for both static and uniform loading patterns are presented in Figure 8 in order to highlight the differences between the initial and the retrofitted models. From the point of view of stiffness of the models, it can be observed that the initial model with flexible floors has different results for both loading directions. In the case of the retrofitted model, there are no longer present such variations in terms of stiffness, due to a more unitary behavior along the orthogonal directions, as desired for the structures with rigid diaphragms.

The improvements observed in terms of maximum horizontal force are significant on Y direction, where both Pushover loading patterns reach about 80% increase in strength. Taking into account that most of the interventions were concentrated on transversal walls, almost no changes are recorded on the results from longitudinal loading direction, when comparing the initial structure with the retrofitted one.

Since the retrofitting works were designed to increase the strength, no improvements are observed in terms of increased displacement capacity. The maximum global displacements from the nonlinear static analyses of the retrofitted models reach lower values than the initial model, especially in the case of the transversal loading direction, along which improvement works on masonry walls were concentrated.

Figure 8: Pushover curves comparison

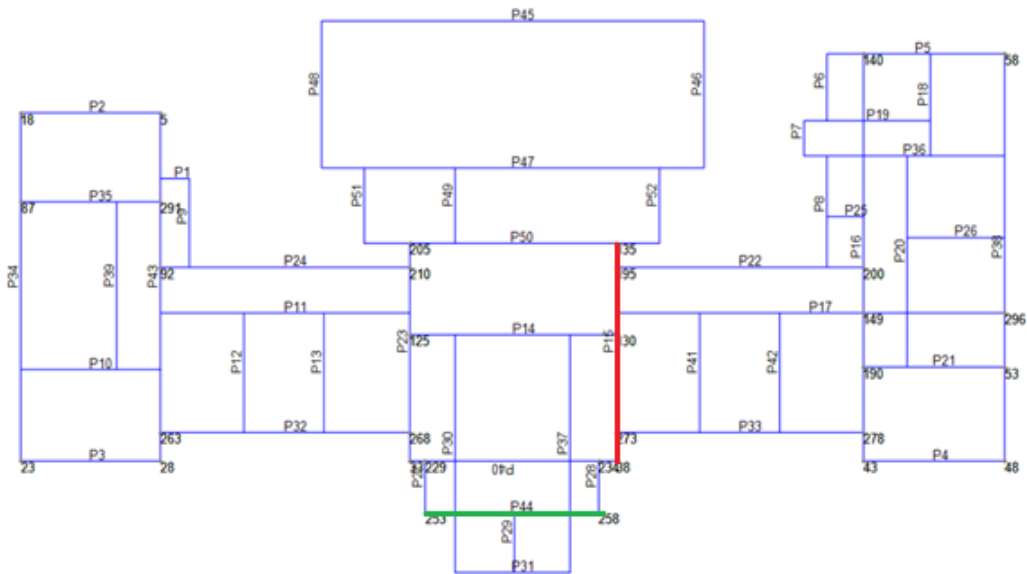
The highest relative displacements resulted from the Static Pushover case on the initial model appear at the walls from the ground floor level in case of longitudinal loading direction and on the first level for the transversal loading direction. For X direction, almost 30% of the masonry walls from the ground floor overpass the drift limit corresponding to damage control, with 2- 3 cm displacement. In case of Y loading direction, more than 20% of the walls reach the life safety stage with relative displacements higher than 3.6 cm. The highest relative displacements are recorded on one of the portico's sides (wall 28) and also the adjacent interior wall no. 15, marked with red on Figure 9. Their displacements correspond to the collapse prevention performance limit, according to the drift proposed as reference by ASCE [4]. The highest relative displacement recorded for the longitudinal direction is also highlighted in green for the wall no. 44 in Figure 9.

Figure 9: Damage stage color code for all the walls with highest relative displacements

These results are in good accordance with the information regarding the damage assessment, showcasing once again the local vulnerabilities caused by the portico, the openings layout of the main façade as well as the misalignment of transversal interior walls. For wall no. 44 and no. 15, detailed results are presented in Table 2 and Table 3 with respect to the ultimate displacements recorded in nodes along the height and also the damage stage of the macro elements. Since wall no. 15 was retrofitted by jacketing, unlike wall no. 44, a comparison between results of the initial model and of the retrofitted model is also shown.
