## STATIC TEST ON FULL SCALE RAMMED EARTH BUILDING WITH MESH–WRAP RETROFITTING STRATEGY

**Keywords:** Rammed Earth Structure, Composite Masonry, Full-scale test, Retrofitting

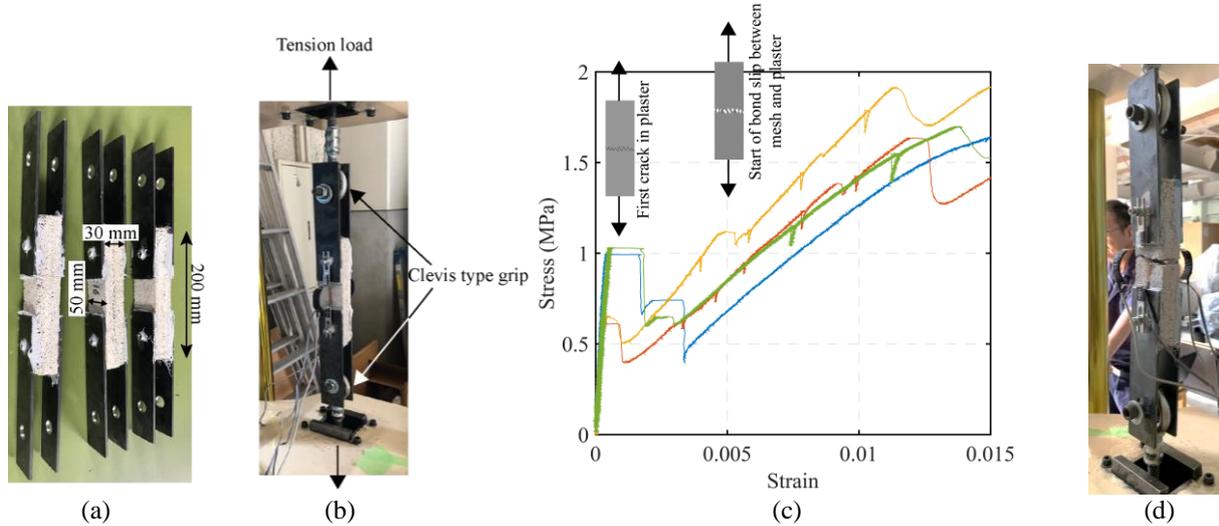
**Figure 1:** Material characterization tests for mesh retrofitting component: (a) Test coupons epoxy-bonded at the ends to steel plates, (b) Test set-up with clevis type grips, (c) Tensile stress versus strain plots for tensile coupon tests of M-Mesh, (d) Typical failure mode at the end of coupon test

For material characterization of the retrofitting components, test coupons (Figure 1a) 200 mm long, 50 mm wide, and 30 mm thick were prepared for M–Mesh and tested under tensile loading with clevis type grip as shown in Figure 1b. Figures 1c and 1d show the test results for the tensile coupon tests. The plot in Figure 1c shows an initially high stiffness and drop in load at around 0.6–1 MPa stress representing the initial cracking in the mortar. Afterward, the stiffness reduces significantly, and the crack widens with further slip along the length of the coupon (Figure 1d). The authors will generalize these tensile test coupon tests to incorporate in the material characteristics for finite element modeling generation in their future works.

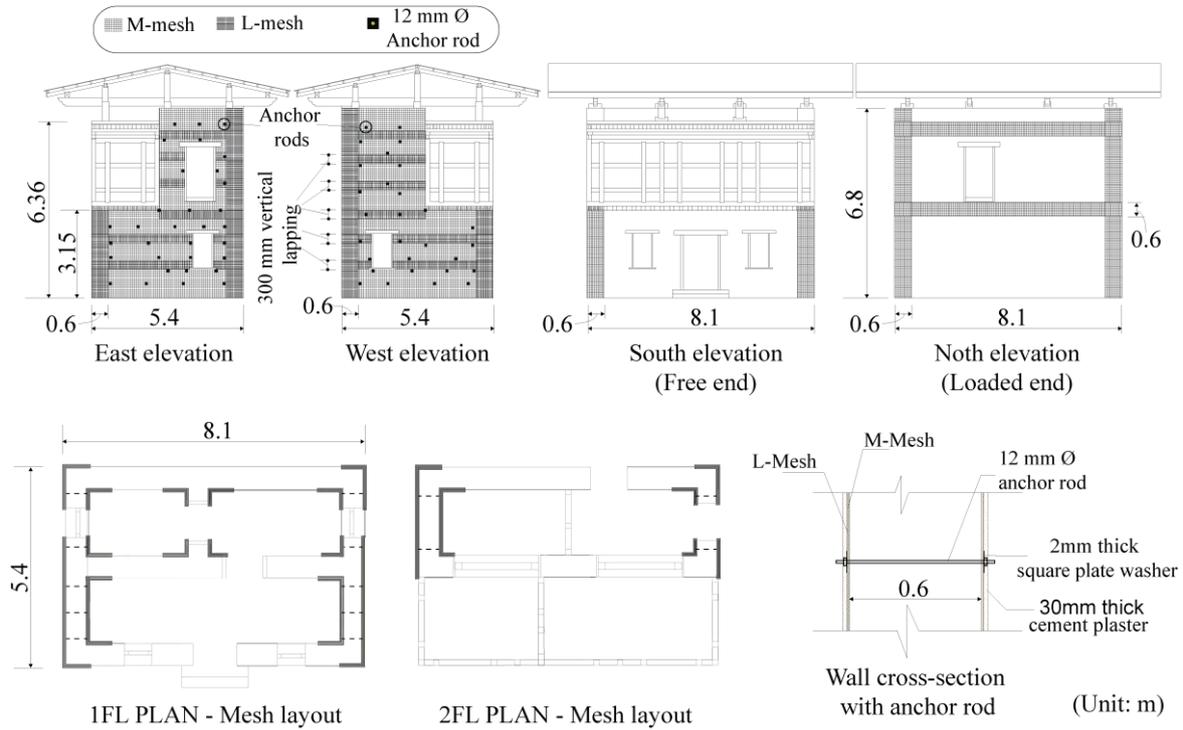
**Figure 2:** Prototype retrofitted rammed earth building specimen (RRE)

The full–scale tests were carried out on a prototype Bhutanese traditional house. The building represents a traditional residential house of Bhutan following the typical architectural pattern with limited openings at first floor level and a large opening on the second floor of the building's front facade. The prototype has a floor area of 8.1 m  $\times$  5.4 m as shown in Figure 2,

Figures 2 and 3 show the details of the retrofitting works carried out on the specimen. It should be noted that the retrofitting was started after completion of the first series of tests on the unreinforced specimen, URE. Two types of wire mesh were used, standard mild steel welded mesh as the main mesh, M-mesh ( $\varnothing$  1.8 mm and 34 mm c/c spacing) and light and galvanized welded mesh as a lapping mesh, L-mesh ( $\varnothing$  1.45 mm and 28 mm c/c spacing) at the corners and along the height of the walls. A lapping length of 300 mm was provided in the vertical direction in regular intervals, while 600 mm lap was provided in the horizontal direction at the corners. First, the mesh was placed on the walls using U-hooks. This was followed by clamping of mesh to the walls using 12 mm diameter rods inserted through the jugging holes and bolted with nuts, as shown in Figures 2 and 3a. Finally, a 30 mm thick cement plaster (cement and sand at 1:3) was applied over the mesh. Prior to plastering, the wall's surface was pretreated using cement slurry (thin mix of cement and water). For the floor joist, X-bracing with timber of size 75mm $\times$ 75mm was provided to connect the floor joists. The X-bracings were bolted to the floor joists at the center and the ends. It should be noted that only the in-plane loaded walls (east and west elevations) were retrofitted as shown in Figure 2, with an extension of the L-mesh to the north and south elevations up to 600 mm. The RRE specimen was tested after three months of curing.

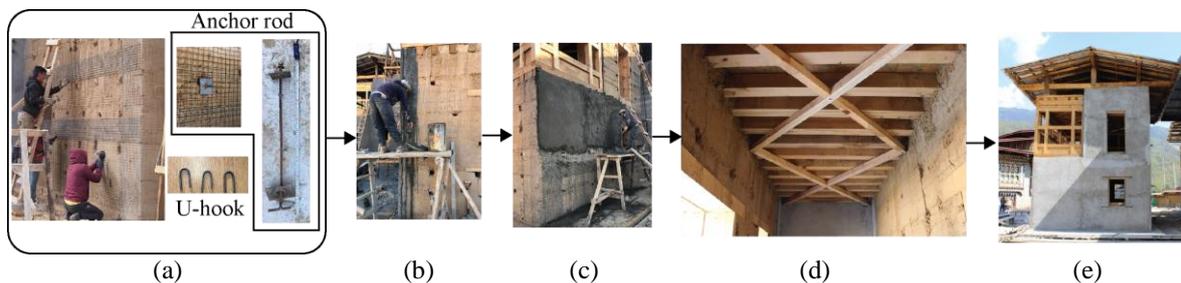
**Figure 3:** Retrofitting work process: (a) Placement and anchorage of mesh, (b) Application of cement slurry as pretreatment, (c) Cement plastering, (d) Wooden brace for floor rigidity, (e) Final specimen after retrofitting

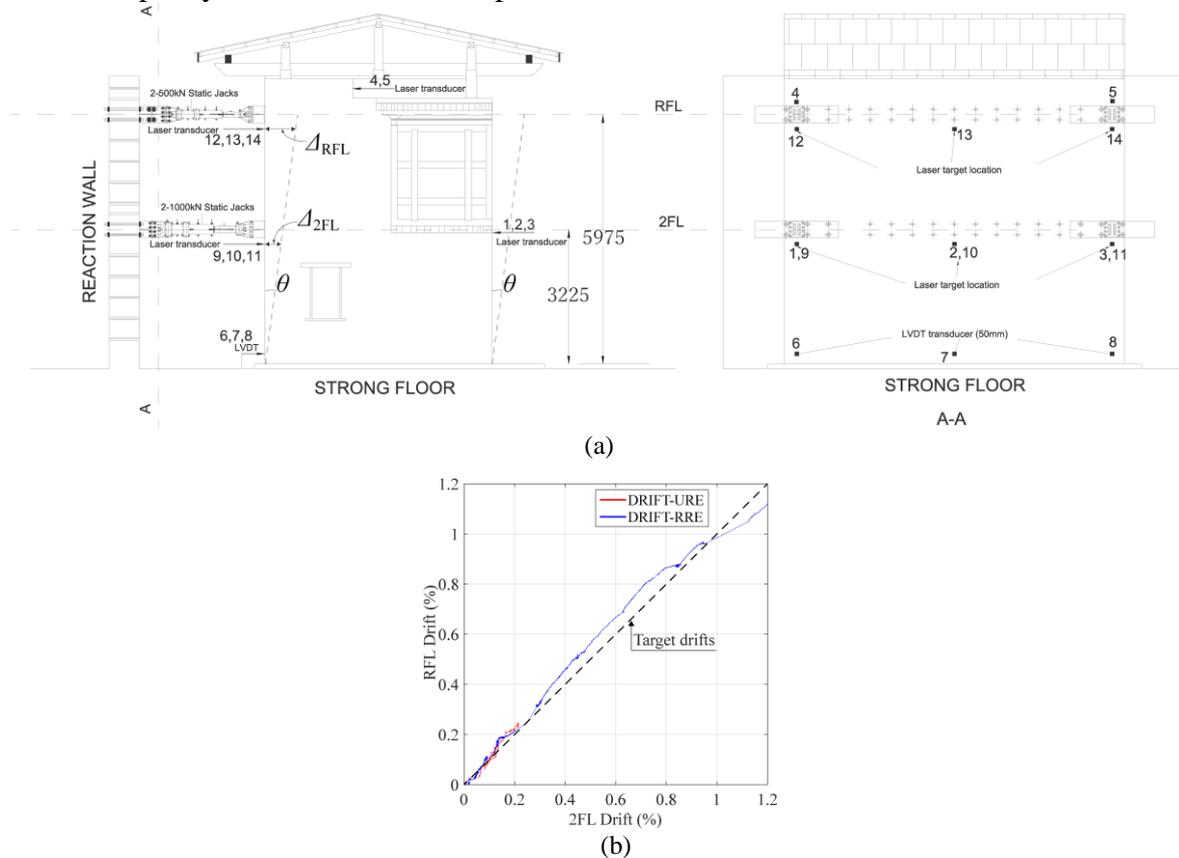
**Figure 4:** (a) Test set-up and instrumentation, (b) Actual and target storey drifts

The test set-up for the static test is illustrated in Figure 4a. Two 1000kN capacity jacks were positioned at the second-floor level (2FL), and the other two of 500kN capacity were placed at

the roof–floor level (RFL). One end of the jack was connected to the reaction wall through the built–up section and the other end to the test specimen’s wall face through a 9.5 m long H–section. There were two 9.5 m long H–sections installed at each floor level, resting on support systems that allow them to slide along the support with the jacks. The static jack is a hydraulic system that was manually operated. The instrumentations are illustrated in Figure 4a. The instrumentation involves load cells installed on hydraulic jacks to measure the applied forces. The displacement was measured using 14 displacement transducers: ten laser transducers (Keyence, IL–300) and four strain gauge type transducers (TML SDP–100C, SDP–50C) at three different levels (base, 2FL, and RFL) of the test specimen both at the loading and the free side. A multi–channel dynamic strainmeter DS–50A was used for data logging with the LAN interface setting. The data sampling rate was set at 100 Hz.

drift, defined as the absolute displacement of the roof (Sensors 12–14 in Figure 4a) divided by the height of the sensor from the ground. From the global capacity curves, the ultimate strength for RRE specimen (714 kN) was about 2.4 times URE specimen (294 kN), an increment of 420 kN. Further, the roof displacement for RRE (38.5 mm) at the maximum base shear was about 4.2 times for URE (9 mm).

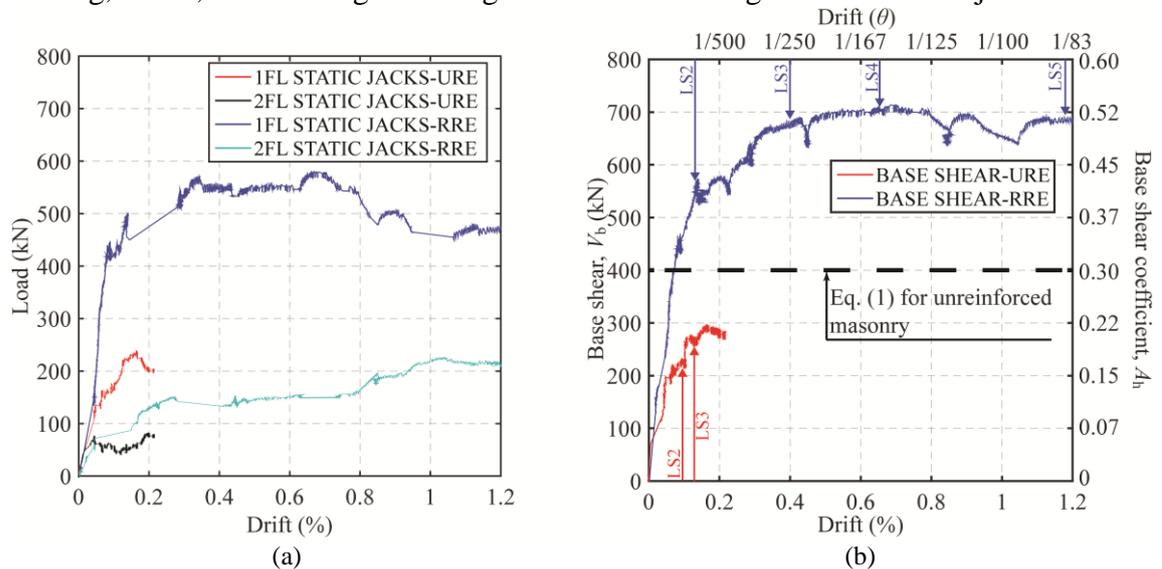
**Figure 5:** (a) Capacity curves in each floor for both prototype unreinforced and retrofitted specimens, (b) Global capacity curves for both prototype and retrofitted specimens

Figure 5a shows the capacity curves in each floor correlated to the load cell readings for 2FL and RFL static jacks of both the prototypes, the unreinforced specimen, URE, and the retrofitted one, RRE. The presence of a large opening on the second floor and less contributions from the wall in load sharing means that the load recorded for the load cells in RFL was comparatively lower to the ones in 2FL. The first floor level, on the other hand, houses solid walls all around the building, hence, contributing to the higher load cell readings from the static jacks.

Figure 5b shows the global capacity curves with cumulative base shears of URE and RRE specimens. It should be noted that the drift ( $\theta$ ) shown in the capacity curves is the roof storey

Indian Standard Code IS 1893 [7] provides simple formulations to compute design base shear for unreinforced masonry in the Indian subcontinent, which was for comparison purposes in Figure 5b, represented by dotted lines. The design base shear [7] is given by:

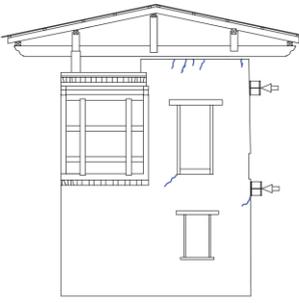
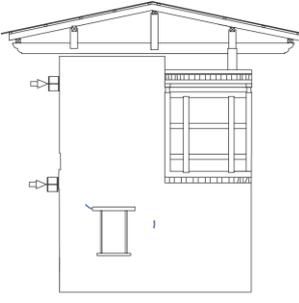
<p><u>Storey drift, <math>\theta = 1/1000</math></u>                      East elevation:                      - Small cracks below the door opening and the top RE block                      - Small cracks below the loading point in 2FL                      West elevation:                      - Small cracks above the window  <u>Limit state: LS2 Slight damage</u></p>

For URE specimen, the crack documentation, as illustrated in Figure 6 are presented for three storey drifts, 1/1000, 1/750 and 1/500. As reported earlier, the test was stopped at the drift of 1/500 for later retrofitting purposes and re-testing of the same building. The first few hair-line cracks originated near door openings and below the loading point in east elevation, and near lintel and jugshing holes of west elevation when the storey drift was up to 1/1000 (Limit state: LS2 Slight damage). For the storey drift of 1/750, there was an extension of cracks in the in-plane walls and new cracks were visible within the rammed earth blocks in 1FL (Limit state: LS3 Moderate damage). At 1/500 storey drift, there was a widening of the previous cracks and new inclined shear cracks within the rammed earth blocks in west elevation. A vertical crack about 1.5 m long also appeared at the far end in west elevation with some earth particles even falling (Limit state: LS3 Moderate damage). The authors felt the specimen experienced substantial damage to warrant its repair, and the test was stopped at this point since the main aim was to retrofit this building for re-testing purposes.. There was a negligible increment in cumulative base shear for URE specimen with further increment in drift. Therefore, based on authors' observations, limit state of LS4 representing "Extensive damage" will possibly occur for URE at storey drift of 1/250, which may not allow effective retrofitting of the specimen.

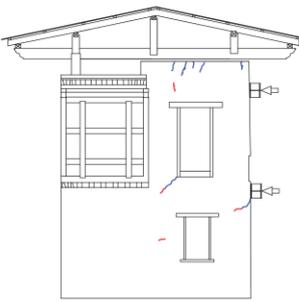
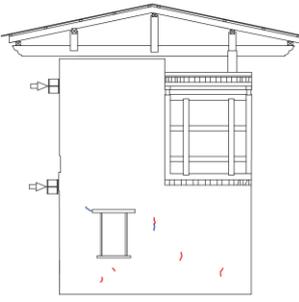
<p><u>Storey drift, <math>\theta = 1/750</math></u>                      East elevation:                      - Extension of the cracks below the door opening as well as below the loading point in 2FL                      West elevation:                      - Small cracks visible within the rammed earth blocks  <u>Limit state: LS3 Moderate damage</u></p>

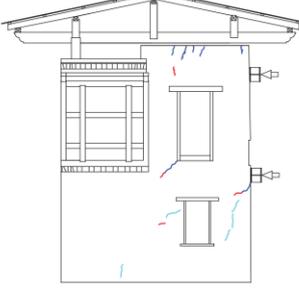
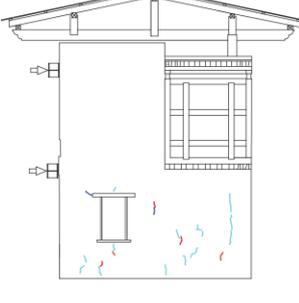
<p><u>Storey drift, <math>\theta = 1/500</math></u>                      East elevation:                      - Widening and extension of the cracks below the loading point in 2FL                      - New cracks near the window opening                      West elevation:                      - Significant number of inclined cracks within the rammed earth blocks below 2FL originating from the Jugshing holes                      - A vertical crack about 1.5 m long appeared at the far end from loading point  <u>Limit state: LS3 Moderate damage</u></p>

**Figure 6:** Crack evolution for unreinforced rammed earth (URE) specimen at different load levels and their respective limit states
