# Technology, validation and demonstration

## D6.2 (WP6): CONSTRUCTION OF THE W2POWER TOWER DEMONSTRATOR

This deliverable deals about the production of the two towers for the W2POWER windmill.

It explains all the production of those large composite parts, from the design of the tools to the delivery of the parts.

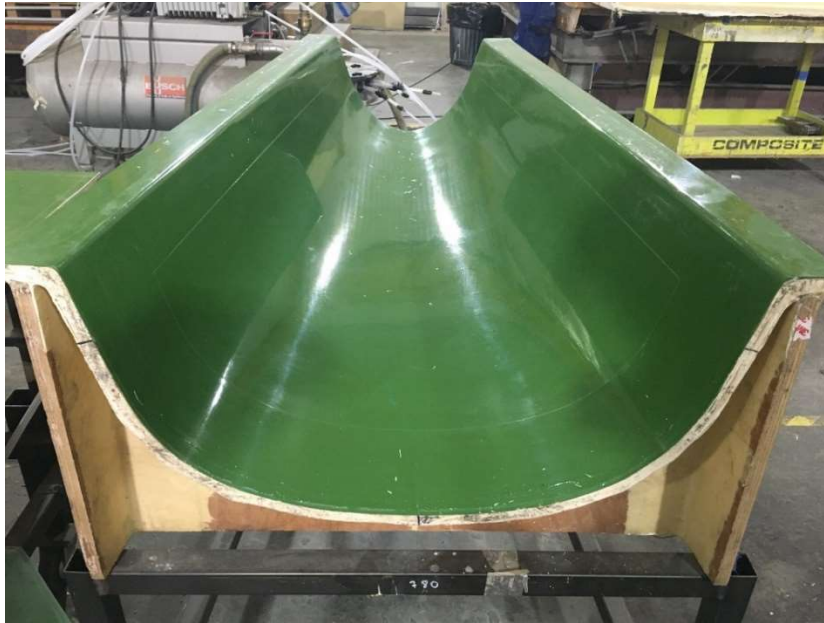
The maximum scantling was put in a mold with similar section to the real one.

Figure 3 : test mould

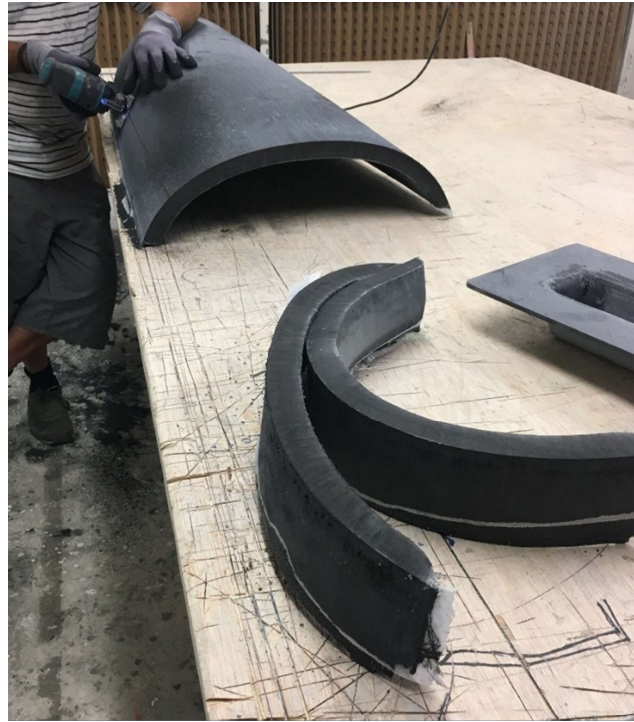
The first part was cut in many slices to check that the resin impregnation was conform everywhere with no dry spot in the core of the part.

Figure 5 : slice cutting of the test part

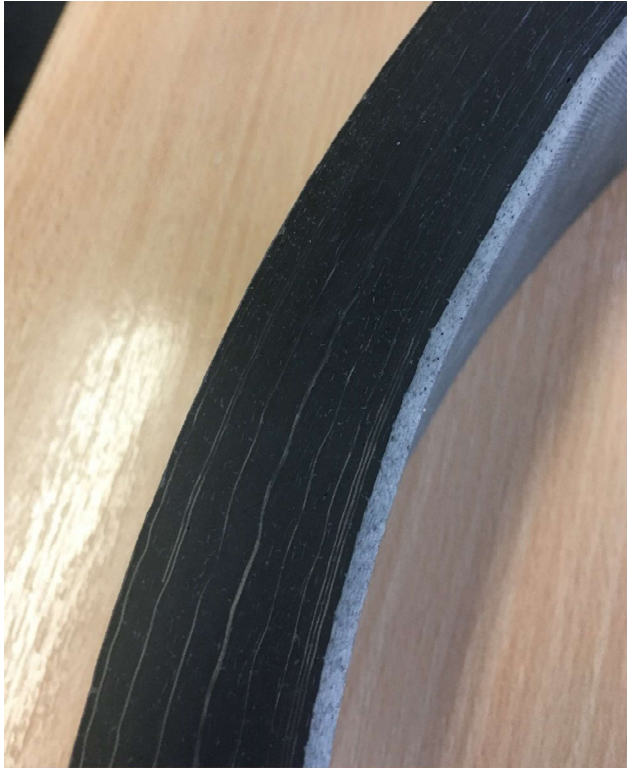
Another batch of test was to validate the exact thickness of the part. One question was to know the impact of the overlapping. The width of a roll fabric is 127cm and the developed width of the mould is larger. So we have overlapping of the fabric which is increasing the total thickness of the part. The knowledge of the total thickness is primordial for the mould design. We are starting from the geometry of the metal ring, we add the gap between the metal and the composite part and then the thickness of the composite part. This gives the surface of the female mould.

Figure 6 : edge of the test part

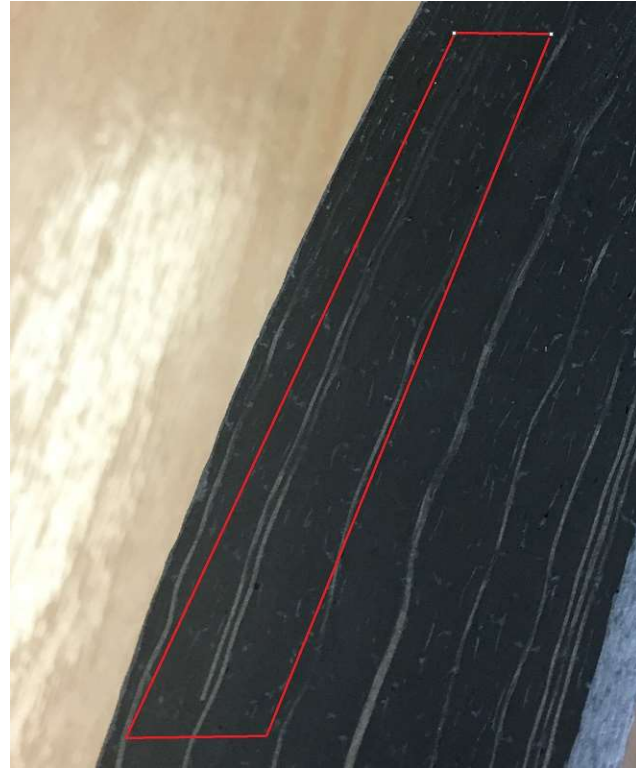
Figure 7 : detail of overlapping

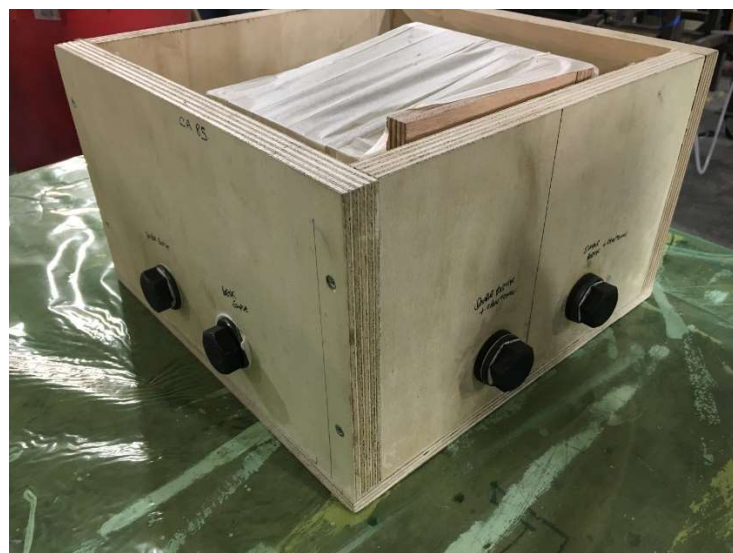
Another test was to know the reaction of the casting resin with the assembly imagined. The resin has to stay in the gap between the parts. But this type of product is very fluid and can escape by any tiny hole.

Figure 8 : resin casting test

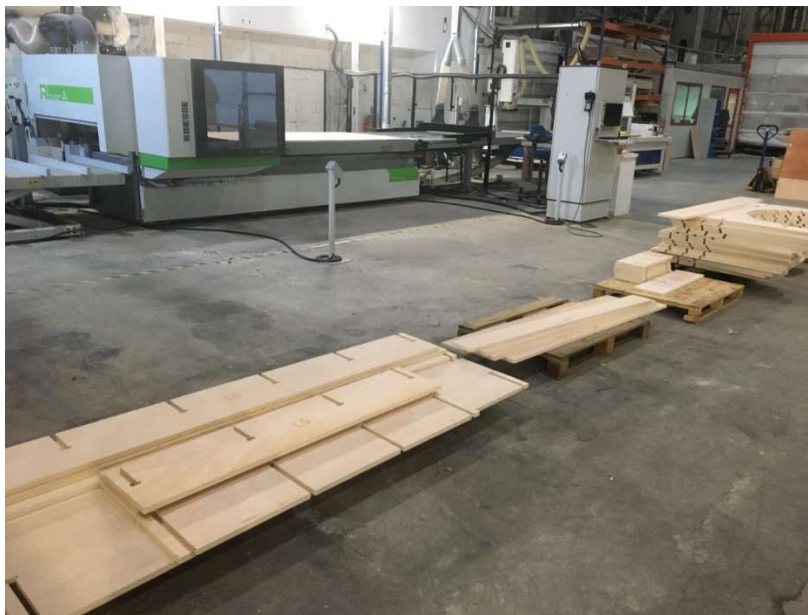
Once the mould is designed in 3D by the design office, the file is forwarded to the computer numerical cutting department. The 3D file are converted and coded into files that can be read by the numerical machines. Moreover the design should be post treated to be adapted to the dimensions of the raw material. For example, the flat parts should not exceed the standard dimensions of plywood panels. For larger parts, it should be an assembly of “small ones”.

Figure 9 : panels cut by CNC

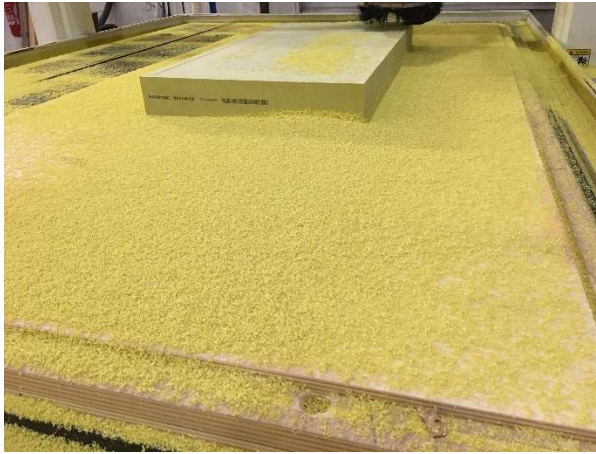
The plug part is done with 5 axis milling machine due to the complex shape of those parts.

Figure 10 : plug milling

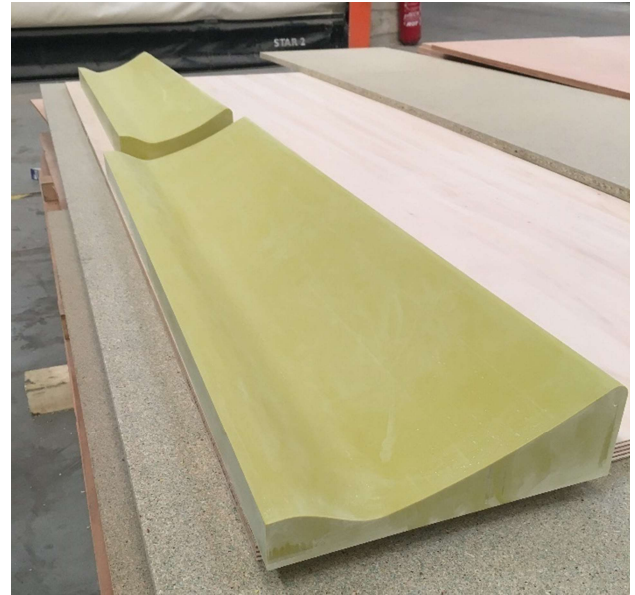
Figure 11 : section of plug finished

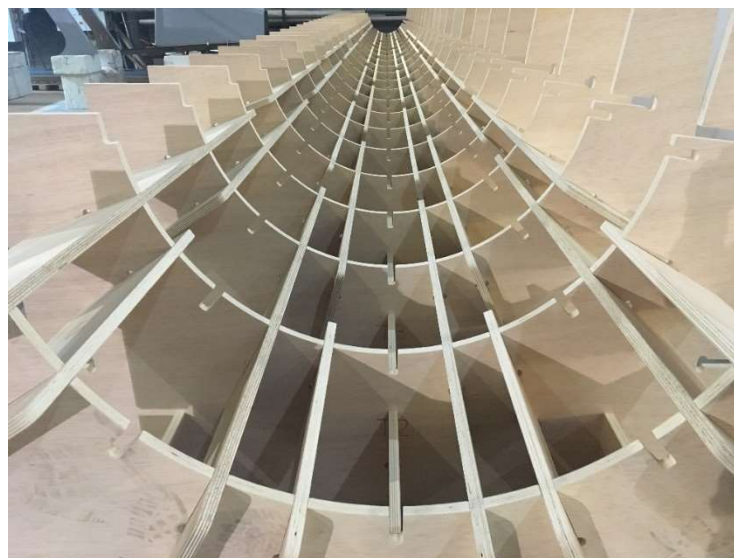
Once all the parts of the “puzzle” are ready, we can start the building of the mould structure. The design was made to have a self blocking geometry of the structure. Each part is participating to the general stability of the mould.

Figure 12 : mould structure

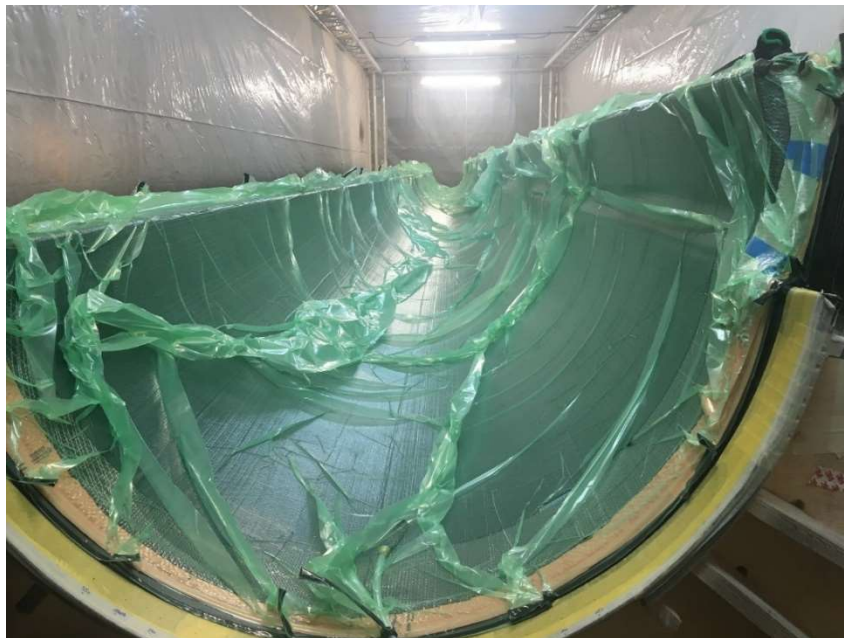
Due to the large thickness of the parts, every night the part is kept under vacuum to have a good compacting of the fabric.

Figure 17 : Compacting of the fabric

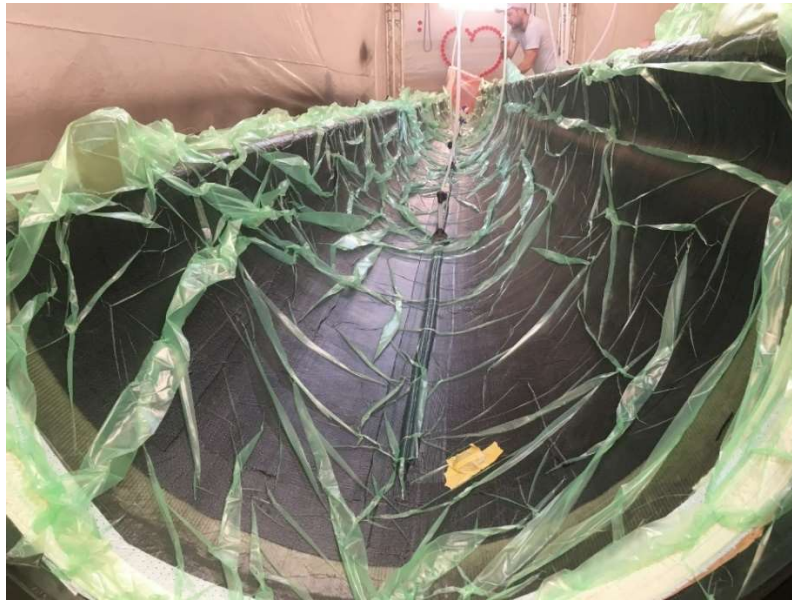
The infusion had to be performed in an environment with a good management of the temperature. The big thickness of the part is making the control of all parameters vital. If any of them is turning wrong the infusion can fail. In such a case all the material goes to the garbage.

Figure 18 : infusion

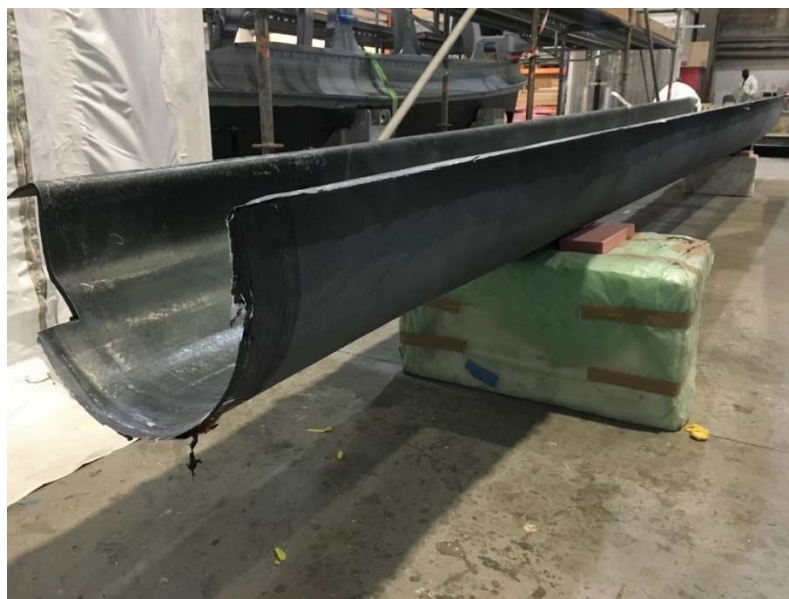
After the polymerization of the resin, the parts are post cured to ensure the best properties of the composite. Once this step is done, the parts are removed from the mould and the edges cut according to the final dimensions.

Figure 19 : half mast unmoulded

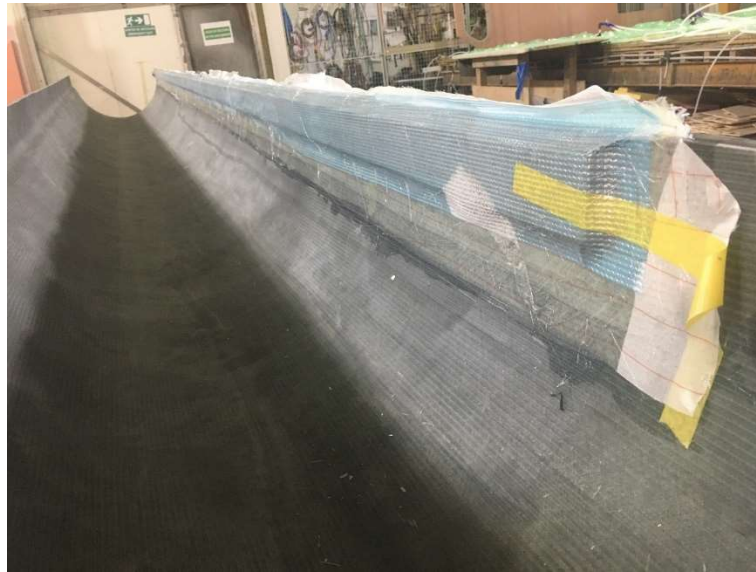
A stripe of steel is laminated on each half part in order to be drilled and threaded during the assembly without internal intervention.

Figure 20 : lamination of the steel insert

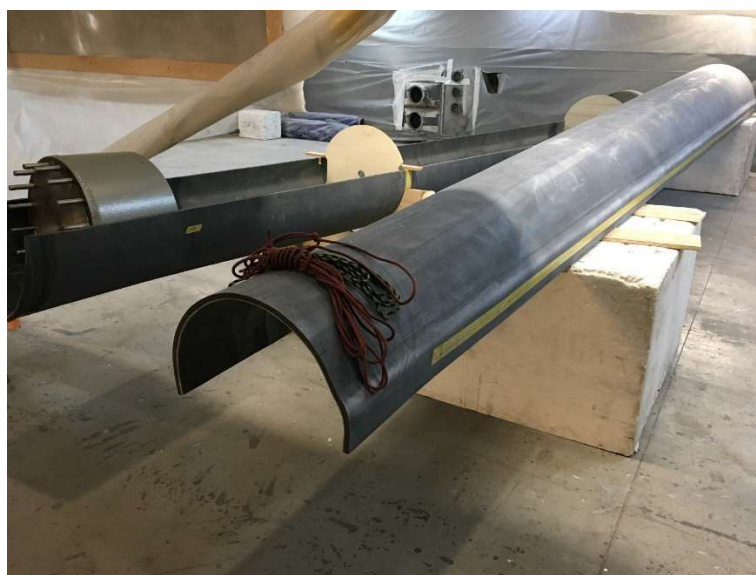
Some extra layers of glass fabric were added in the rings areas to have a possibility for grinding in case of geometry problem. The aim is not to grind the carbon fabric.

Another function of this layer is to be an insulator as glass is a non-conductive material.

Figure 21 : Two half parts ready for assembly

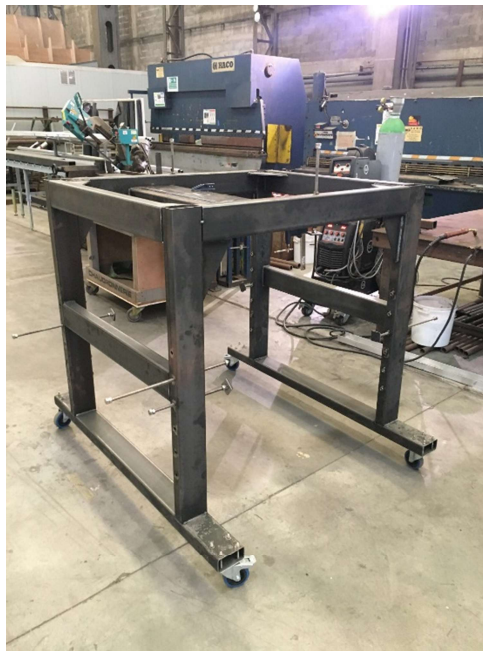
A specific trolley was designed to perform the hundreds of holes for the assembly procedure. The berth system is design to maintain the top part of the mast on a horizontal line to fit the drilling system on the trolley.

Figure 23 : drilling trolley

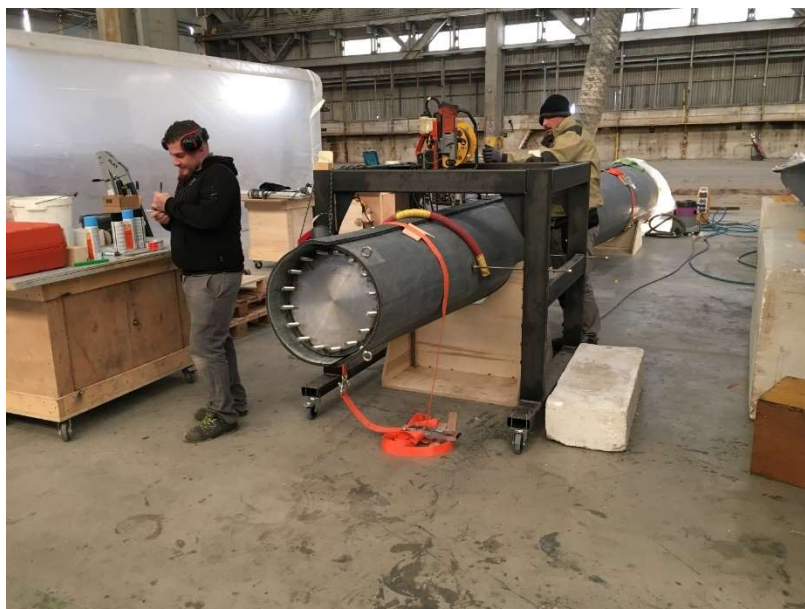
The drilling operation is quite a long step, as there are more than 300 holes to drill and thread.

Figure 24 : drilling operation

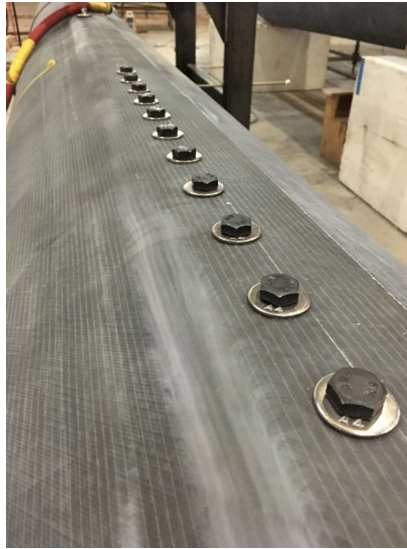
The bolts are put for an temporary period to allow the turning of the mast.

Figure 25 : Temporary bolting

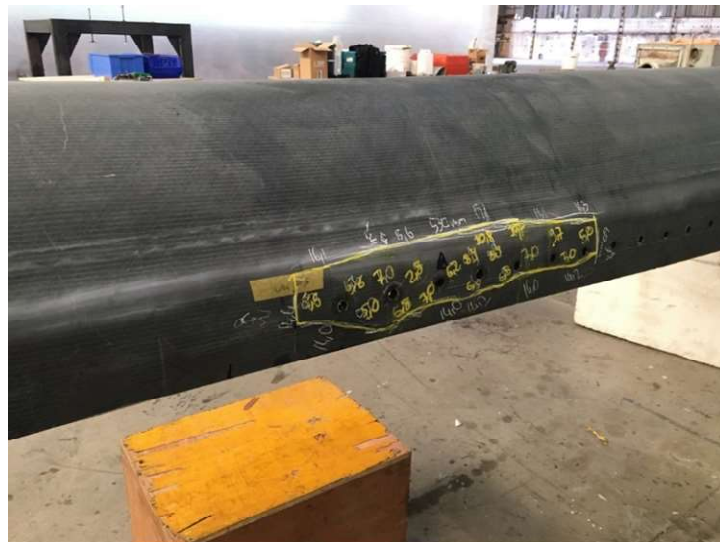
During the pre tightening an area between the two parts was not correctly fitted with glue. The stiff of the part is so important that with a very low torque we encountered a delamination in the area. We had to perform an non destructive ultrasonic survey to evaluate the damage and set up a repairing process.

Figure 26 : results of ultrasonic NDT

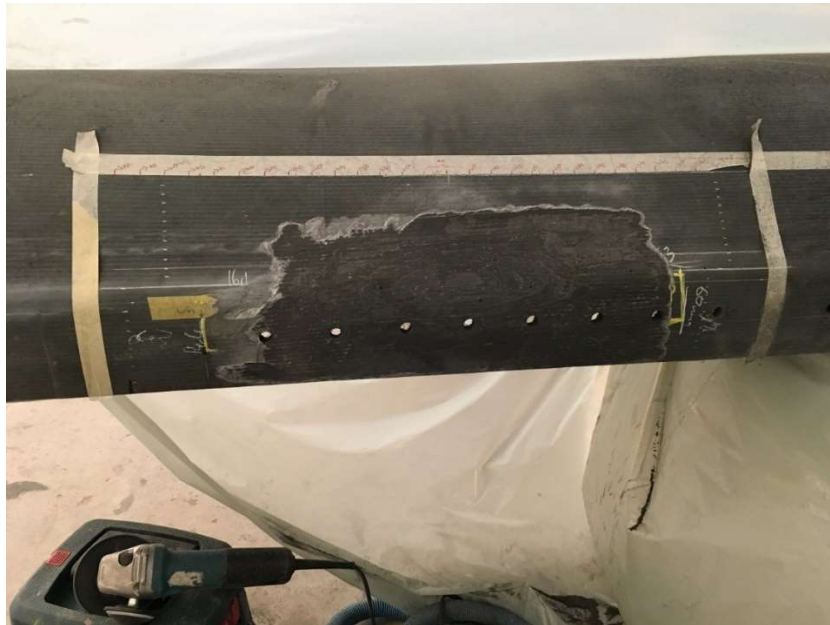
The repair process was to grind from the surface to the delamination and to rebuild the scantling by vacuum hand layup. All the scarf and overlapping were respected.

Figure 27 : grinding of the area

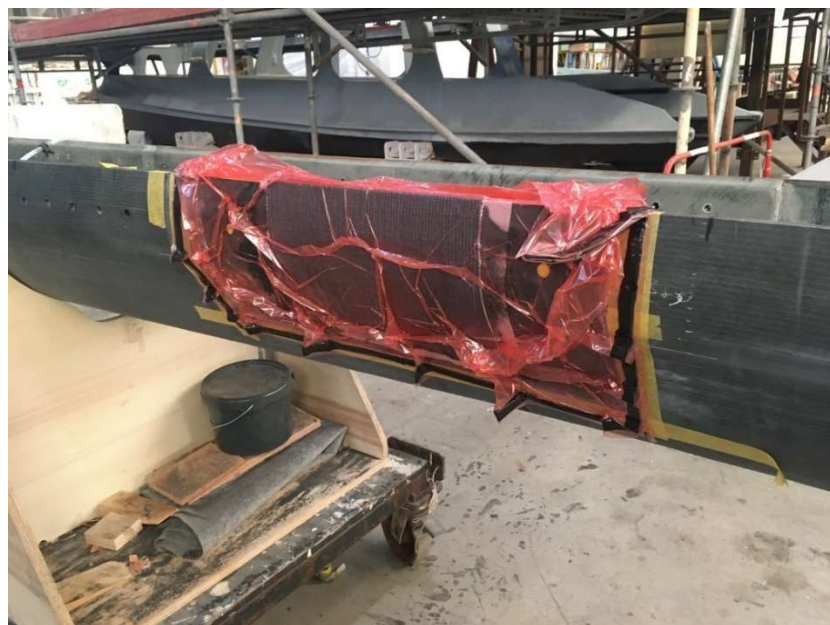
Figure 28 : Repair under vacuum

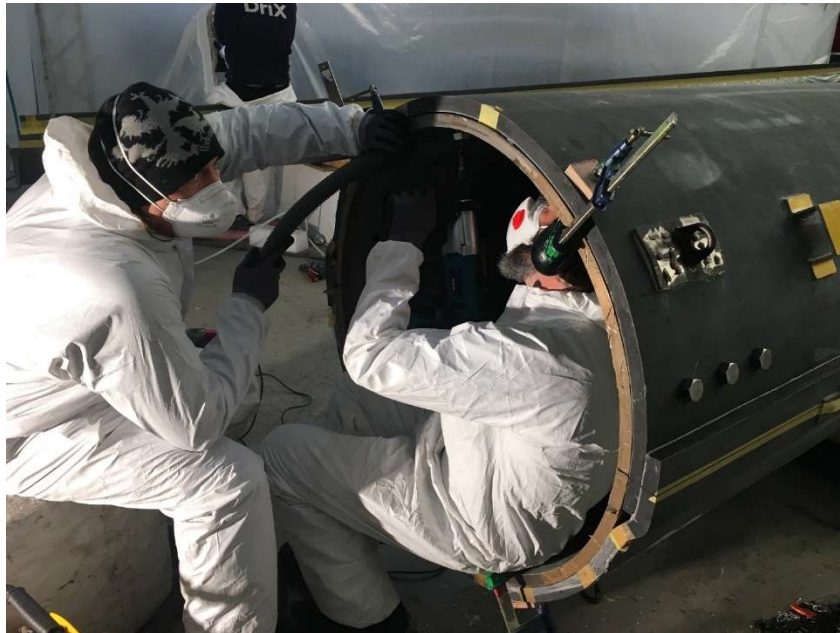
Once the assembly of the two half masts done, the assembly of the extremities could happen. Some special tools were made to use the thread of the bottom ring as a guide, but without any risk of damaging them. From this step the position of the ring regarding the tower cannot be changed.

Figure 29 : drilling for bottom ring assembly

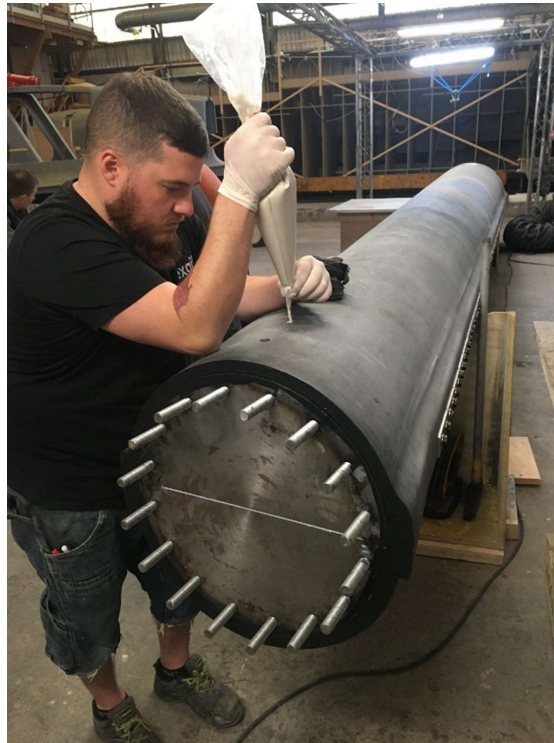
Once in the right position, a resin casting should fill the gap between the composite part and the metallic ring.

Figure 31 : resin casting for top ring

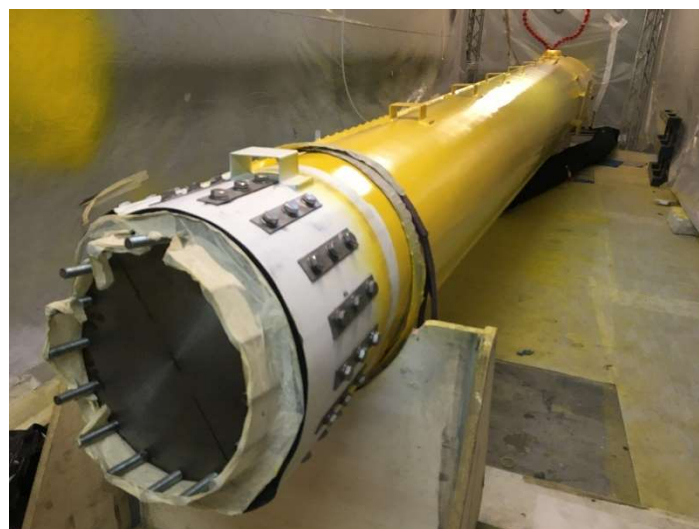
Once the gap filled, the bolting process is carried on. Like for the other one, repartition plates are use. The torque can be applied on the bolt with no risk of damaging the composite.

Figure 32 : Top ring bolted

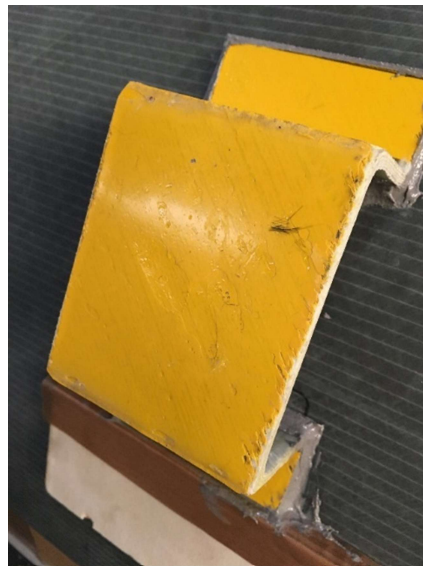
Several supports were used to do a process test with the dry paint coating.

Figure 33 : cable tray support with dry coating

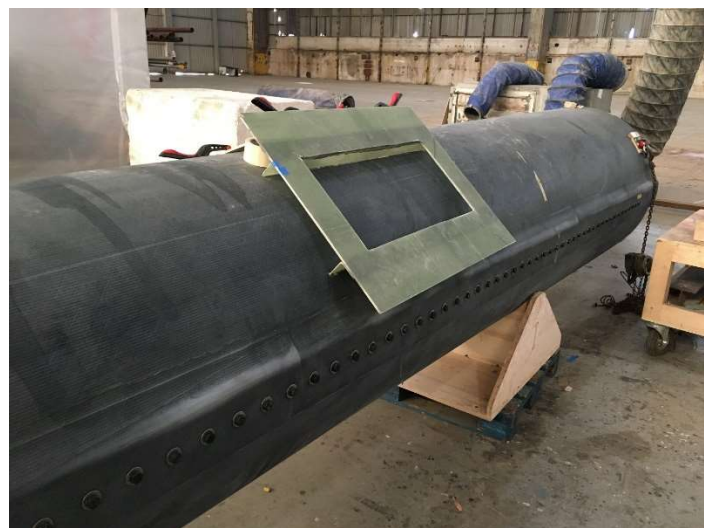
The supports were bonded or laminated, depending of the weight supported.

Those supports allow an easy interface with the equipment. They can be drilled and bolted without having composite knowledges.

Figure 34 : electrical box support laminated

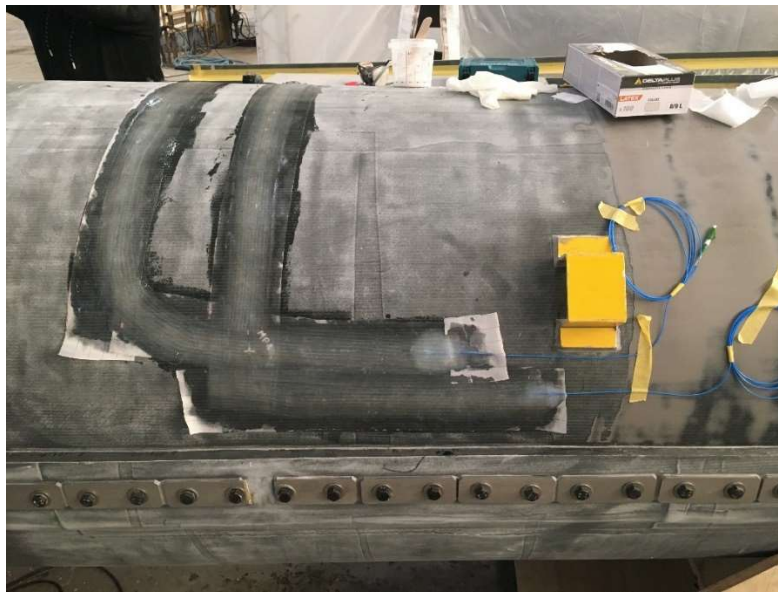
One difficulty is to work with the bare fiber. The embedded fibre area has no protection, so the fiber is very fragile and complicated to see during manipulation.

Figure 37 : optic fibre laminated to the tower

There is an extra length (with protection in blue) ended by the connector. This connector will be plugged to the interrogator to have the data for the structural health monitoring of the structure.

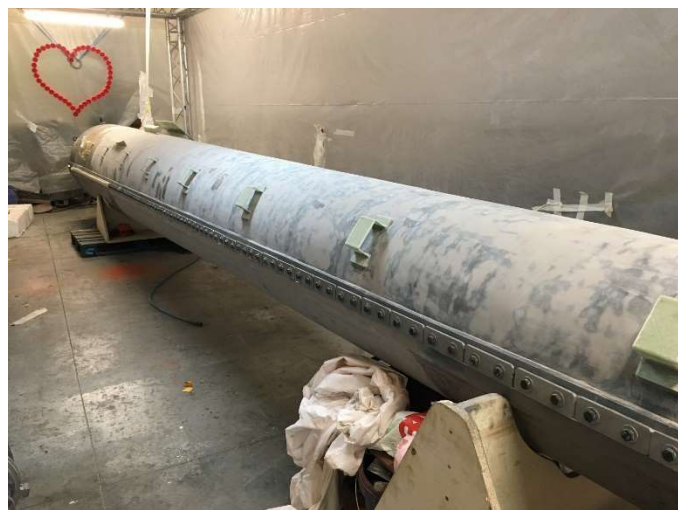
The tower got a finishing system. The steps were a fairing of the surface to eliminate the small defects, a primer and a topcoat respecting the color reference.

Figure 38 : mast with fairing

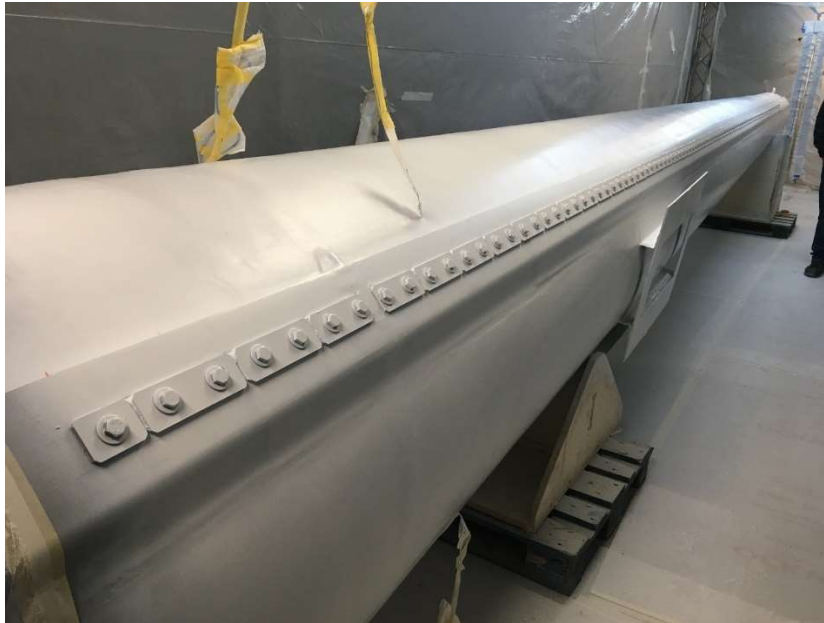
Figure 39 : mast in primer

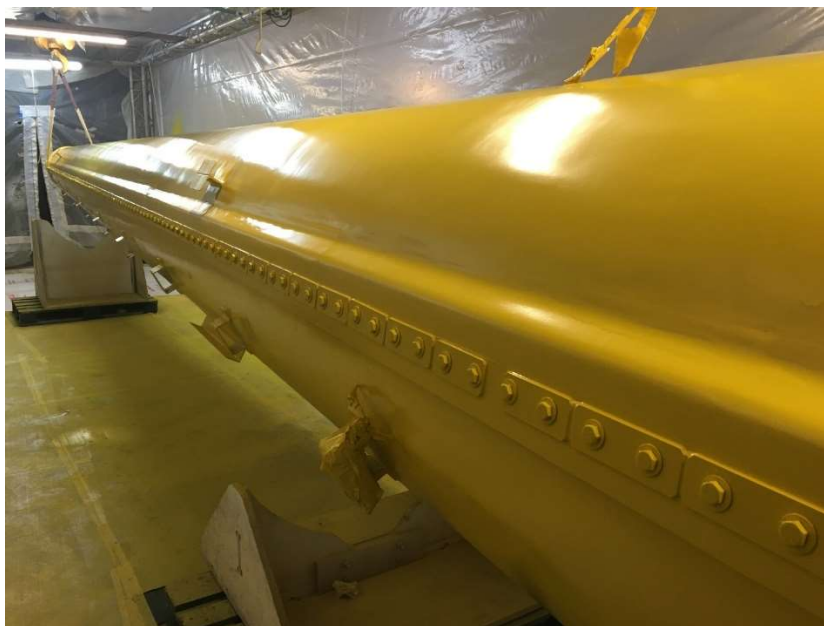
Figure 40 : Mast with topcoat

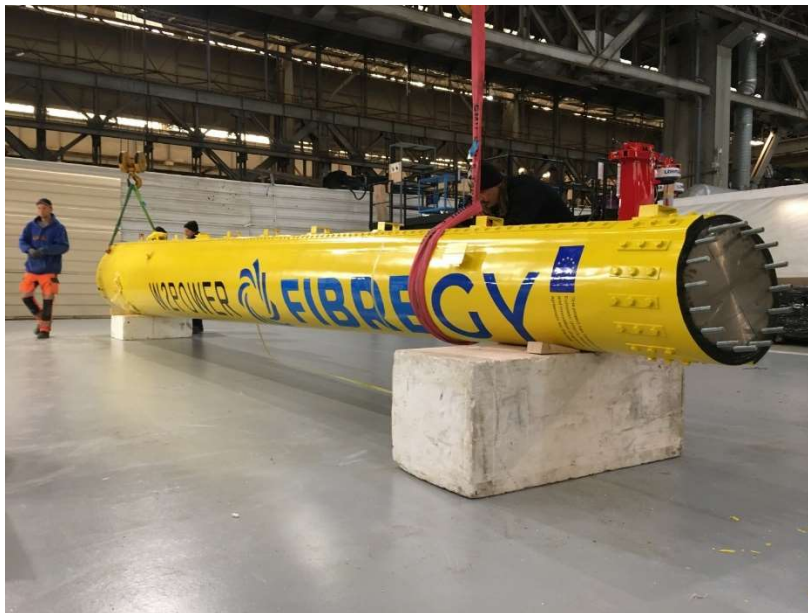
The mast was ready for shipping from France to Canaria Island.

Figure 41 : mast ready for shipping

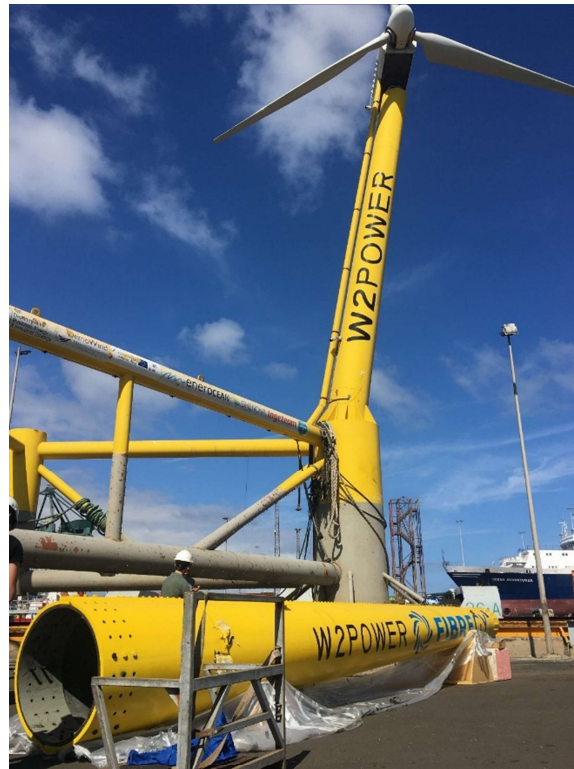
The first mast was delivered in the local shipyard in Canaria Island. Some technical meeting occurred to define to process for the towers' swap.

Figure 42 : composite mast and steel demonstrator
