THE NON-SMOOTH TALE OF ACCUMOLI CIVIC TOWER

Abstract. In this paper, advanced numerical models are used to study the progressive damage of a historic building, namely the Palazzo of Podestà and the Civic Tower of Accumoli (central Italy). The dynamic behaviour of the structure is analyzed following important seismic events such as those that occurred in 2016-2017. Discontinuous and continuous approaches are used. In the formers, the masonry response is represented both with Discrete Element Method (DEM) and the Non-Smooth Contact Dynamic (NSCD) method; in the latter the masonry non linearity is replicated using the Concrete Damage Plasticity (CDP) model. The numerical results showed a good correspondence of all the approaches with the real damage suffered by the structure after the seismic sequence.

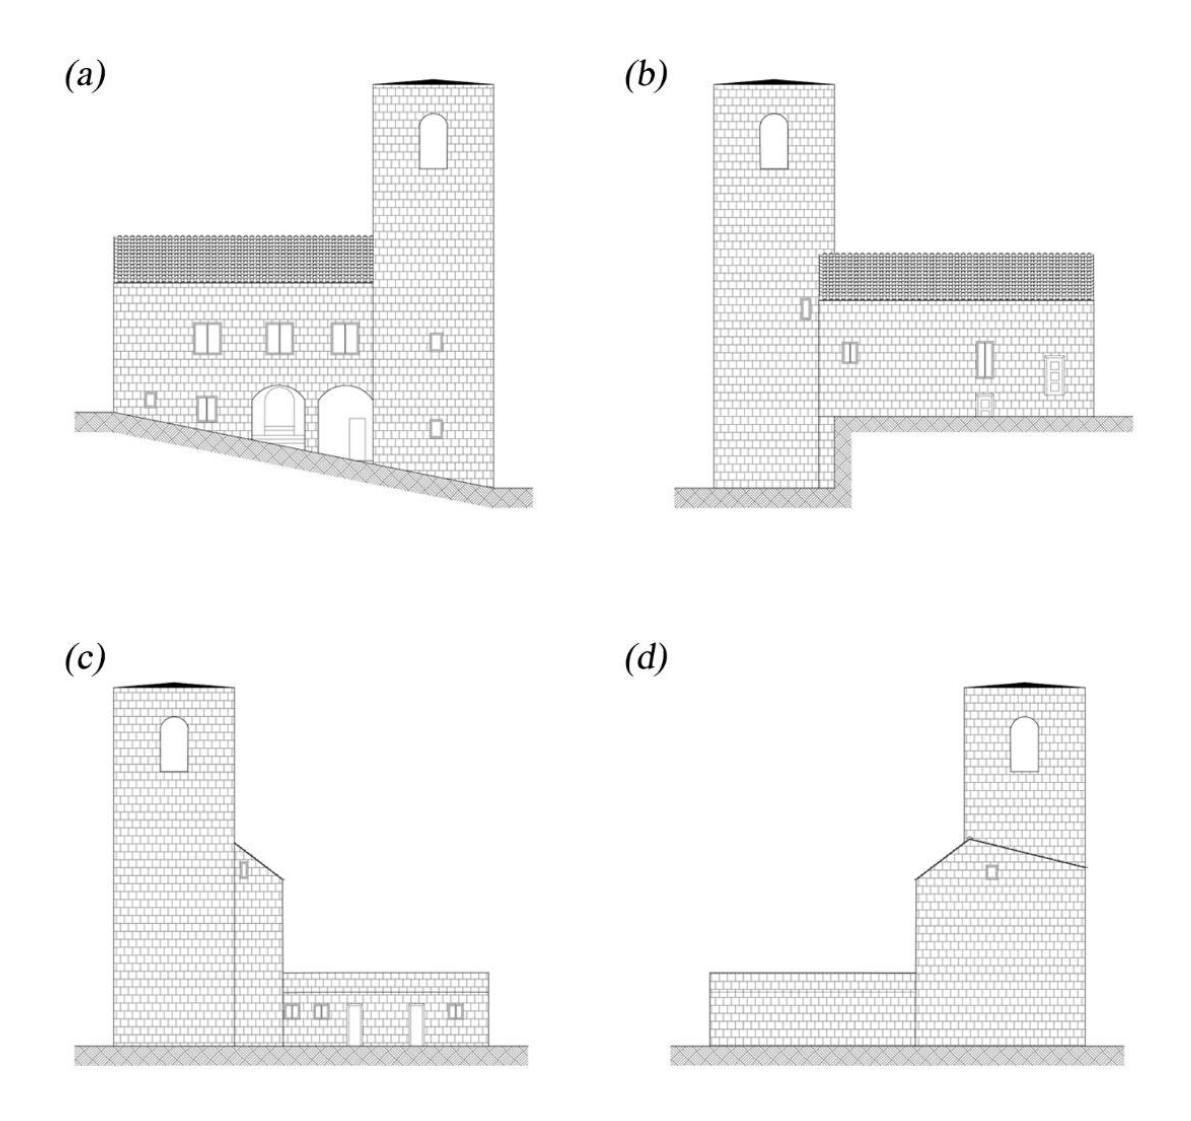
At the heart of this small village there is the case study of this paper, i.e. the Civic Tower of Accumoli and the adjacent Podestà palace. The Tower dates to the twelfth century, it is unique in its kind in the entire Tronto's valley. It is located in via Tommasi, featuring a square plan measuring $6.15x6.15 \text{ m}^2$ with walls of 1.20 m thickness at the base and 1.00 m at the top. In elevation, the maximum height exceeds 20 m (Figure 2). The bearing structure consists of multileaf walls [5,6], the perimeter curtains are in cut stones and the inner core is in irregular stones. The structure ends with a pitched roof in reinforced concrete.

Figure 2: North façade (a), South façade (b), East façade (c) and West façade (d).

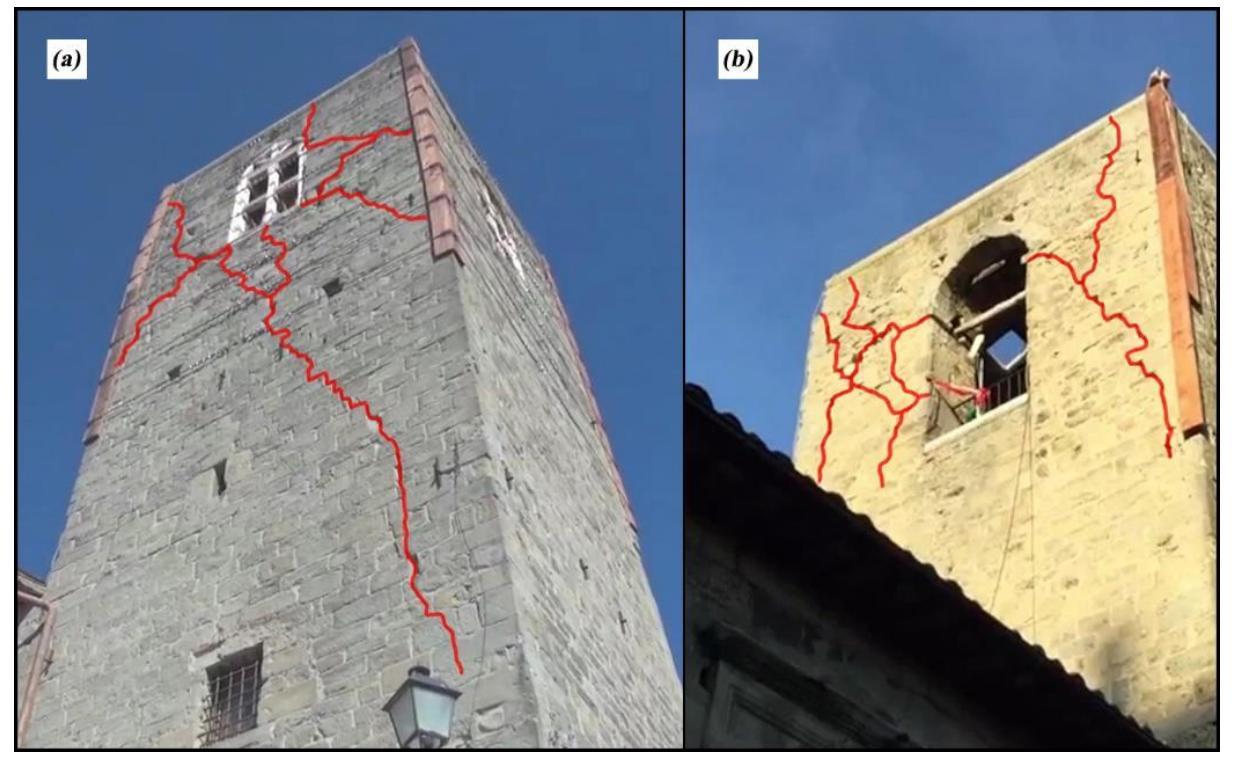
After the 2016 earthquakes, the complex exhibited visible cracks, especially on the tower as visible in Figure 4.

Figure 4: Real damage of the North façade (a) and West façade (b).

Italy in 2016. It is possible to note a good correspondence between the models with the NSCD and DEM methods and the real damage. In particular, the global and local behavior of the structure is obtained. Furthermore, good results are obtained with the continuous approach, which, however, unlike the discontinuous approach, cannot faithfully reproduce the cracks because the parameters of the materials have a high influence on the structural response.

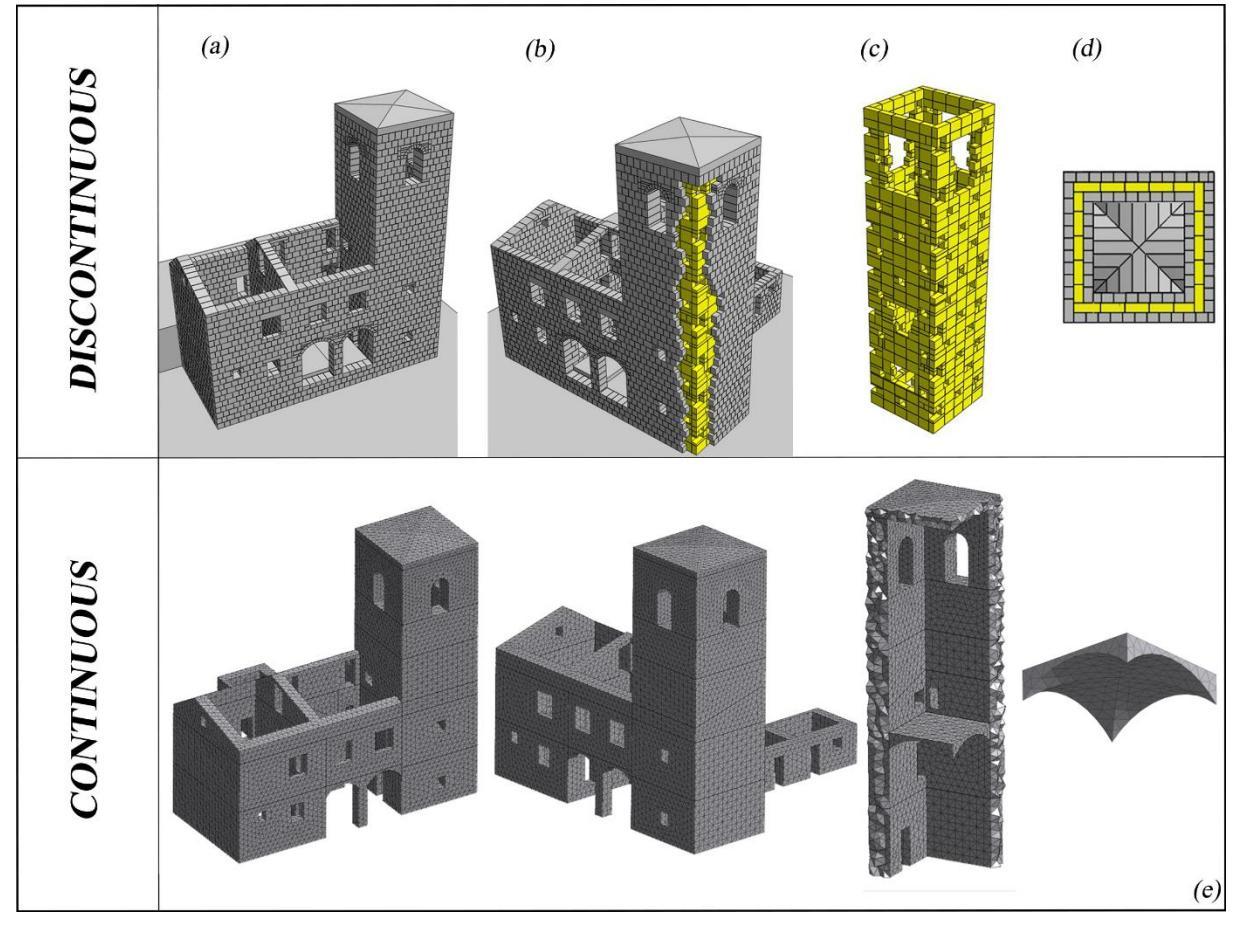
code and with the Distinct Element Method (DEM) [13–15] implemented in 3DEC© code. A 3D numerical model is created, and the masonry is discretized in different individual rigid blocks, reproducing the real behaviour of the structure, and analysing the progressive damage under a seismic action [16–18]. The size of the blocks has been approximated in order to obtain a fair compromise between a good degree of detail and a not too expensive computational burden (Figure 5) [12]. Furthermore, it was decided to model the tower also considering its internal filling (Figure 5.b-c-d) as can be seen in Figure 5c, made with larger blocks than the two external leafs in order to limit the computational burden.

Figure 5: Discontinuous (a-d) and continuous model (e).

homogeneous isotropic medium [19]. To reproduce the nonlinear behavior of the masonry, the Concrete Damage Plasticity (CDP) model [20,21] is used. Such a model is one of the most used to analyse the masonry behavior under horizontal loads [8]. Indeed, it can simultaneously provide the compression and the tension damages and consider the recovery of stiffness due to cracks closure. In the CDP the yield surface and the constitutive laws in tension and compressions with their associate damage curves must be defined. To realize the FEM model the geometrical domain was discretized with tetrahedral bricks elements of the mean dimension of 0.35 m to whom the materials parameters were assigned. The FEM counts a total of 92986 elements 23091 nodes and 69276 degrees of freedom (Figure 5.e). The maximum tensile's damage was fixed to 95% to avoid numerical instability.

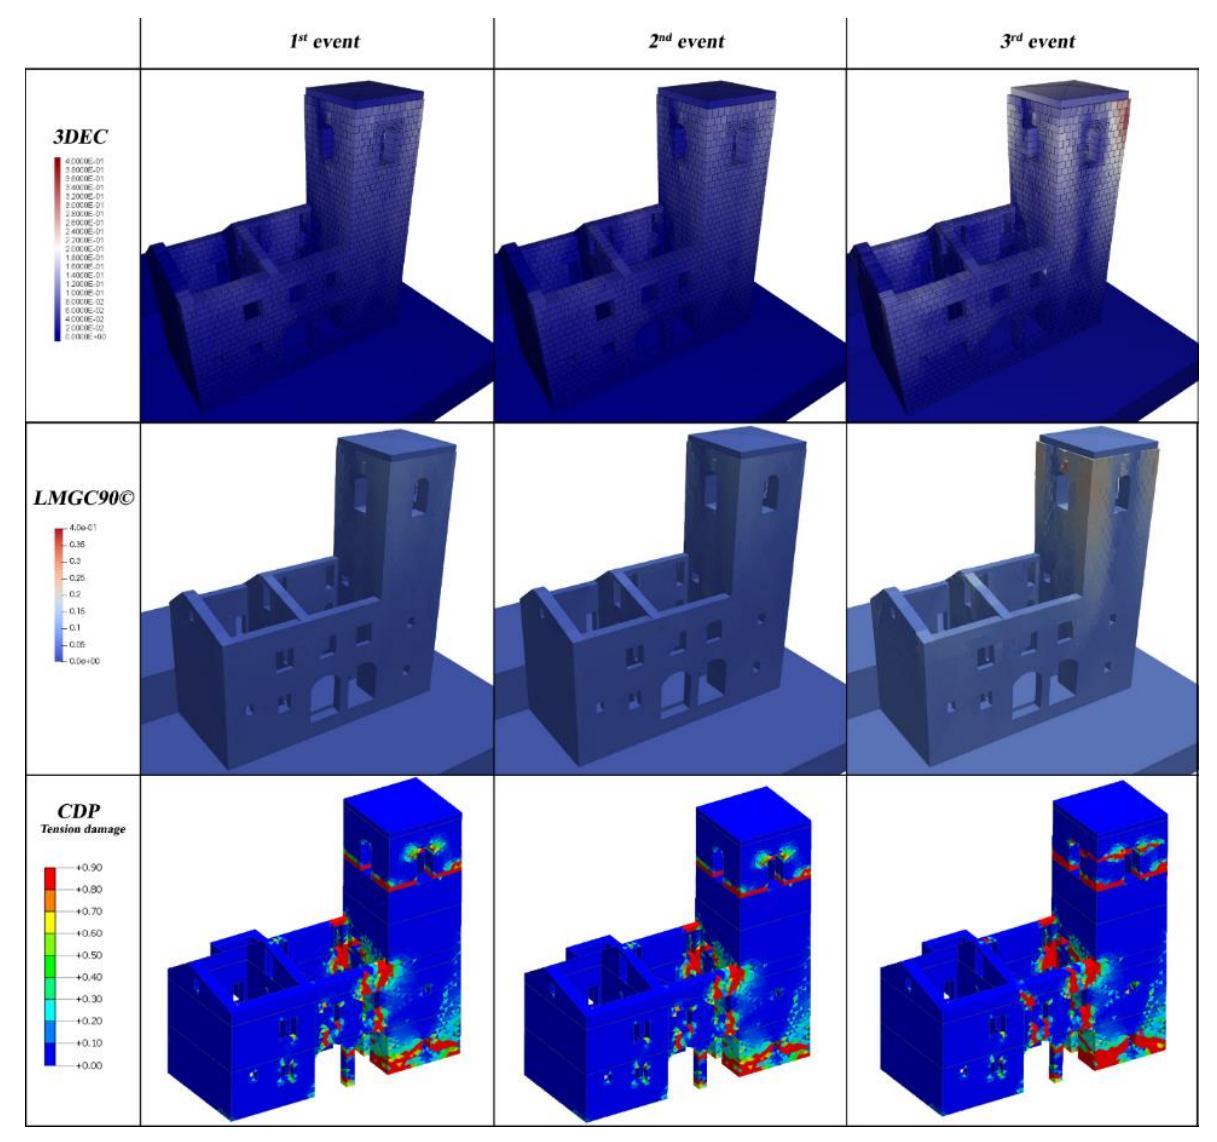
Figure 6 shows an excellent correspondence of results between DEM and NSCD. The part of the structure that is most affected by the seismic sequence is the belfry, in fact following the first two events the formation of crack patterns on it is visible. Following the earthquake of 30th October 2016, it is possible to notice the propagation of crack patterns between the palace and the tower. Furthermore, the palace after the last shock is damaged near the openings on the ground floor. The tower instead highlights the formation of vertical crack patterns on all the façades. On the other hand, the FE model also shows the vulnerability of the bell-cell. After the first event, horizontal cracks at its base are visible; instead, at the end of the sequence, a crack appeared also in the upper corner of the single arched windows. In contrast to the discrete approaches, the continuous showed important cracks in the connection between the tower and the palace just after the first events (Figure 6).

Figure 6: Comparison between results of 3DEC©, LMGC90©, and FEM.

Finally, it is important to stress the fact that all the approaches were able to identify the bellcell as the most vulnerable element, as incidentally demonstrated by the 2016 seismic sequence. However, the cracks' pattern is more accurate with the discontinuous approaches instead than with continuous one. It is certainly linked to a loss of the resistant properties of the mortar, but also to a masonry's texture with irregularities, at least in the filling. With these boundary conditions, the masonry exhibits crumbling instead of a monolithic behaviour, the first one impossibile to catch with continuous approaches.
