Proven Performance: Aged TPO Field Study

Abstract. *New thermoplastic polyolefin (TPO) roof membranes have been extensively analyzed in laboratories, roof exposure farm fields, and under accelerated weathering conditions. The ASTM International material standard specification for TPO membranes has been regularly improved since its inception to incorporate more demanding tested-product performance, including requirements for accelerated weathering and aging. Industry data on the aged performance of TPO roof membranes to date has largely been based on laboratory work, regional studies, and anecdotal case studies of TPO roofs, predominantly those that have been improperly designed and/or installed, and membranes with retired formulations that resulted in premature failure. Today, there are TPO roofs in the United States that have been in service for nearly 20 years. This paper will review the long-term performance of a large sampling of TPO roof membranes installed throughout the United States by evaluating thickness, flexibility, inspection under 7X magnification, aged seam strength, and repair weld adhesion. The intent of this study was to evaluate 1) field-aged TPO roof membrane p

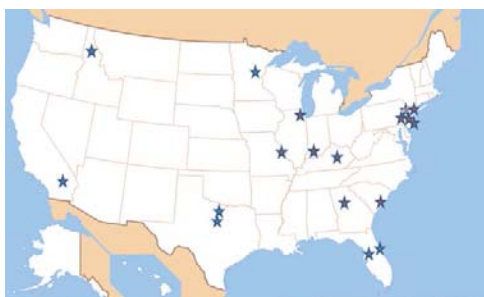
Figure 1. To date, samples have been collected from 20 roofs across the United States.

Samples were taken from 20 different roofs across the United States (See Figure 1). Climatic conditions of the United States cities were matched up with their European counterparts, and are shown in Figure 2 to illustrate the approximate European climate equivalents captured in this study. These roofs were installed over office buildings, manufacturing facilities, retail outlets, libraries, automotive repair shops, warehouses, and a grocery store. All data gathered was used in the analysis.

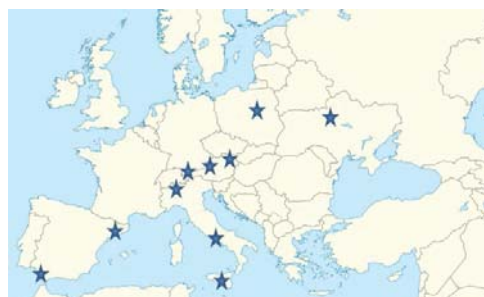
Figure 2. European climatic equivalent locations to the samples collected across the United States.

On average, a typical roof membrane in this study was installed between 2005 and 2006 has been exposed to 20 hail storms, over 50 feet of rain, over 500 days of 32°C+ (90°F+) and wind gusts of up to 148 kph (92 mph). Specifically, the roof membrane from Orlando, Florida has been exposed to the elements for over 17 years. This roof has weathered 9 hurricanes, 13 hail storms, 56 feet of rain, 1,660 days of 32°C+ (90°F+) and wind gusts of up to 169 kph (105 mph). While the United States and European climates are somewhat comparable, the wind gusts are more aggressive than what is typical in Europe.
