## Proven Performance: Aged TPO Field Study

**Abstract.** *New thermoplastic polyolefin (TPO) roof membranes have been extensively analyzed in laboratories, roof exposure farm fields, and under accelerated weathering conditions. The ASTM International material standard specification for TPO membranes has been regularly improved since its inception to incorporate more demanding tested-product performance, including requirements for accelerated weathering and aging. Industry data on the aged performance of TPO roof membranes to date has largely been based on laboratory work, regional studies, and anecdotal case studies of TPO roofs, predominantly those that have been improperly designed and/or installed, and membranes with retired formulations that resulted in premature failure. Today, there are TPO roofs in the United States that have been in service for nearly 20 years. This paper will review the long-term performance of a large sampling of TPO roof membranes installed throughout the United States by evaluating thickness, flexibility, inspection under 7X magnification, aged seam strength, and repair weld adhesion. The intent of this study was to evaluate 1) field-aged TPO roof mem

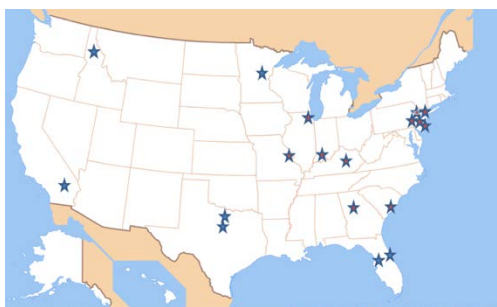
**Figure 1.** To date, samples have been collected from 20 roofs across the United States.

Samples were taken from 20 different roofs across the United States (See Figure 1). Climatic conditions of the United States cities were matched up with their European counterparts, and are shown in Figure 2 to illustrate the approximate European climate equivalents captured in this study. These roofs were installed over office buildings, manufacturing facilities, retail outlets, libraries, automotive repair shops, warehouses, and a grocery store. All data gathered was used in the analysis.

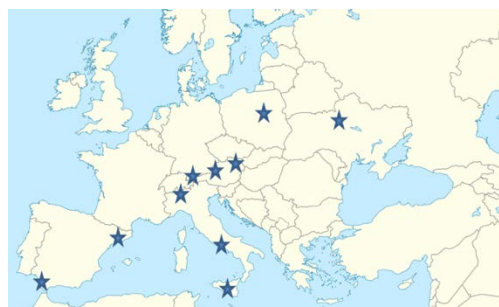
**Figure 2.** European climatic equivalent locations to the samples collected across the United States.

On average, a typical roof membrane in this study was installed between 2005 and 2006 has been exposed to 20 hail storms, over 50 feet of rain, over 500 days of 32°C+ (90°F+) and wind gusts of up to 148 kph (92 mph). Specifically, the roof membrane from Orlando, Florida has been exposed to the elements for over 17 years. This roof has weathered 9 hurricanes, 13 hail storms, 56 feet of rain, 1,660 days of 32°C+ (90°F+) and wind gusts of up to 169 kph (105 mph). While the United States and European climates are somewhat comparable, the wind gusts are more aggressive than what is typical in Europe.
