Reduced Mandated Inspection by Remote Field Eddy Current Inspection of Unpiggable Pipelines

Technical Final Report

Reporting Period Start Date: October 1, 2005
Reporting Period End Date: September 30, 2006

Prepared by:
Gas Technology Institute
1700 S. Mount Prospect Road
Des Plaines, Illinois 60018

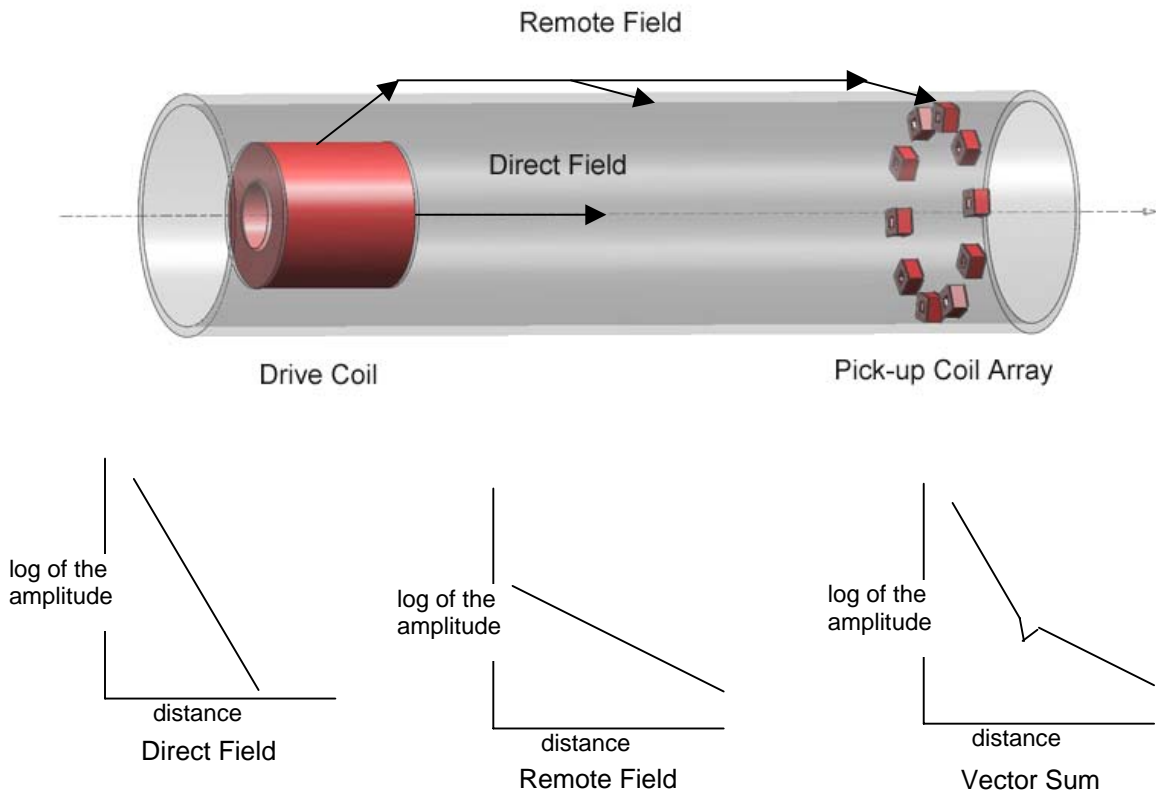
Figure 1: Variation of the amplitude of propagating fields with distance along a pipe.

Figure 1 shows the basics of the remote field eddy current (RFEC) method. The exciter coil sends 20 Hz to 200 Hz electromagnetic waves propagating down the pipe and through the pipe wall. The electromagnetic waves traveling inside the pipe (direct field) are highly attenuated because they are well below the cutoff frequency for propagation – for which frequencies need to be in the gigahertz range - in a wave-guide. As far as the electromagnetic waves are concerned, a pipeline is nothing more than a wave-guide. Approximately two pipe diameters from the source coil, these 'direct' waves all but vanish. Meanwhile, the waves that have penetrated the wall (remote field) can penetrate back into the pipe as well. At about two pipe diameters from the exciter coil and beyond, these waves swamp the direct field waves attempting to propagate down the bore of the pipe and, therefore, can be detected and measured. This is the reason for the term "remote field eddy currents" (as opposed to the near or direct field currents from waves propagating down the bore of the pipe). This is exactly

what is needed. Any pipeline flaws such as metal loss from corrosion or other causes that affect the propagation of these RFECs back into the pipe alter the detected signal so that the flaws may be detected and measured by the sensing coils.

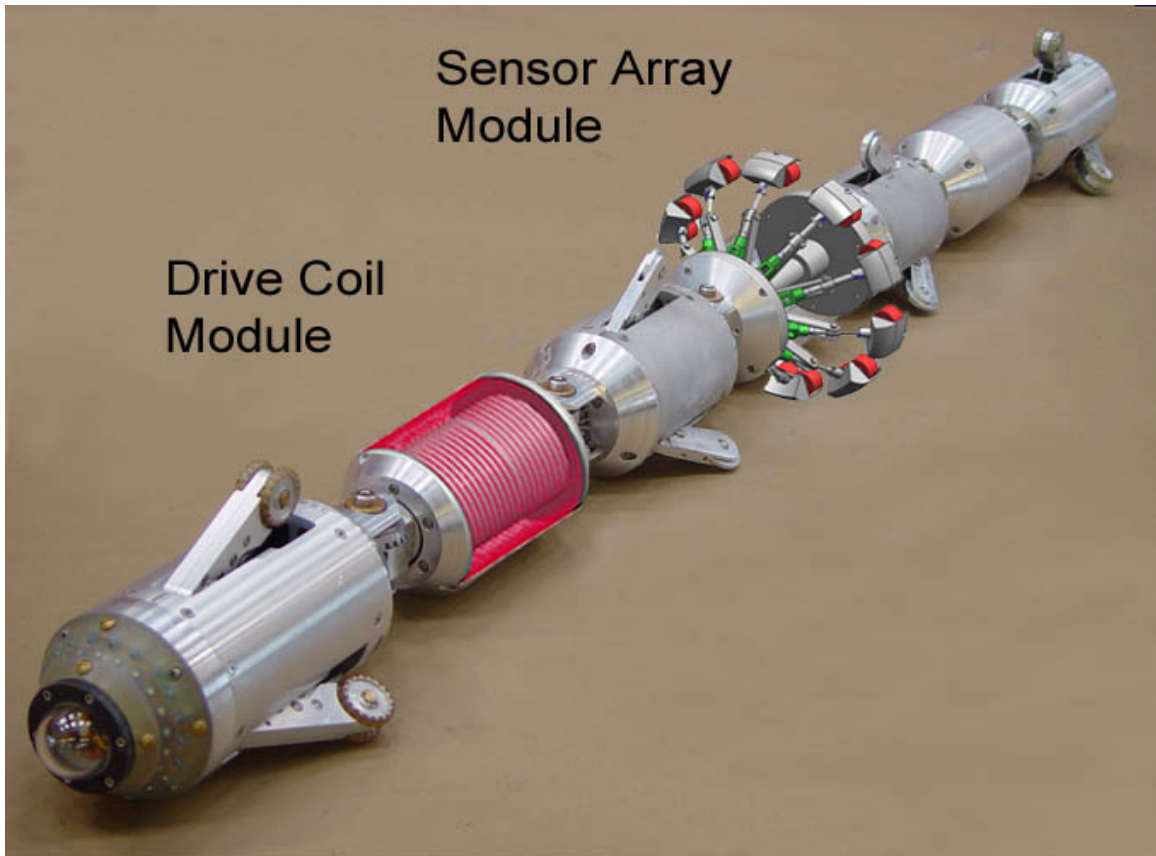
Figure 2: A simulated drawing of the RFEC technology integrated with Explorer.

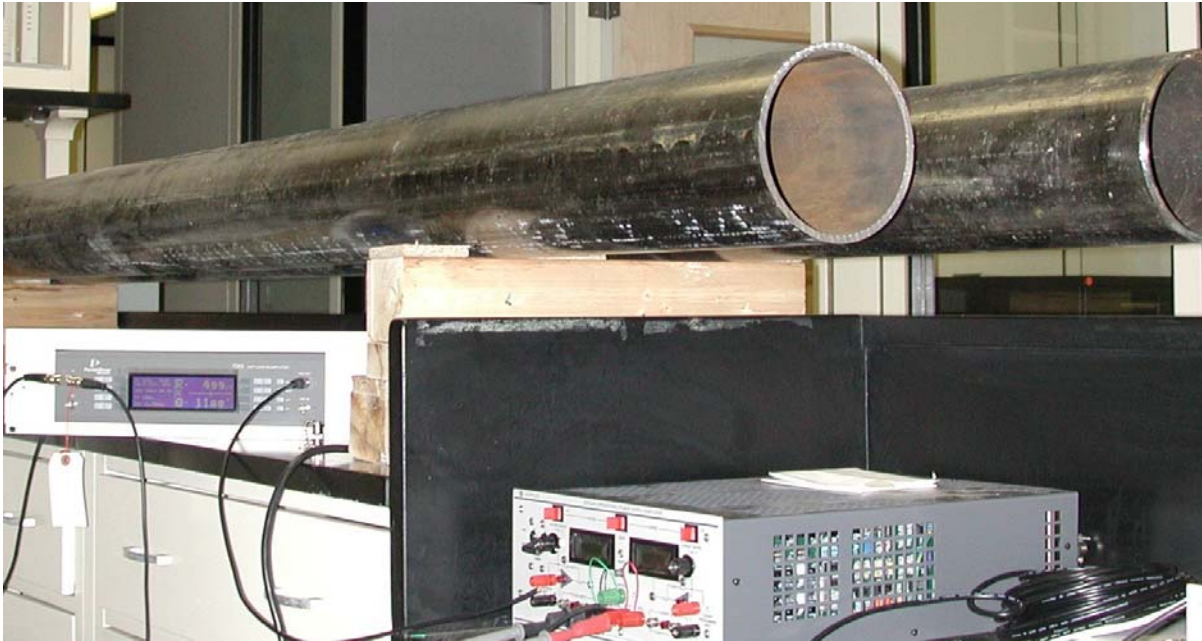
Figure 3: RFEC laboratory setup.

Figure 3 shows the laboratory setup for performing the majority of the RFEC research tasks. We machined defects sets into two 10' sections of 6" diameter pipe. One pipe is seamless, the other is seam welded. For each pipe a Kepco BOP, bipolar operational power supply, shown on the right, drives the exciter coil and a PerkinElmer lock-in amplifier, shown on the left, filters and amplifies the signal received by the sensing coil.

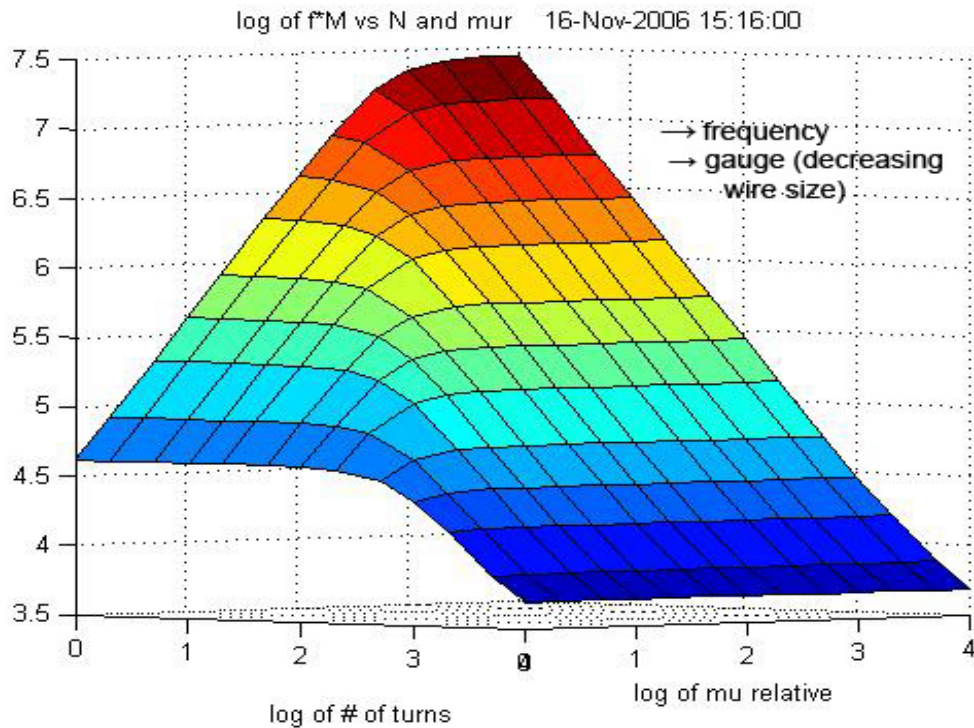
The calculated results are shown in Figure 4 as a function of the logarithm of the number of turns and the relative permeability. For convenience, the result plotted is the frequency times the moment, since that is what the sensing coils measure. As the frequency and the gauge increase the transition

Figure 4: The logarithm of the dipole moment as a function of the number of turns and the relative permeability.

from an impedance dominated by resistance to that dominated by inductance shifts to the right. Note that increasing wire gauge corresponds to decreasing wire diameter. The figure shows the results for a 3.5" diameter coil, which is suitable for most 10" to 16" unpiggable pipe. For 10" and 12" pipe with plug valves, or any pipe with severe bore restrictions, smaller diameter coils can be used. The increased allowable power consumption for a tethered system will compensate for the decrease in coil diameter.

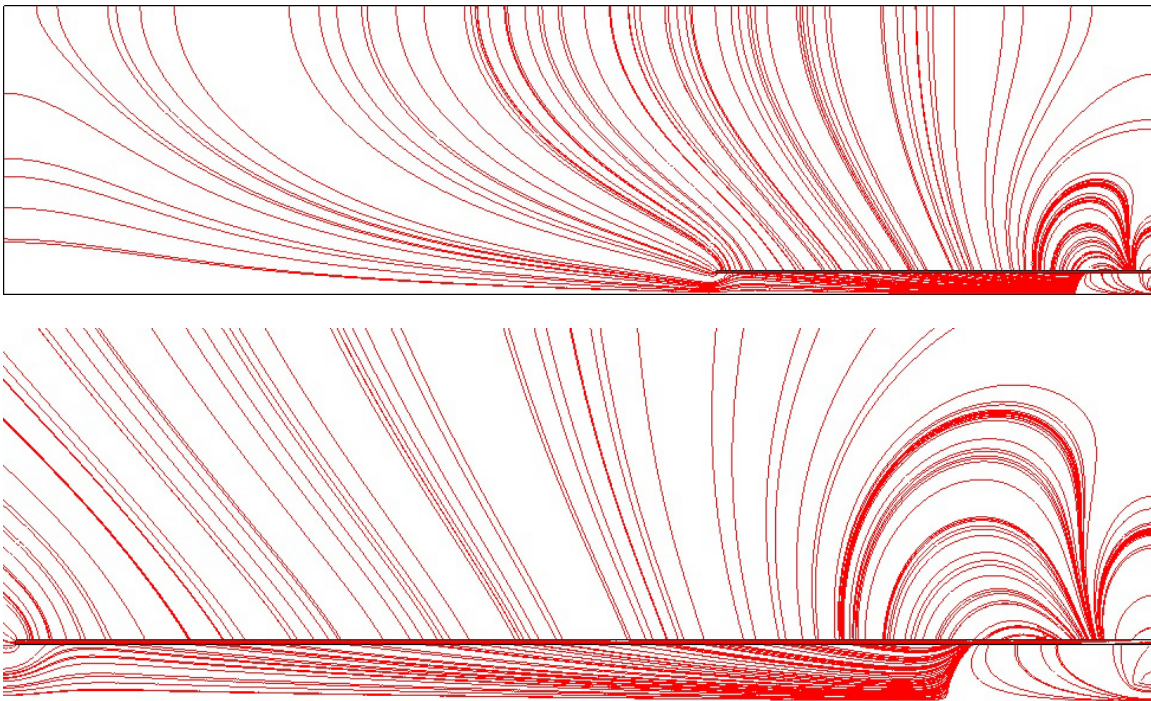
Figure 5 shows the magnetic flux density lines for a model of the 6" diameter by 0.25" wall thickness 10' long seamless steel pipe used in the NDE laboratory for the RFEC experiments. Axial symmetry reduces the calculation to a 2D calculation, while reflection symmetries reduce the calculation to a one quarter model. The top view shows the full model. The electrical insulation boundary conditions at the top and sides ensure that the magnetic flux meets the boundaries at right angles there, as would be expected for flux lines far from the source. There are places where it is obviously not quite correct, but these are far enough from the regions of interest to not affect the calculations there. The drive is a 2" diameter, 2" long coil at the right bottom corner (not visible), with 4000 ampere-turns of drive current. The frequency for the calculation was 50 Hz. The pipe permeability was set at 100, which may be low, but the results seem reasonable. The bottom of the model has the axial symmetry boundary condition.

The bottom of Figure 5 is an enlargement showing the flux density in and around the 6" pipe and shows the fields at the coil and the pipe end effects.

Figure 5: The FEA model of the 6" x 0.25" seamless pipe, showing lines of magnetic flux density.

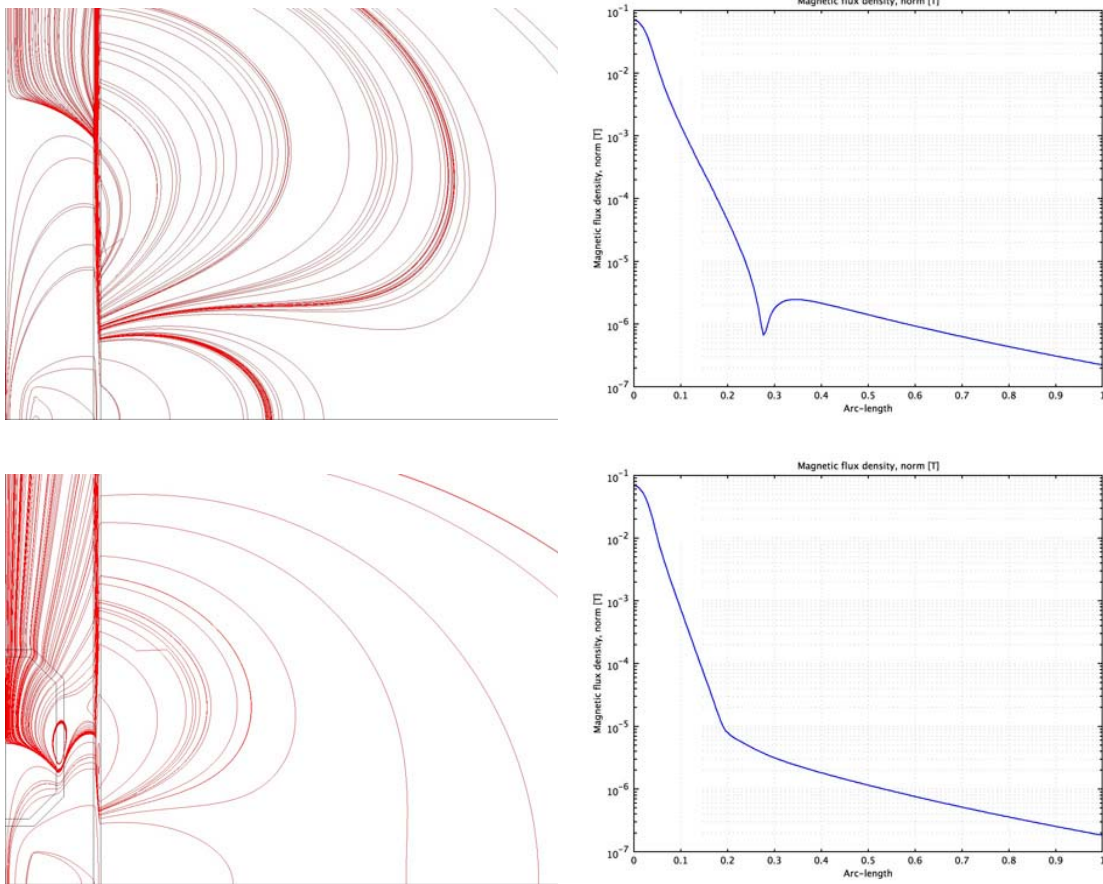
We used the calculations to investigate the effects of robot modules on the propagation of the electromagnetic fields. Experimental results showed that these modules would improve the RFEC measurements and the calculation verified that as is shown in Figure 6. The top of the figure shows the field near the drive coil and a pullout along the axis of the 6" pipe. The result compares favorably with the measurements shown in figures 11 and 13, which show the transition region at 8" while the calculations show it at 0.28 m, or about 11". The bottom of Figure 6 shows the effect of inserting an empty aluminum robot module, 4" in diameter by 6" long, and with 0.25" wall thickness. The magnetic flux loop shown through the module wall shows the strong eddy currents set up in the module. Those eddy currents are generated by the direct field trying to propagate down the bore of the tube, greatly reducing it. As a result, the remote field becomes larger than the direct field sooner, and the transition region moves

closer to the drive module as shown by the pullout curve, where the transition region has moved inward to 0.22 m, or about 8.5” from 11”.

Figure 6: Robot modules attenuate the direct field more rapidly.

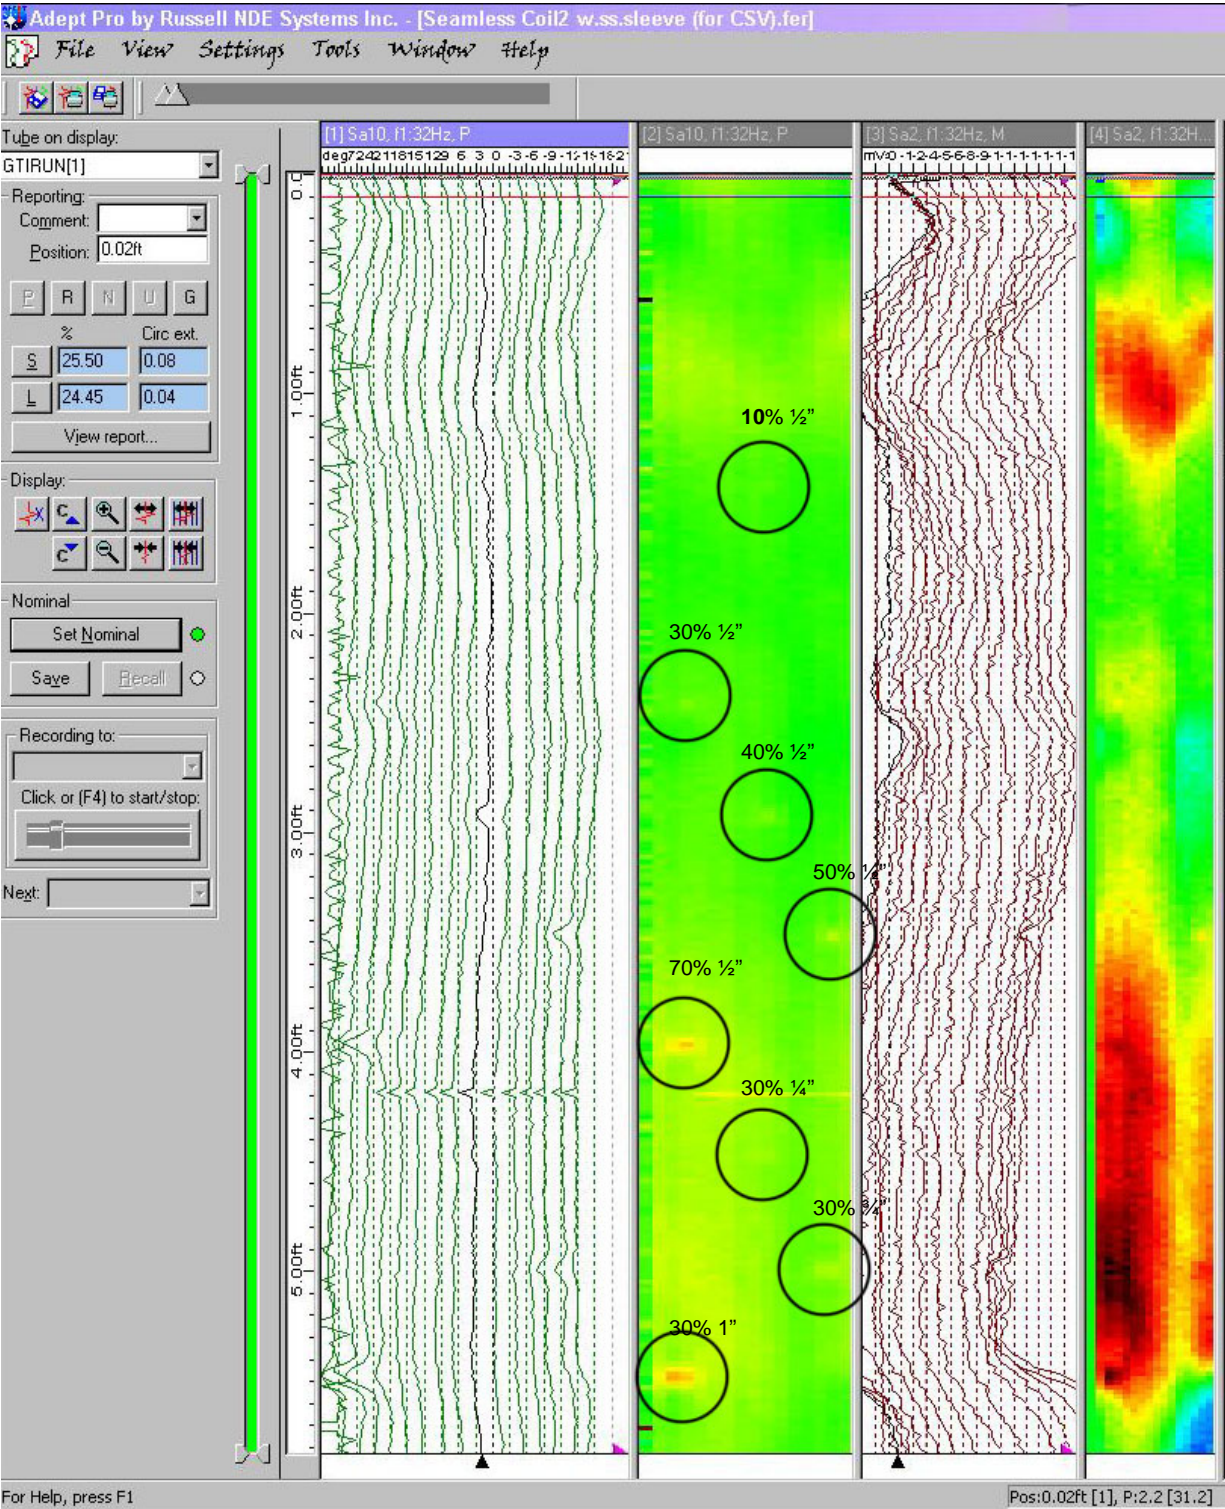
Figure 7: Screen shot of 6" seamless pipe scan from Adept Pro Software.

Figure 7 is a scan of the entire 6" seamless pipe. During this test, a stainless steel sleeve, was placed between the exciter and sensor coils. We were testing the effect of metal components on detection results since robotic components are metallic and size restrictions require at least one module between the drive coil and the sensors. Our concern is that the metal could disrupt the electromagnetic fields and produce poor results. In actuality, we obtained better results with the sleeve inserted. This scan covered 10 defects. Eight of them are identifiable in the strip chart to the left of the screenshot. The two defects that did not show in the data were a 5% 1/2" and a 30% 1/4" defect. We suspect the 30% defect was not detected because we scan in 1/4" steps. It is likely that we stepped right over that defect. The results seem to be very promising as the 10% 1/2" defect was found. We repeated this test with a chunk of aluminum of 3" diameter and 3" in length between the exciter coil and sensing coils. The results were slightly noisier but there was no apparent drop in the amplitude of the signal. The smallest defect detected in this run was a 30% 1/2" round.

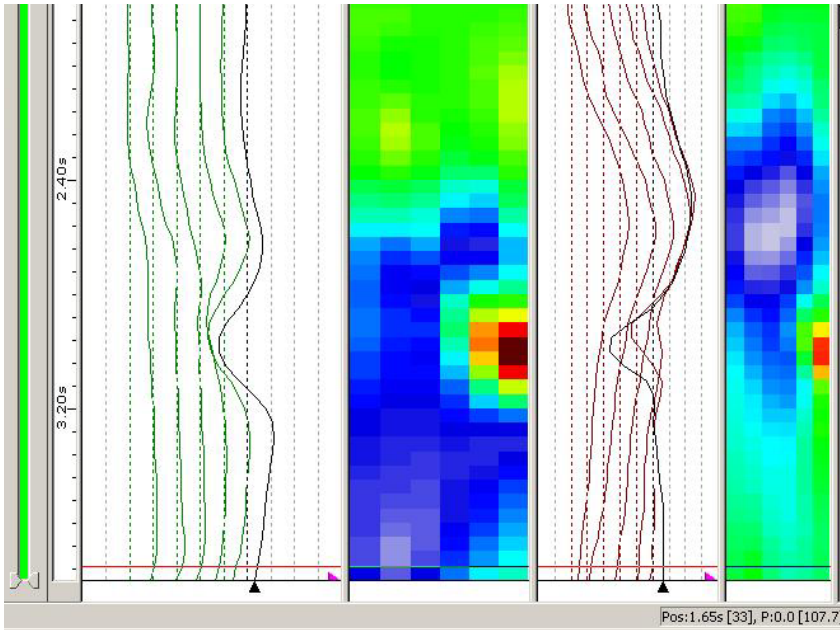
Additional testing was performed on a rusting 6" lined Cast Iron pipe. The RFEC technique has a broad range of applications in conducting and ferromagnetic materials and we took advantage of an opportunity that came up to demonstrate its capabilities. The technique was able to measure the remaining wall thickness through the liner. Despite the Cast Iron appearing to have some remaining wall thickness, the RFEC methods showed existing through wall graphitization, which shows in Figure 8 as dark red.

Figure 8: Screen shot of 6" lined Cast Iron.

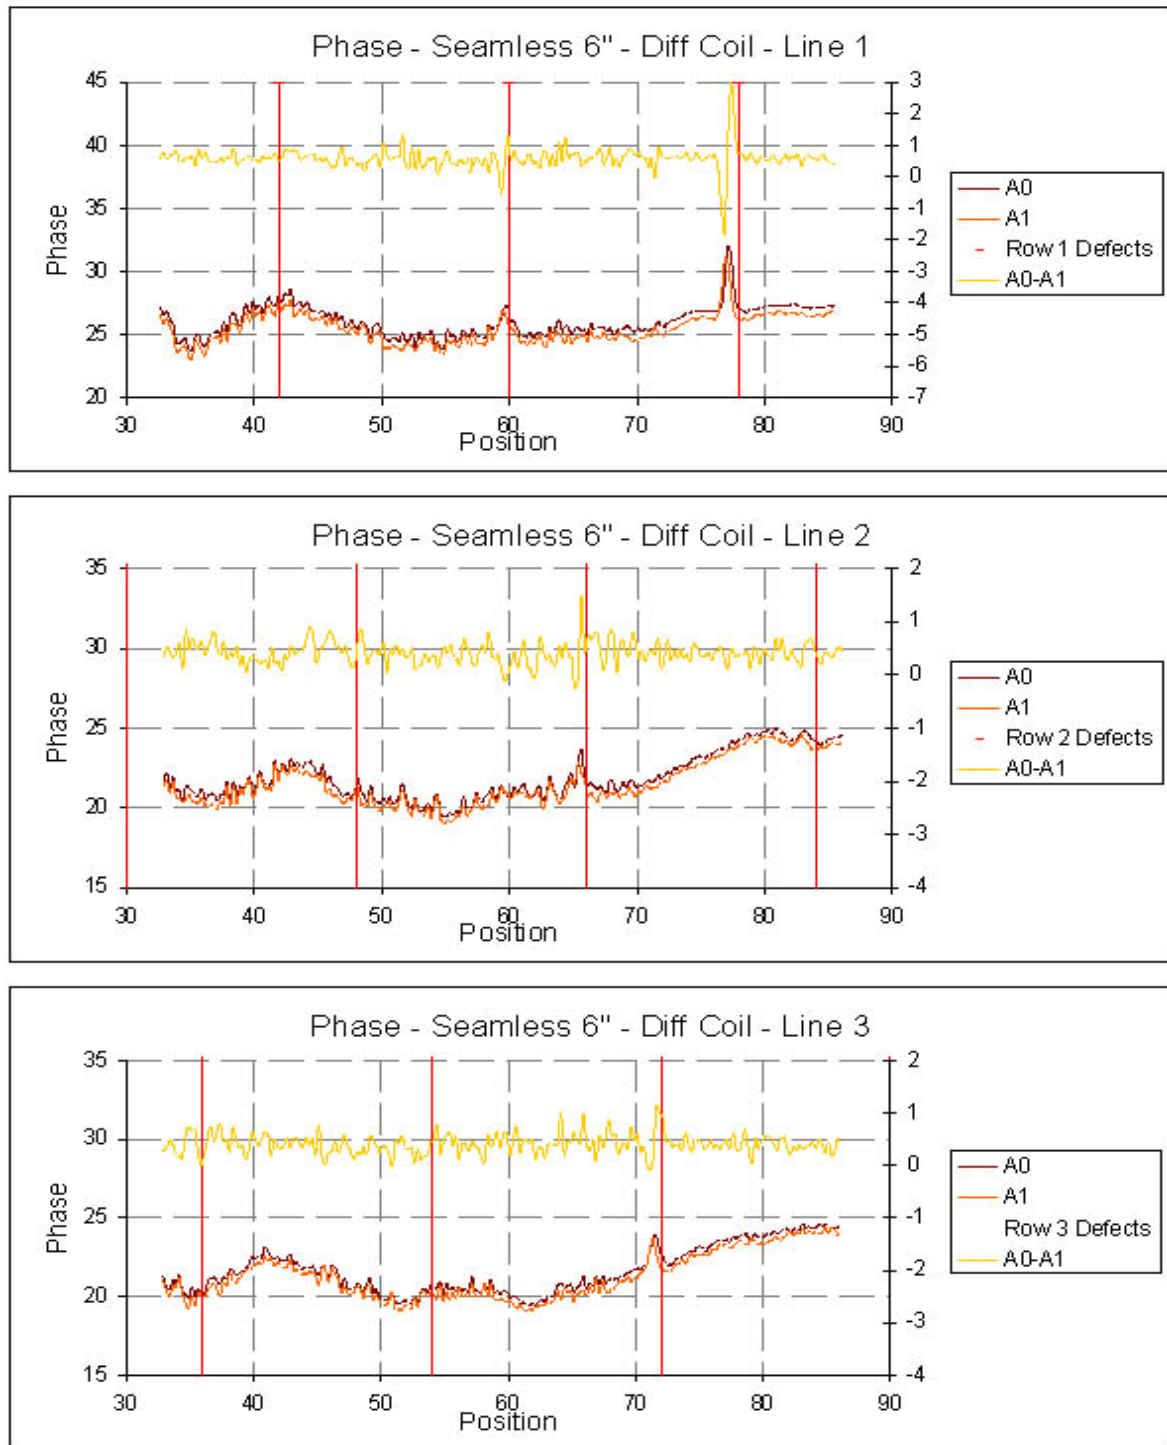
After completing the above testing with metal components, we performed a study of differential coils. Our differential coils consisted of two identical coils mounted close to each other on the same axis and were operated with each coil 180° out of phase with the other's current. Data analysis included taking the absolute measurement of each coil then subtracting them to get the differential. Results of scanning the pipe along all three defect lines of the 6" seamless pipe are shown in Figure 9. The absolute measurements are plotted in red and orange and the differential measurement is plotted in yellow. The bright red vertical lines represent defect locations along the length of the pipe. The defects measured absolutely are indicated by significant increases in amplitude. A sharp drop followed by a sharp increase in amplitude indicates differential defects. These can be seen in Figure 9. The most obvious is the 80% deep defect located around 78" on Line 1. Because of the length of the RFEC vehicle, we were unable to scan the entire pipe in one pass. For each coil tested, we turned the vehicle around and ran it through from the other end of the pipe. These results

are not in this report. The differential coils do not appear to have any significant advantage over our standard sensor coils.

Figure 9: Results of scanning the 6" seamless pipe with differential coils.

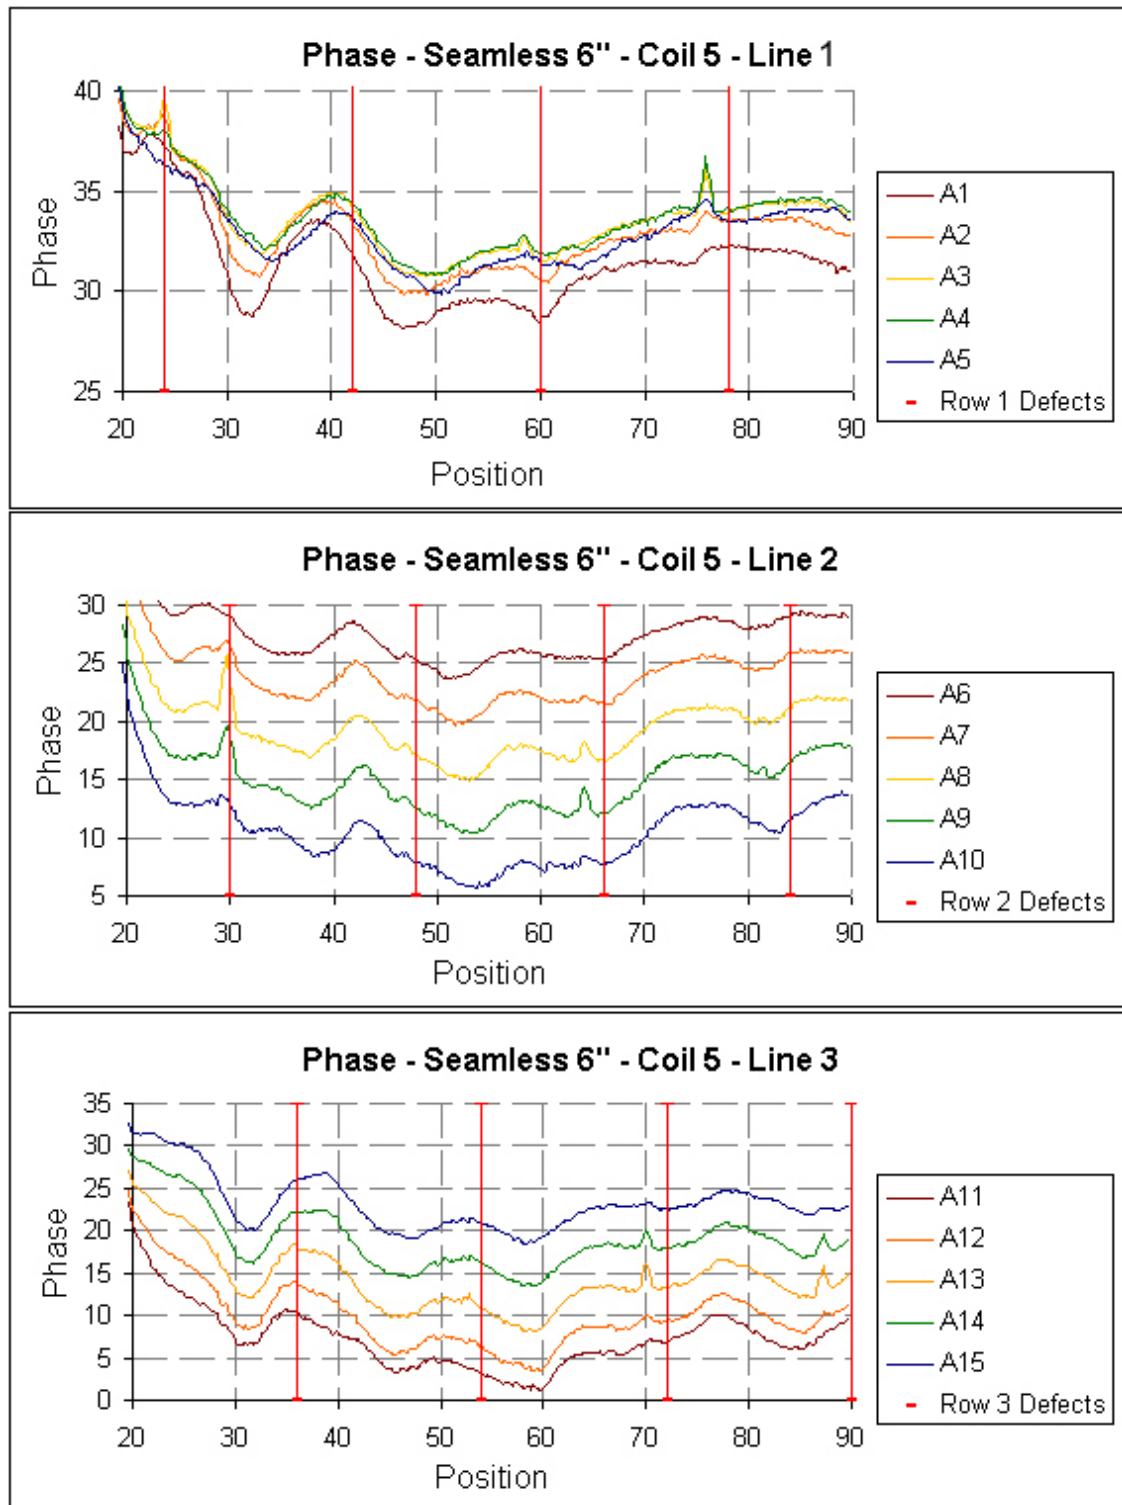
Figure 10: Results of 6" seamless pipe scan using Coil 5 with a mock module.

Figure 10 shows the results of scanning the 6" pipe with Coil 5 as the exciter coil. This test was performed with an imitation aluminum Explorer module between the exciter coil and pick-up coils. This test was conducted to ensure that the metal module would not cause an intolerable disruption of the RFEC signals. We were pleased with the results in Figure 10. The defect locations are marked with red vertical lines. An increase in the phase can be seen in at least one coil at most defect locations. The defects that were not detected are the 5%, 1/2" at 42" in line 1, the 30%, 1/4" at 36" in line 3, and the 20%, 1/2" at 54" in line 3. None of these defects would be repaired in the field.

The figure above shows scanning results of exciter coil 6 in the 6" seamless pipe. The results are similar to Coil 5 results shown in Figure 10. Coil 6 detected all the defects Coil 5 and in addition, detected the 20%, 1/2" defect at 54" in line 3. In other scans with Coil 6, we have seen detection of all defects with the exception of the 5%, 1/2" defect.

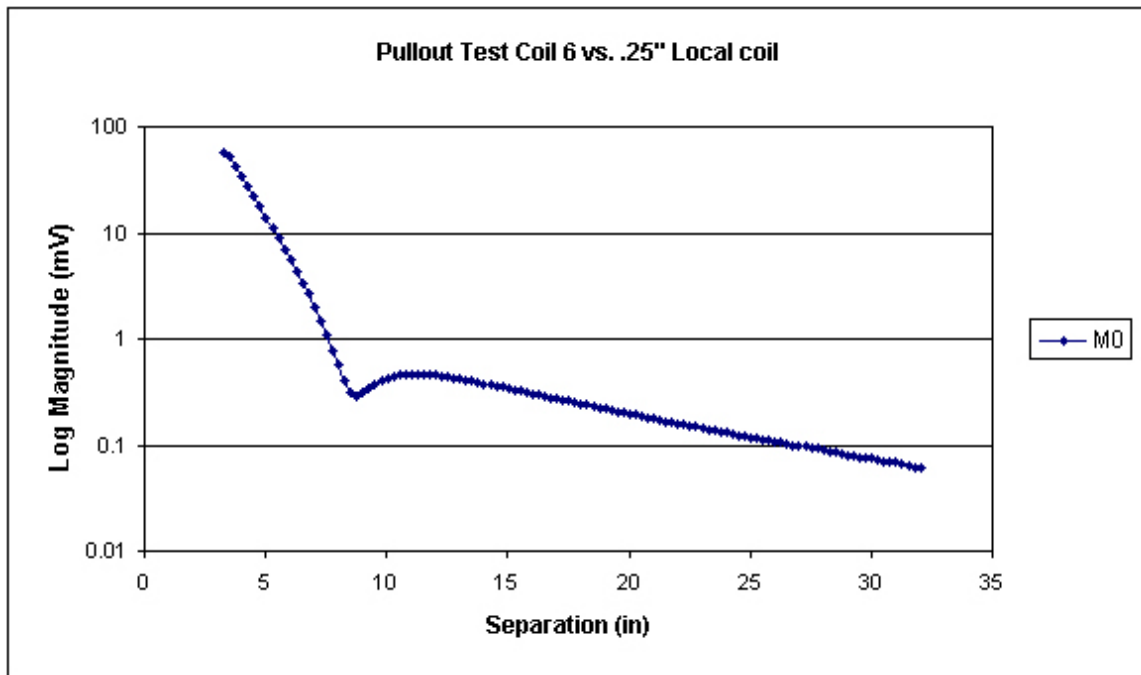
Figure 11: Results of a pullout test using Coil 6.

the signal remains strong through about 20". Following the pullout test, we scanned the 6" seamless pipe using Coil 6. The results are shown in Figure 12.

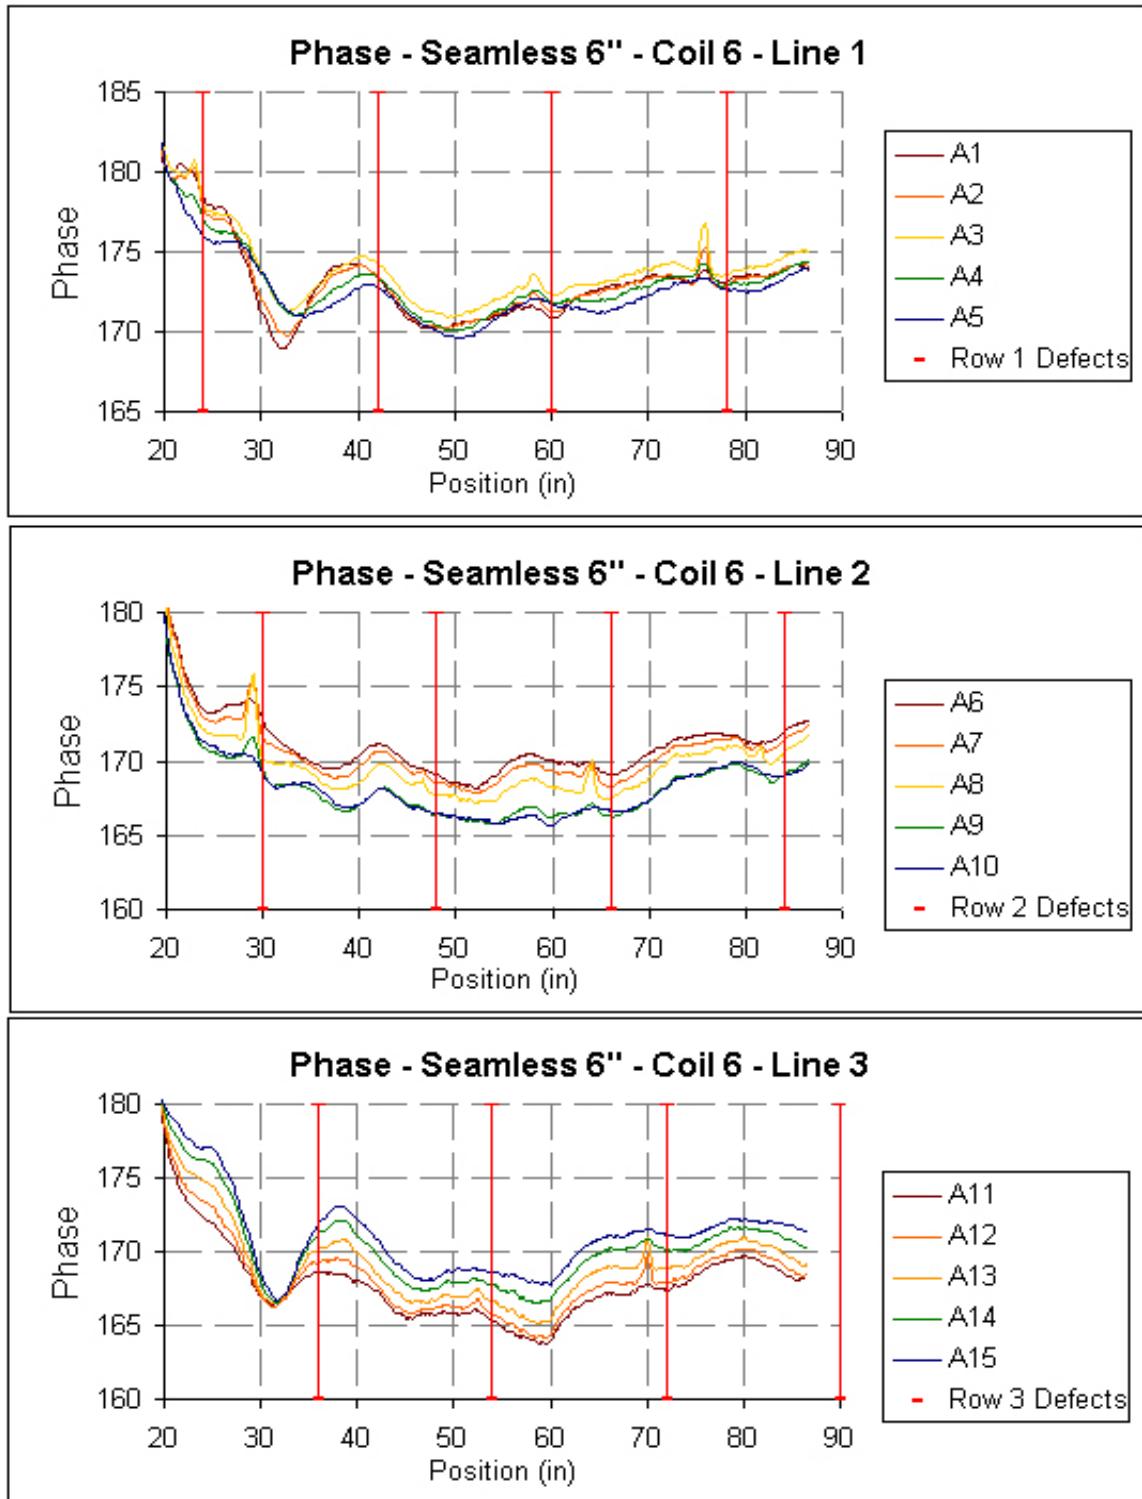
Figure 12: Results of scanning the 6" seamless pipe with Coil 6.

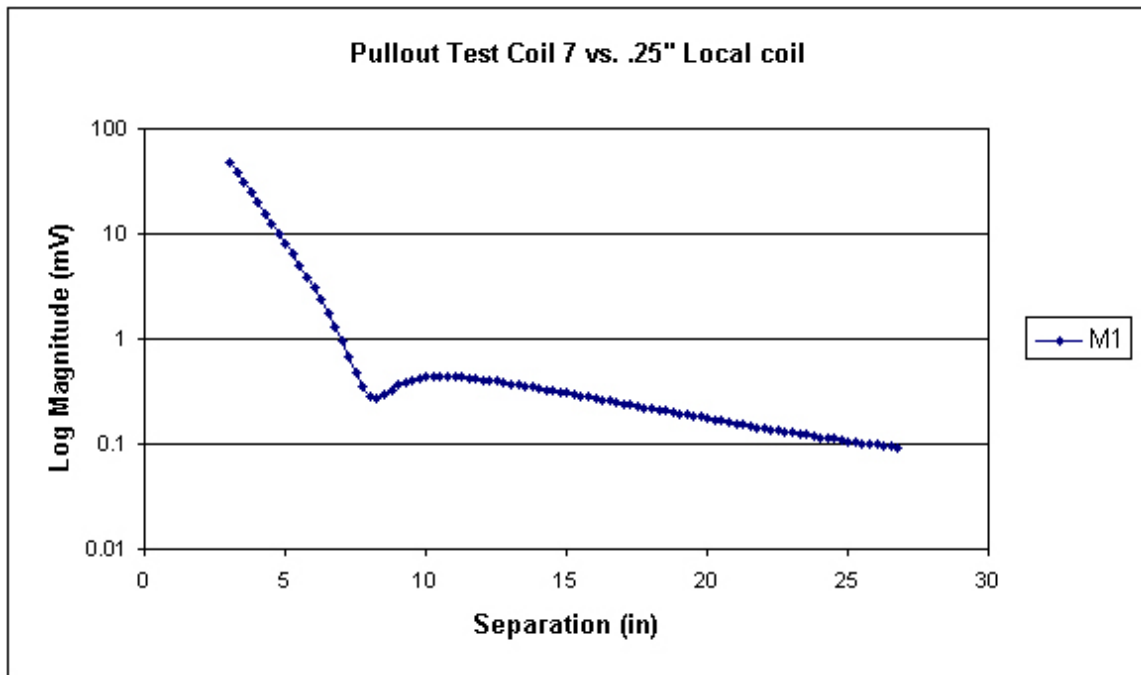
Figure 13: Results of a pullout test using Coil 7.

As we expected, the sensor coils can be positioned closer to the exciter Coil 7 than Coil 6. The sensor coils should be placed at least 10" from Coil 7 for inspection. This is 1" closer than Coil 6 placement relative to the sensor coils. Results of the pullout test for Coil 7 are shown in Figure 13.

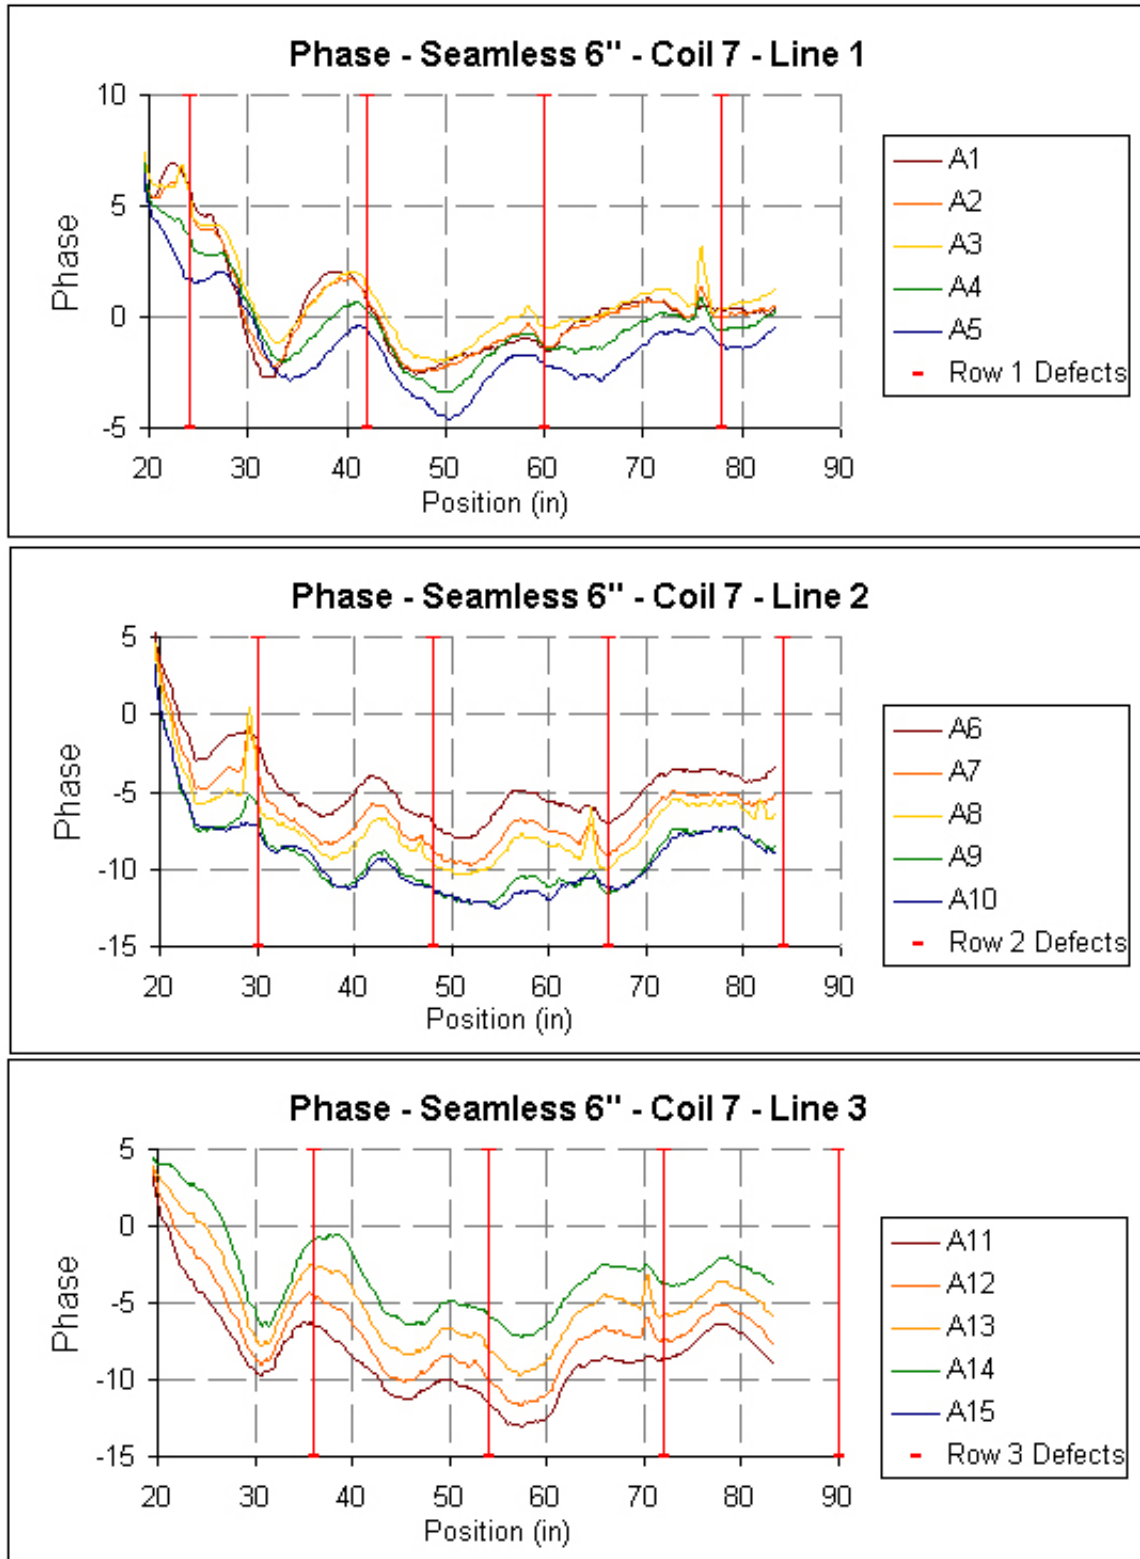
Figure 14: Results of scanning the 6" seamless pipe with Coil 7.

Figure 14 shows results obtained from scanning the 6" seamless pipe with Coil 7 as the exciter coil. To date, Coil 7 has been the only exciter coil to detect all 13 defects, including the 5% wt. Throughout the testing process, the data obtained from scanning the seamless pipe tends to follow the same trends. At the same time, there are also trends in the magnitude and phase data from the welded pipe scans. The patterns in the welded pipe differ from the patterns seen in the seamless pipe. We suspect the gradual rising and falling of the data is attributed to permeability variation in each of the pipes, but could not eliminate residual magnetic fields. In order to better understand the data and to have a set of data to use as the base, we set up a baseline test. We laid both pipes parallel to each other and ran subsequent tests using the same vehicle and lab equipment. The first baseline test results are displayed in Figure 14. We performed the first scan on the seamless pipe. Upon completion of that scan, we transferred the RFEC vehicle to the welded pipe and performed a new scan on the welded pipe. These results are shown in Figure 15 below.

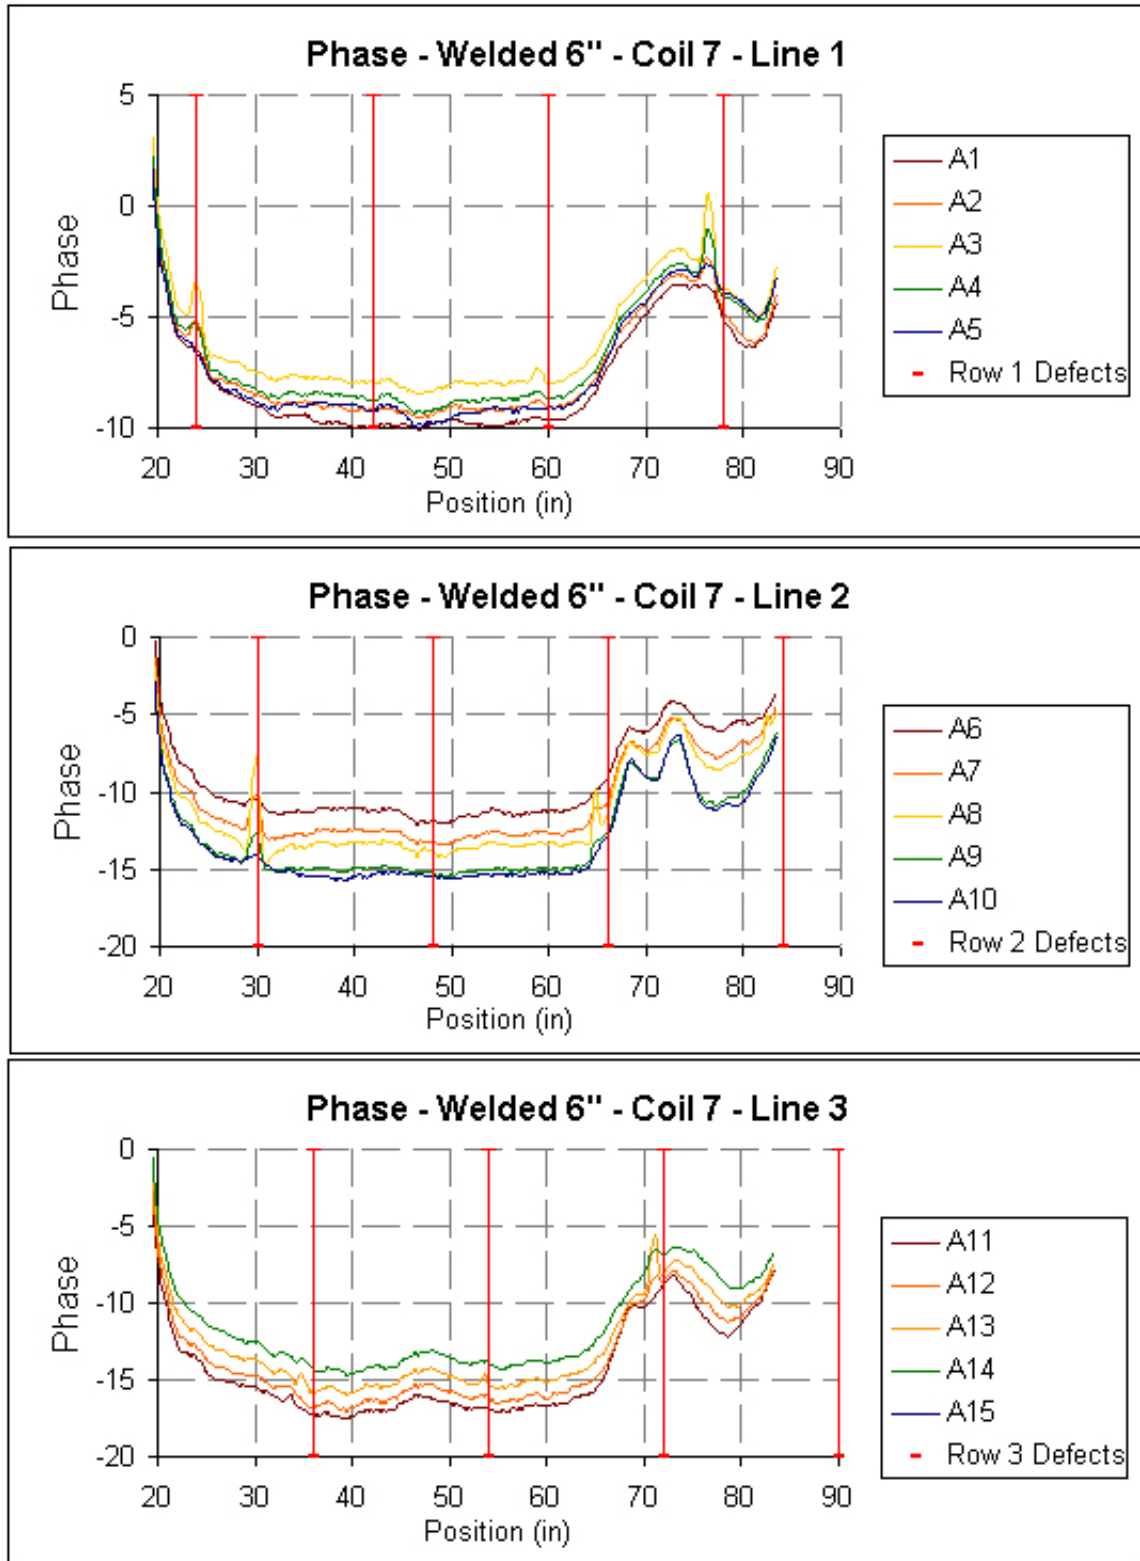
Figure 15: Results of scanning the 6" welded pipe with Coil 7.

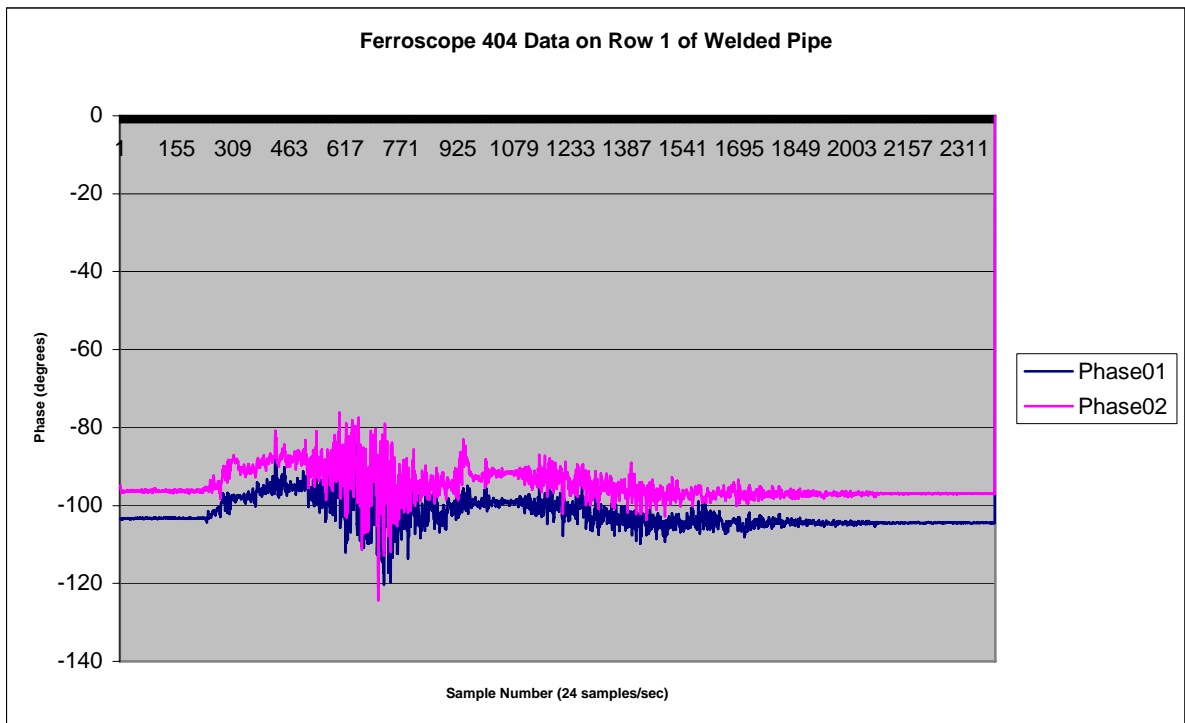
The results of the first test shown in Figure 16 below are for two coils pulled at a rate of about 1.5 inches/second. The complete defect line was scanned in 100 seconds compared to the lock-in amplifier which took about 90 minutes. The length of the lock-in scan is due mostly to the multiplexer which sequences through the 16 pickup coils and the associated settling time between channels.

For the first 250 measurements and the last 300 measurements the coils were stationary and show that the electronic noise is acceptable, causing a jitter of about .3 degrees in the phase data. However the noise level increased dramatically after the system began moving. This was the first test conducted with the Russell boards where data was collected while the coils were moving. We believed that the noise was due to mechanical vibrations of the pickup coils interacting with the residual magnetic fields in the pipe itself. Tests with the system designed to be more rigid and pulled smoother verified this conclusion.

Figure 16: Data from defect line 1 using the Russell board.
