Reduced Mandated Inspection by Remote Field Eddy Current Inspection of Unpiggable Pipelines

Technical Final Report

Reporting Period Start Date: October 1, 2005
Reporting Period End Date: September 30, 2006

Prepared by:
Gas Technology Institute
1700 S. Mount Prospect Road
Des Plaines, Illinois 60018

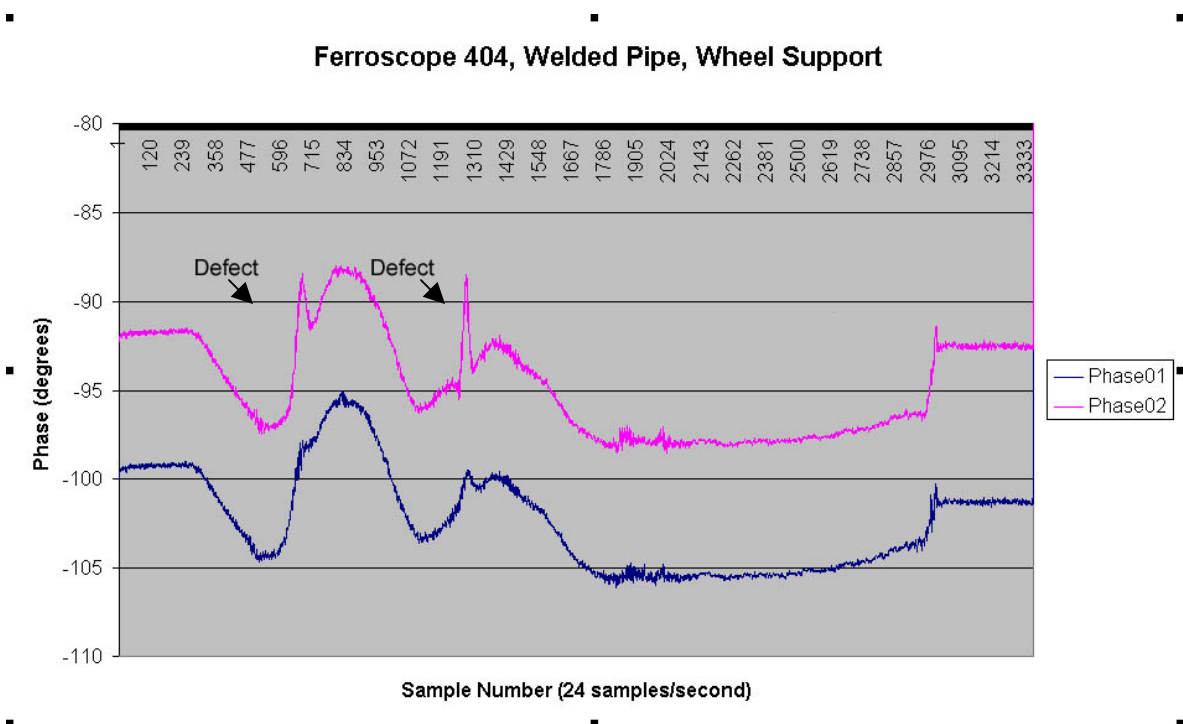
We rebuilt the part that the two pick-up coils were mounted to by adding wheel supports. The wheel supports enabled a smooth pull through the pipe by reducing the mechanical vibrations of the coils and avoiding any scraping against the pipe wall. Data taken with the rebuilt system is shown in Figure 17. We were able to detect two defects. The sizes of these defects are 1", 30%wt and ½", 70%wt.

Figure 17: Phase data from defect line one of the seam welded pipe using the Russell boards with wheel supports.

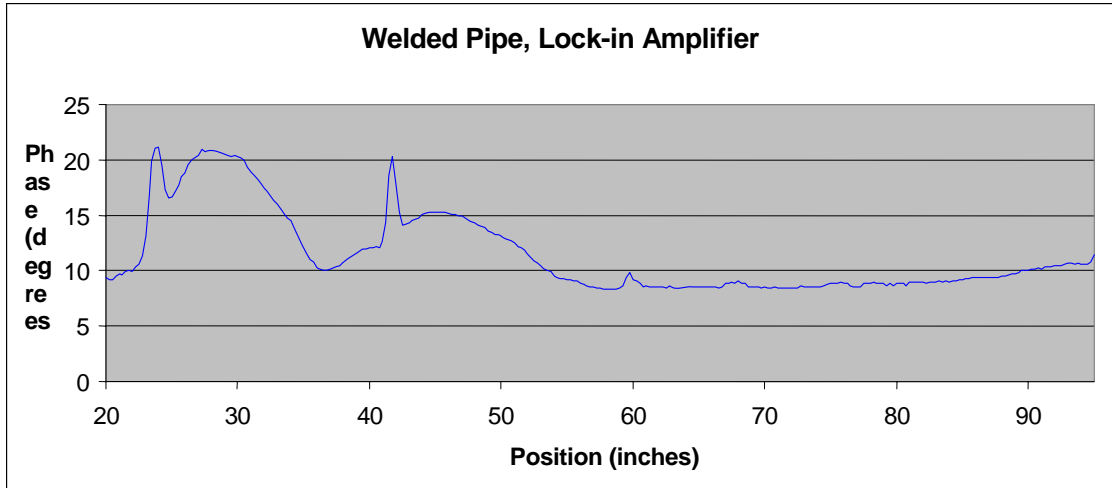
Figure 18: Phase data from defect line one of the seamless pipe using the Lock-in Amplifier.

After inspecting defect line number one using the Russell boards, we noticed that the noise in the data appeared greater than for the lock-in amplifier that we had been using. For comparison purposes, we repeated the inspection using a lock-in amplifier, shown in Figure 18. An rms calculation of noise levels in the phase data gives $.21^\circ$ rms for the Russell Boards and $.16^\circ$ for the Lock-in Amplifier. This normally would indicate that the two are very similar; however, noise from the Russell board comes in bursts. From the lock-in, noise is continuous. The peak burst for the Russell board is 1° peak-to-peak and for the lock-in is $.2\text{--}.3^\circ$ peak-to-peak. These differences are the reason that the $\frac{1}{2}$ ", 30% defect is detected by the lock-in amplifier as shown in Figure 18 but not detected by the Russell board in Figure 17. In actual application this should not be a serious concern since the flaws of interest would be larger than this.

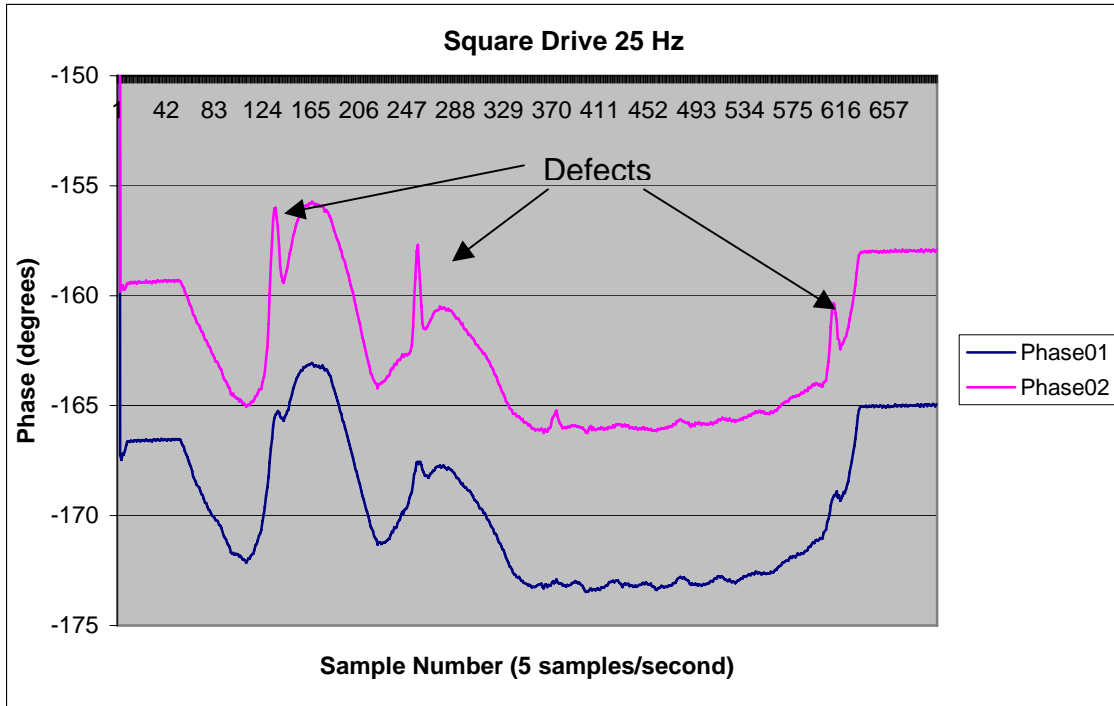
Figure 19: Phase data taken while driving the exciter coil with a 25Hz square wave.

Results of the 25Hz scan, shown in Figure 19, show 4 of 5 defects. Noise levels look reasonable. Starting at 45Hz and up to 75Hz, there was quite a disturbance in the noise. It seems to be periodic and we suspect it may be interference from 60Hz signals created by standard electronic devices (lights, computers, etc.) We only detected 3 of 5 defects during the 65Hz scan, shown in Figure 20, but it is interesting to note that the amplitude of the defect signals is considerably larger, about 3x. The amplitudes of the defect signals in the 85Hz in Figure 21 are 4-5x larger than the signals in the 25Hz test. The periodic type noise is reduced in the 85Hz test and 4 of 5 defects were detected.

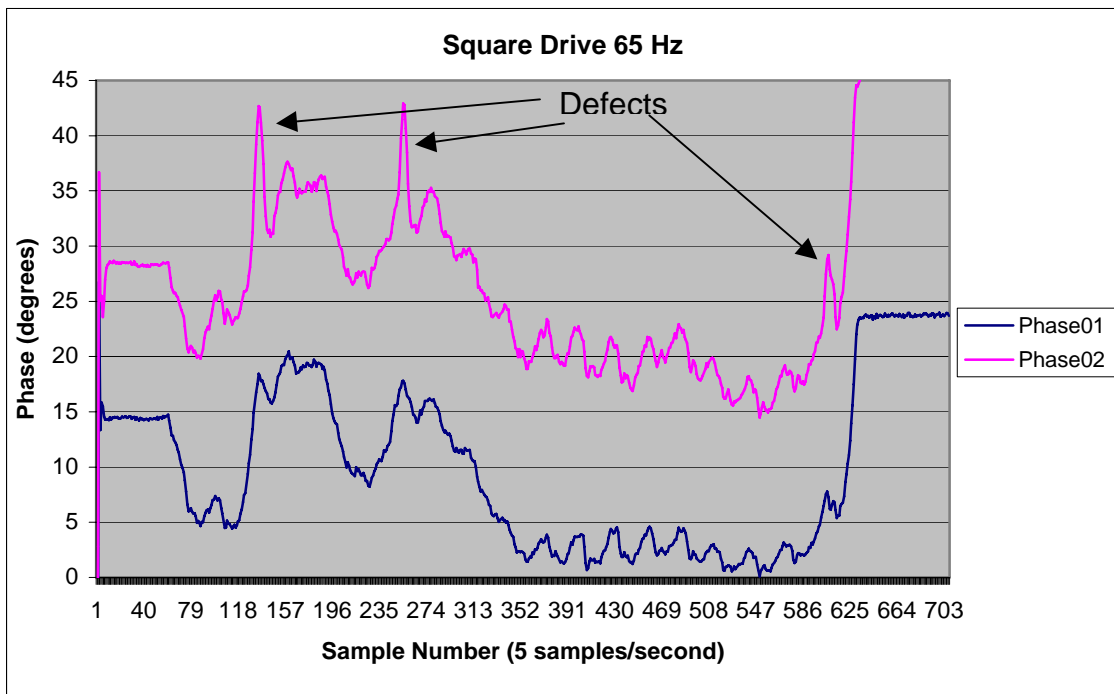
Figure 20: Phase data taken while driving the exciter coil with a 65Hz square wave.

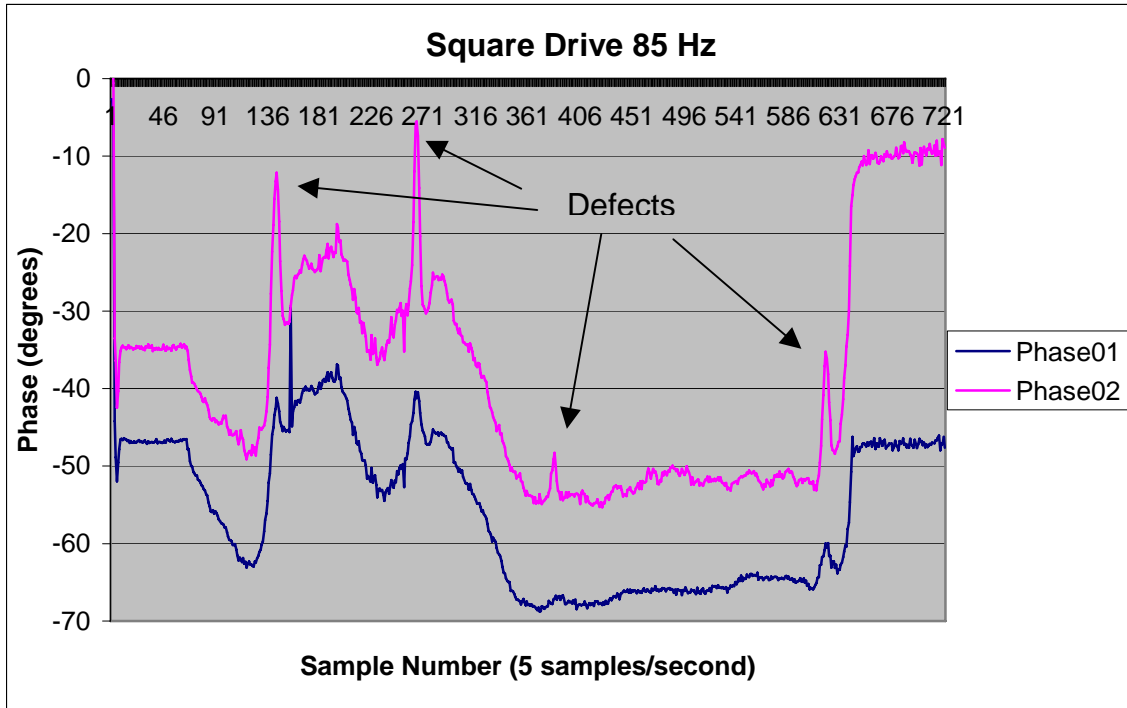
Figure 21: Phase data taken while driving the exciter coil with an 85Hz square wave.

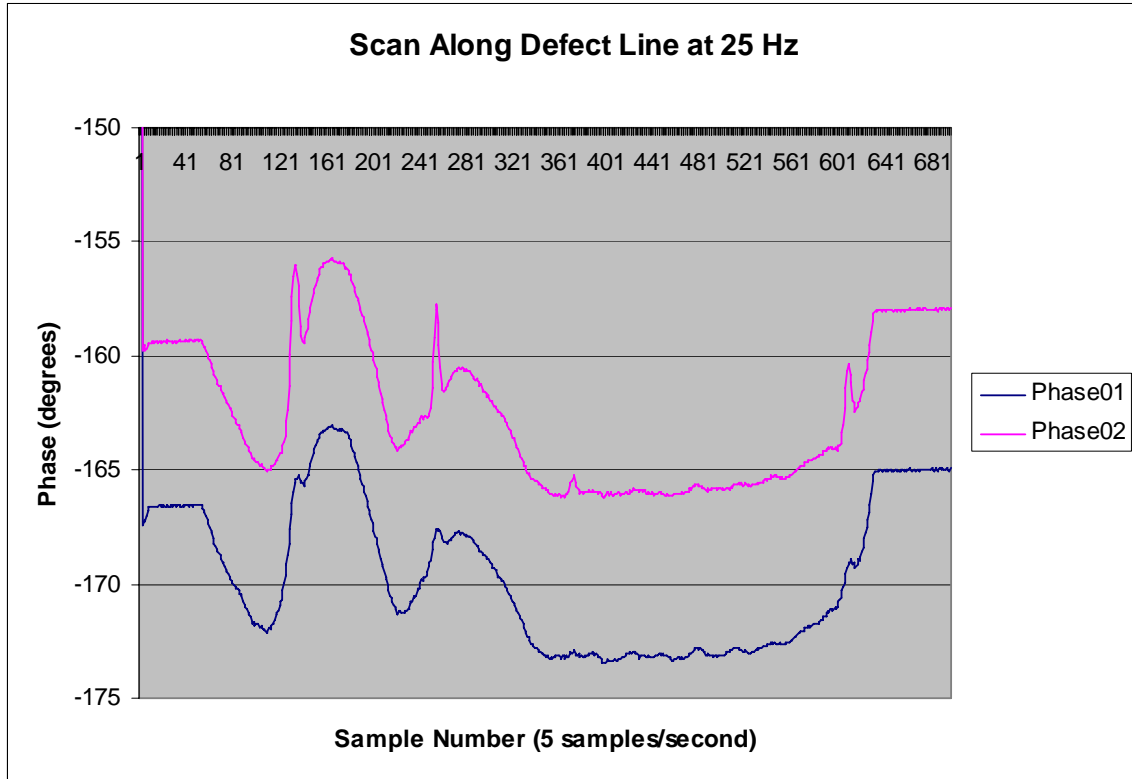
We have observed that changes in permeability, the magnetic property of the pipe, affect the amplitude and phase response of the RFEC. To date we rely on the small lengths of the artificial flaws to distinguish between flaws and permeability changes. In Figure 22 below the sharp spikes from coil 2 (Phase02) at 121, 250, 370, and 601 are artificial flaws while the gradual peaks at 161 and 281 are permeability changes caused by residual stresses and possibly local residual pipe magnetization. We realize that real corrosion can be much longer

Figure 22: Defect scan at 25Hz

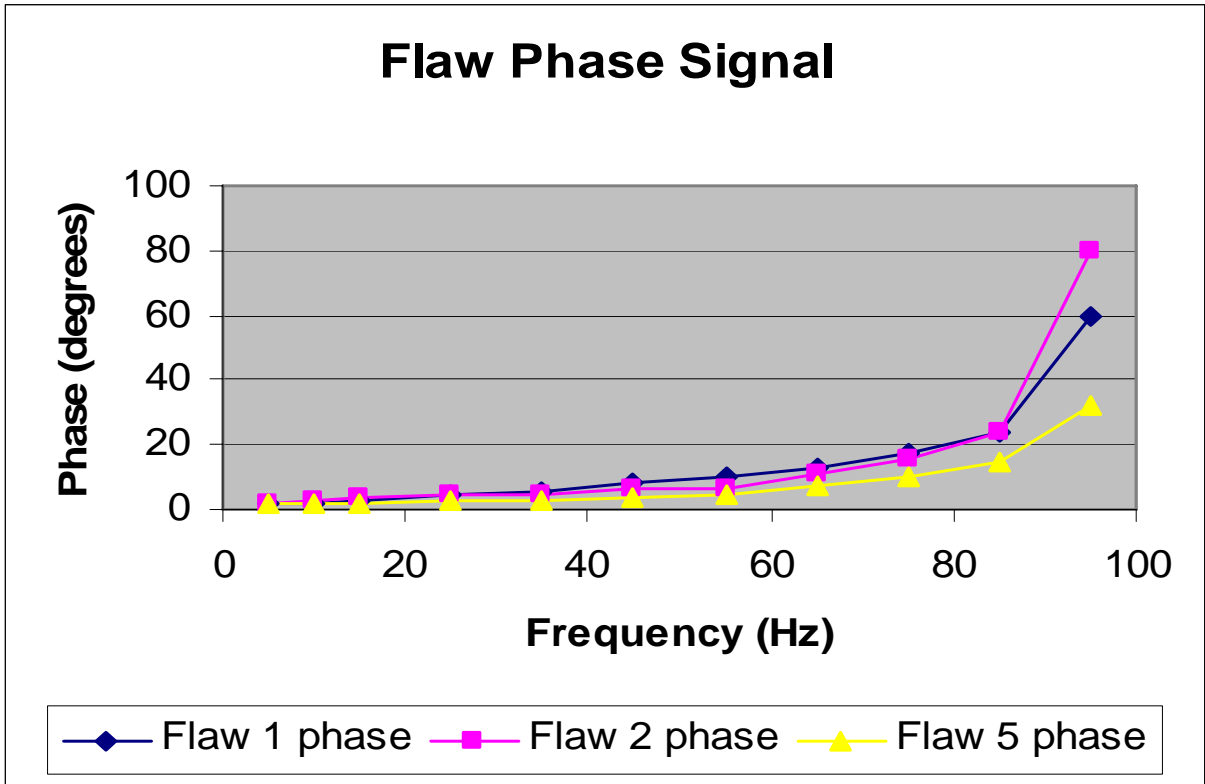
It is possible that analysis at several frequencies may help. The first step was to look at phase information as a function of frequency. The magnitude of the phase deviations at three artificial flaw locations was measured at different frequencies and was found to increase linearly with frequency up to 75 Hz. The results are shown in Figure 23. Flaw one is 1" diameter flat bottom 30% deep, flaw two is ½" diameter round bottom 70% deep and flaw five is 1" diameter round bottom 30% deep. There is a sharp increase at 95 Hz and then there is no detectable flaw signal at higher frequencies. The flaws do show up in the amplitude signal indicating that the analysis should be conducted in the complex plane.

Figure 23: Flaw phase signal

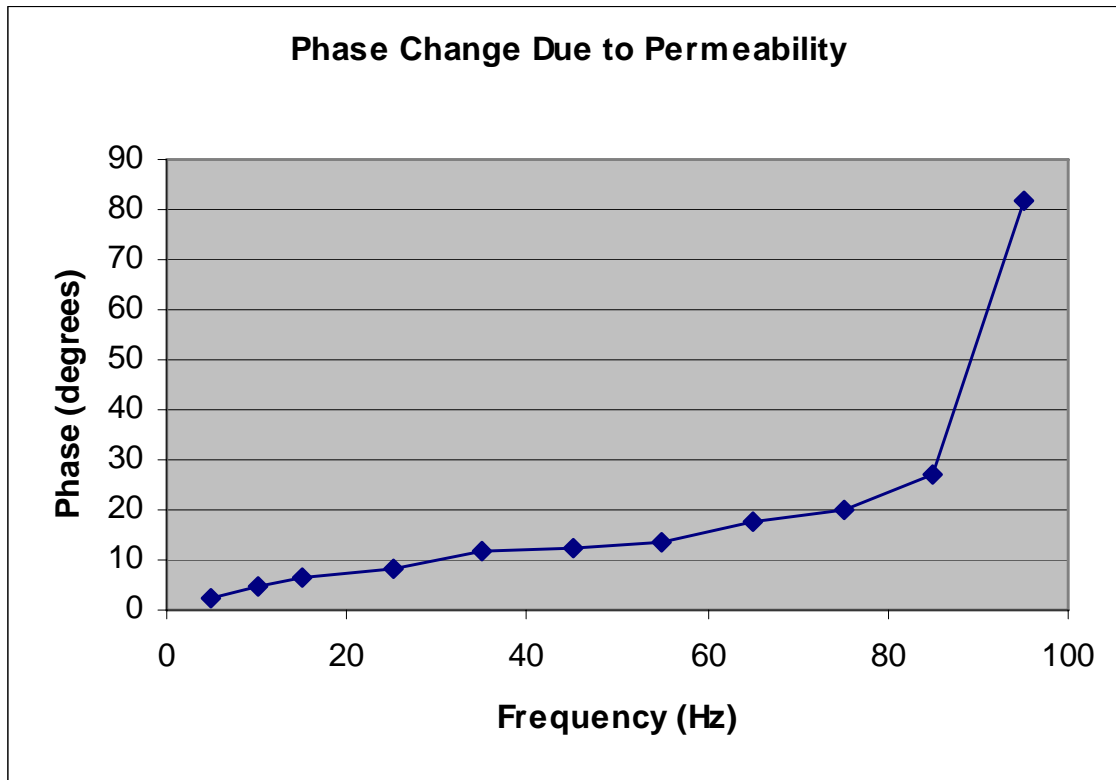
The difference in phase between two locations with different permeability was plotted against frequency and found to also be linear with a sharp increase at 95 Hz. This plot is shown in Figure 24. The similarity of the responses indicates that it may be difficult to distinguish between permeability and gradual thickness changes using phase alone. We expect better results analyzing data in the complex plane.

Figure 24: Phase change due to permeability

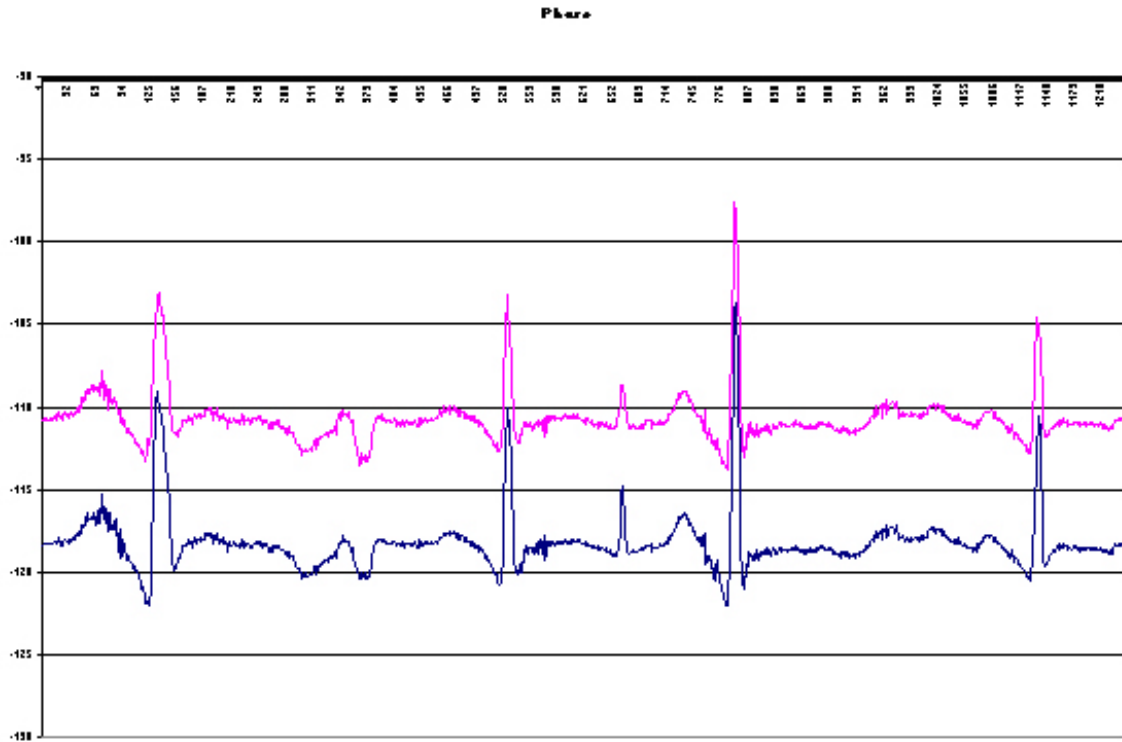
During the week of January 9th 2006, GTI traveled to Battelle Memorial Laboratories in Columbus, OH to participate in the second benchmarking demonstration. We would have liked to have taken a partial or complete build of our module design but time did not permit us that ability. The final design review was not completed until the 16th of December 2005. We did not have enough Russell electronics to run more than two pick-up coils and therefore had to perform the blind tests using our laboratory hardware. We did run the Russell equipment for demonstration purposes. It took approximately 7 minutes to scan 23' of Pipe 3. This is an average speed of .66 in/sec which was determined by the speed of the tow motor, not the speed of the technology. The results of the scan are shown in Figure 25.

Figure 25: Results from scanning Pipe 3 using Russell equipment.

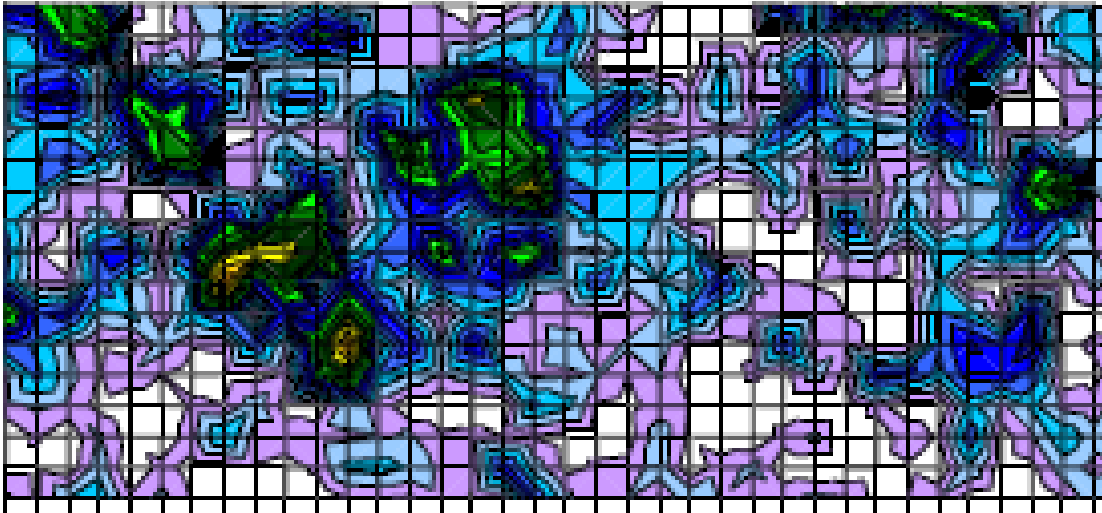
Using laboratory equipment, we blindly inspected three 8” pipes, one of which contained a section of natural corrosion. The data from each pipe was later analyzed each by a different member of the GTI team and was not altogether consistent in the final reporting. Pipe 2 showed excessive scatter and Pipe 3 had a calibration error. The natural corrosion section was in Pipe 1 and was reported to within 5% of its actual depth. The answer key of one of the natural corrosion patches is shown in Figure 26. GTI’s interpretation of data from the same scanned area is shown in Figure 27. There is excellent correlation between the two figures. Table 3 shows various defects from the benchmark. The pictures in the left column are color plots as shown on the answer key. The pictures in the right column are color plots from GTI’s analysis program.

Figure 26: Actual Corrosion

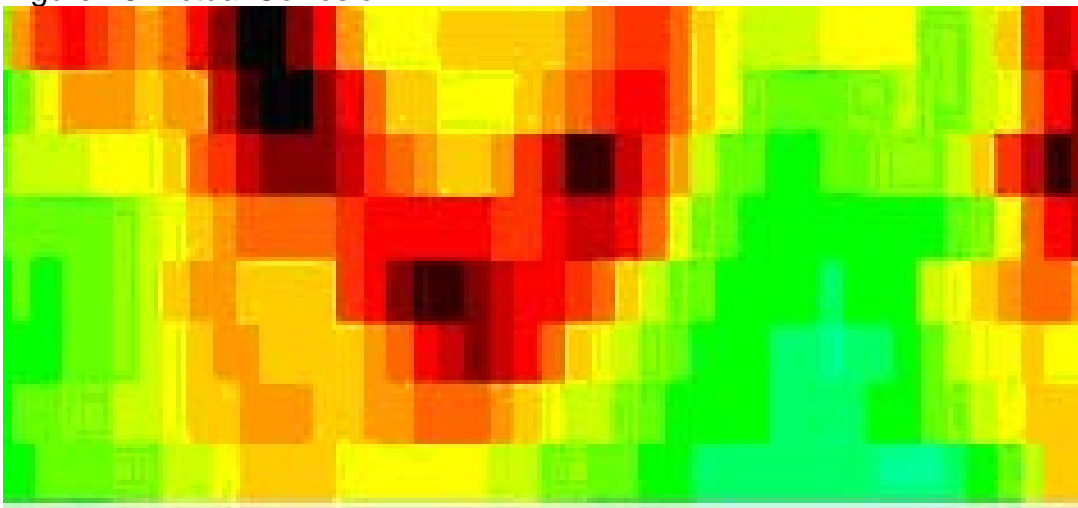
Figure 27: Corrosion as detected by GTI

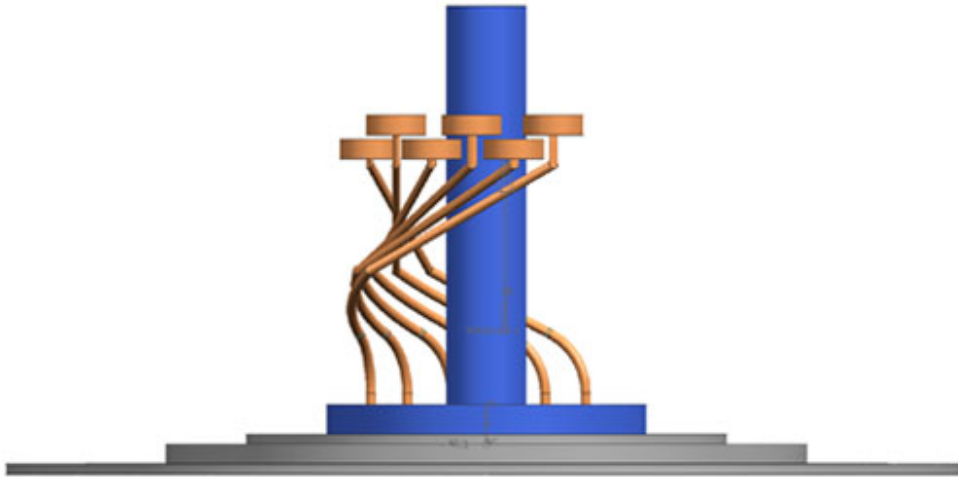
One of the first designs featured arms that curled around a central cylinder. The sensor coils were attached to the end of these curved arms which were allowed to rotate from a base plate. Figure 28 shows a partial model.

Figure 28: Early version of design.

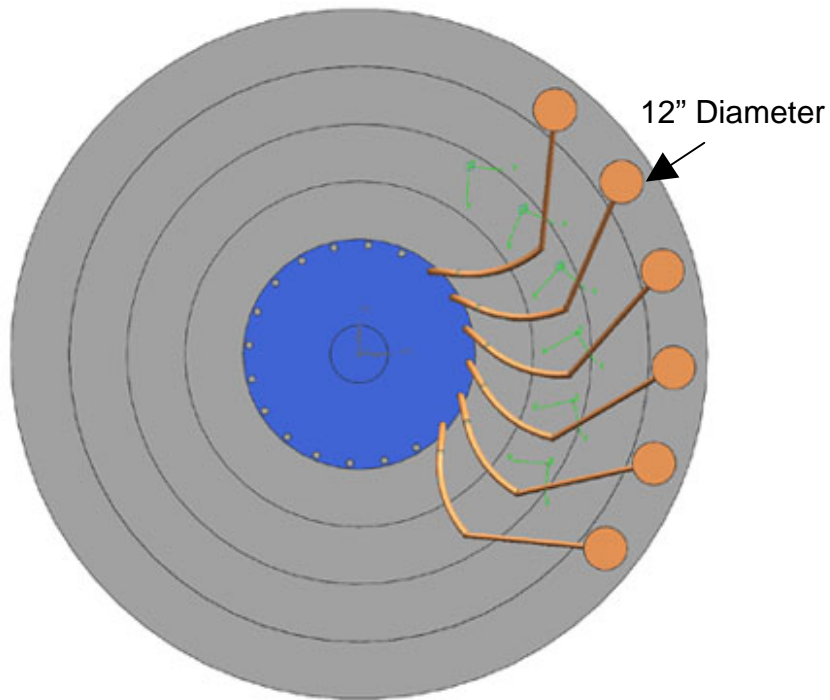
The arm lengths were alternated so that the sensors nested into two circles allowing the module to house a greater number of sensors. Figure 29 shows this particular design from the top, in the 12" position.

Figure 29: Top view of the early design.

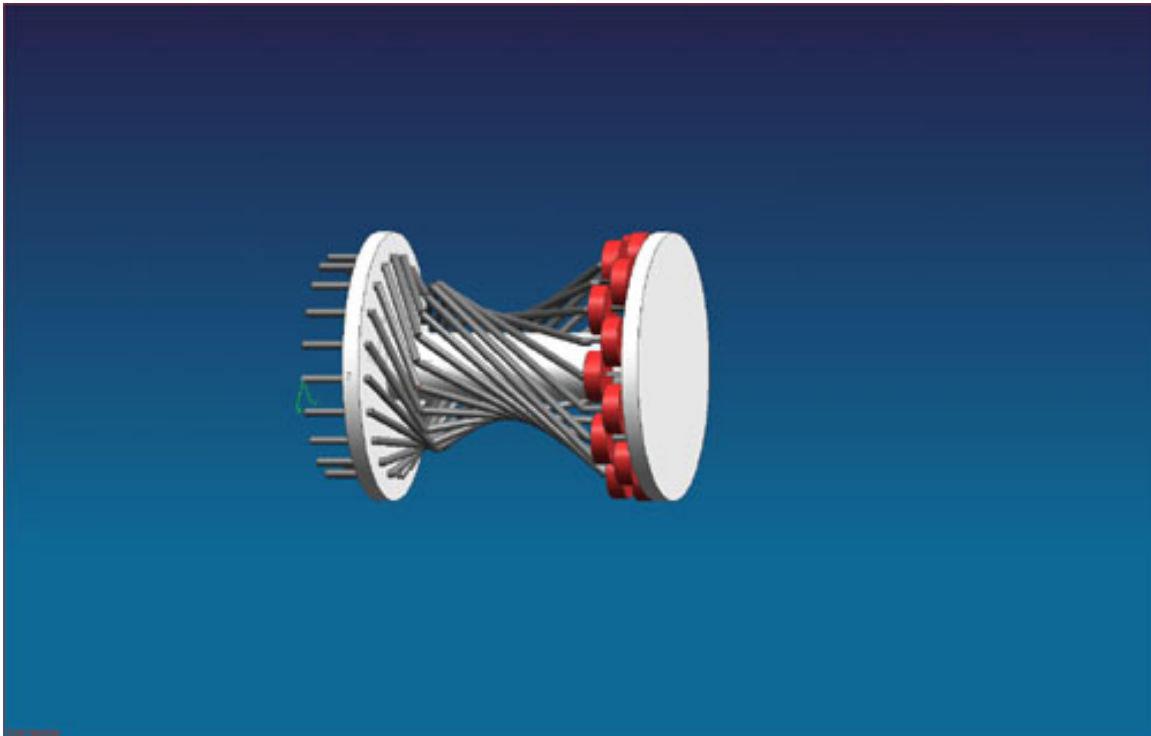
The design evolved slightly and the arm profile was altered. The next three figures display the changes. This version was presented at the mid phase review meeting.

Figure 30: Design 1, side view, arms closed.

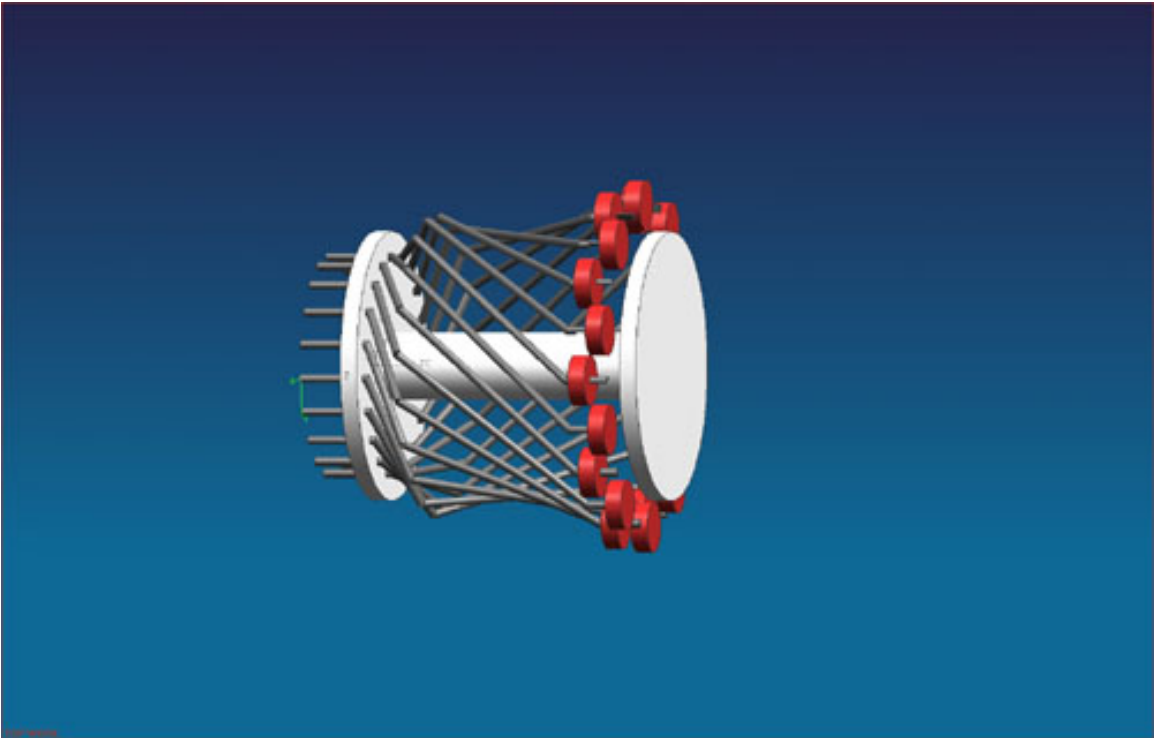
Figure 31: Design 1, side view, arms partially open.

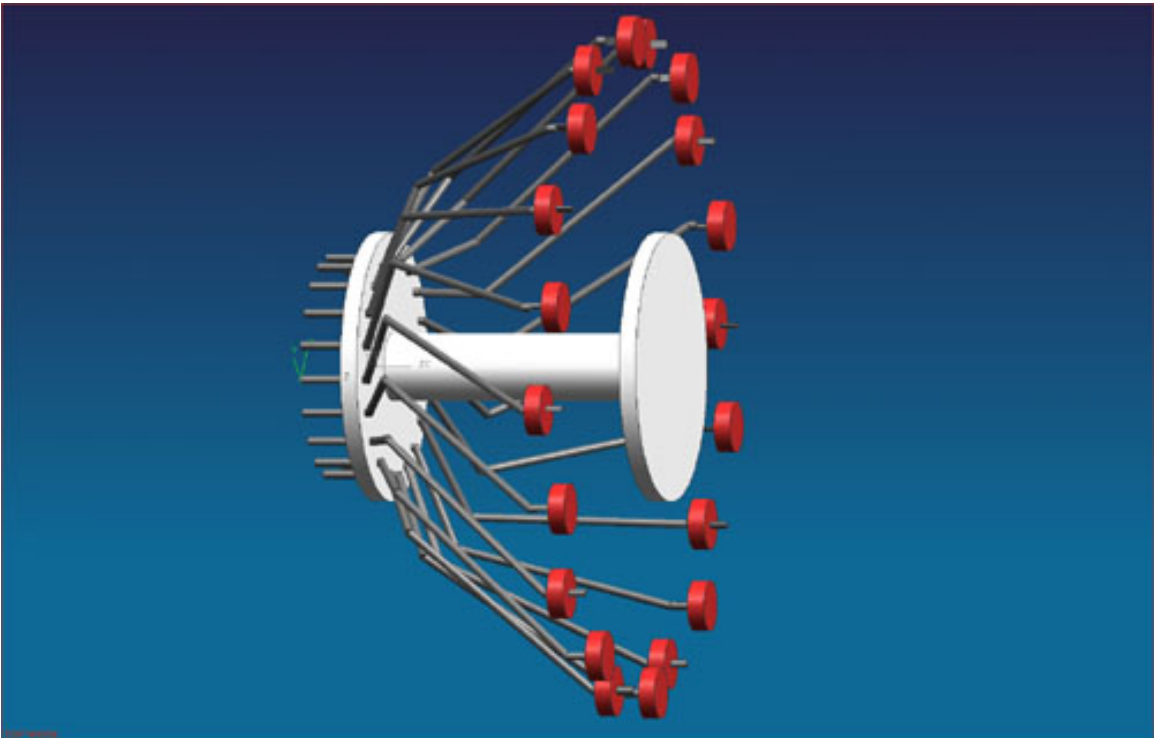
same distance from the center. The fully extended position is shown in Figure 32.

Figure 32: Design 1, side view, arms completely open.

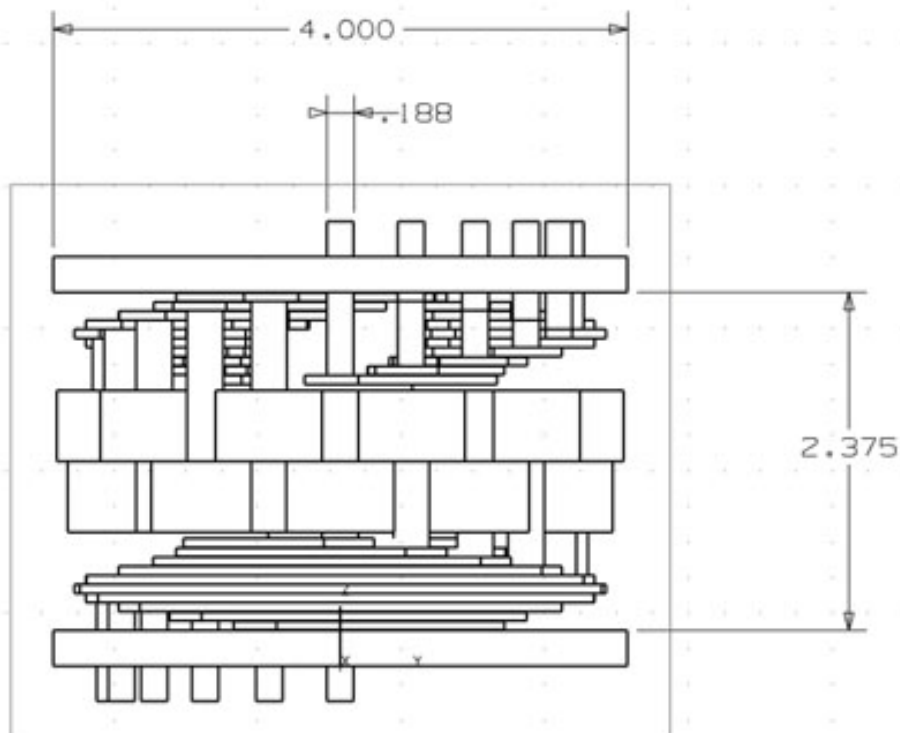
The next evolution of the module design featured electronics boards as the arms. This concept decreased the overall length by 30% and incorporated the electronics in the arms. A 2-D sketch of this design is shown in Figure 33 to portray the compactness of the design.

Figure 33: Design 2, 2-D sketch, side view.

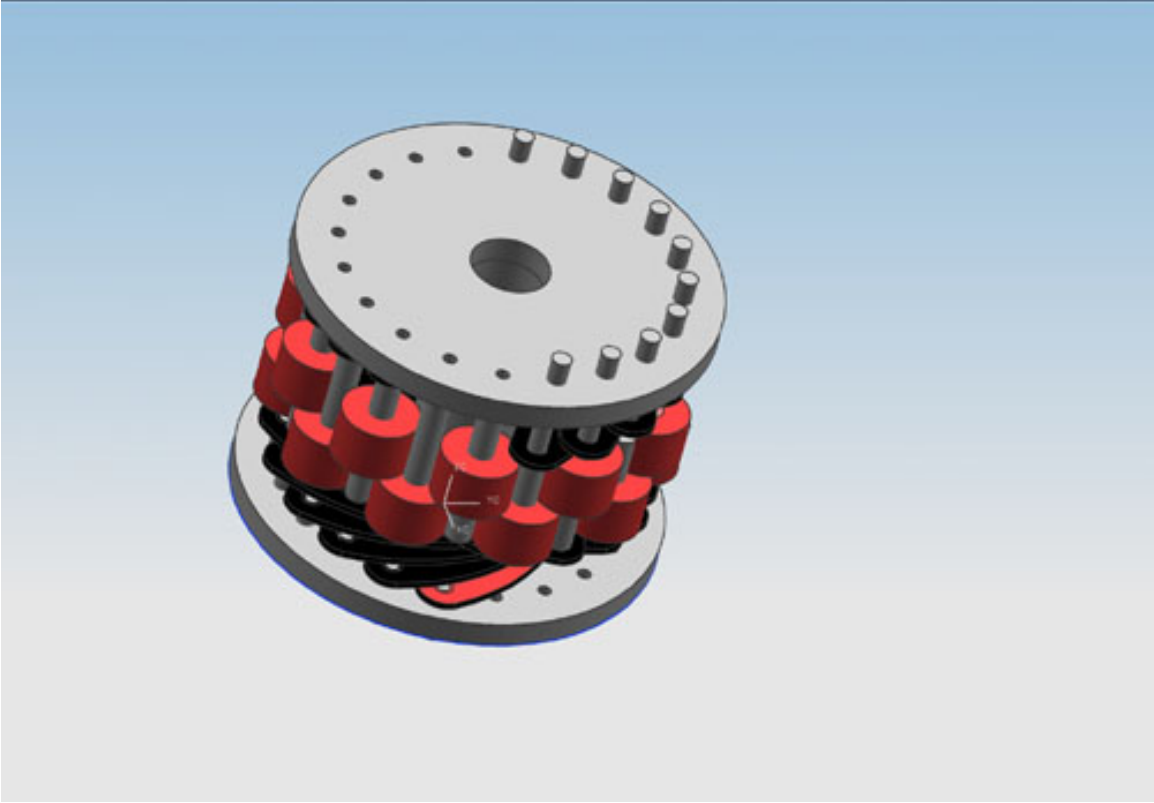
Figure 34: Design 2, isometric view, closed.

Figure 34 above, shows the 3-D drawing. The design introduced two arrays of 10 coils which are easier to see in Figure 32. Interferences prevented all 20 arms being mounted from one end plate so they were split and open opposite each other. Motion of all 20 arms was achieved using a single motor to maintain the rate of expansion and uniform separation.

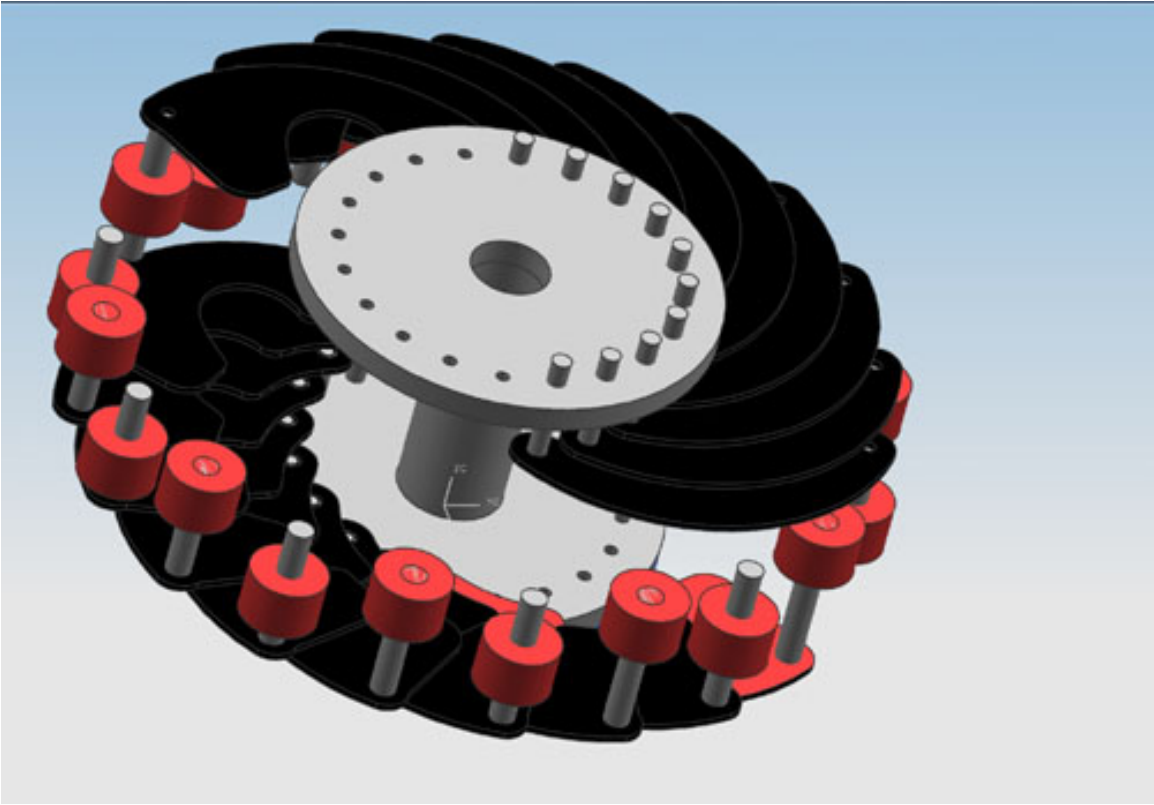
Figure 35: Design 2, isometric view, partially open.

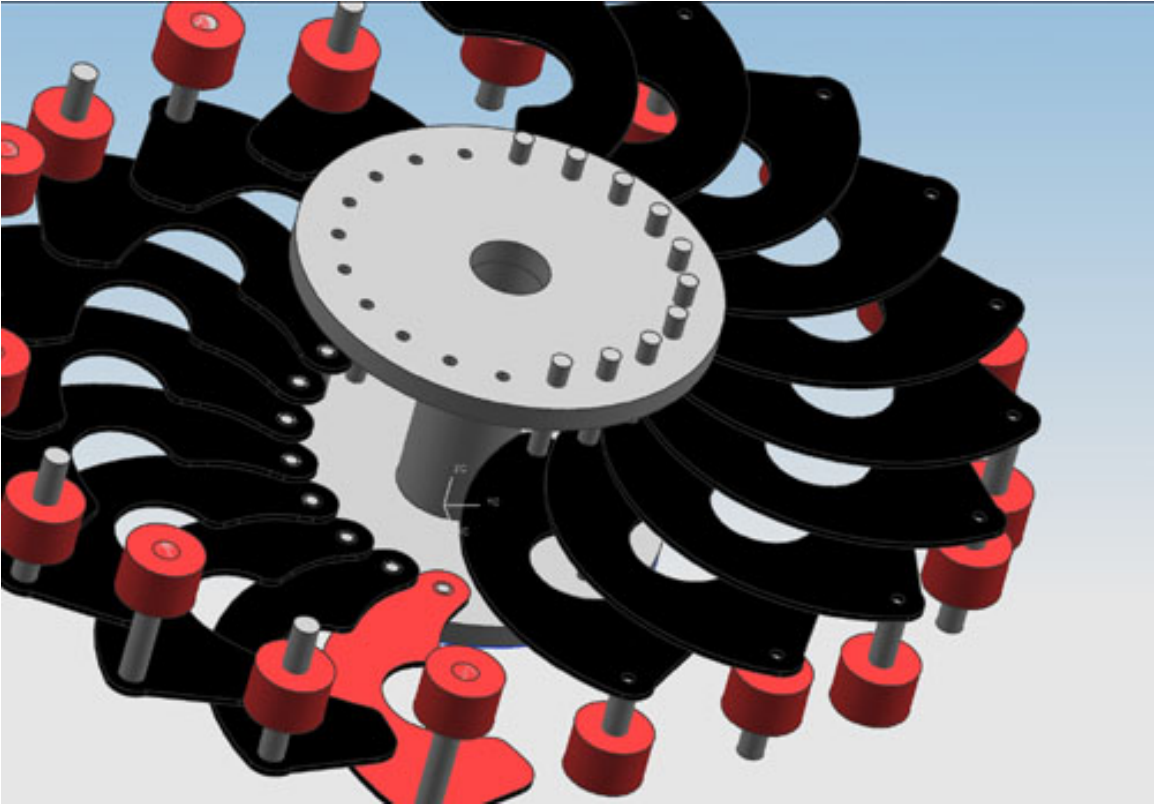
The shape of the arms were a result of the design itself. Although the face area was made as large as possible, provisions had to be made for the center rod of the module. Additionally, the overlap seen by each arm at full extension prevents them from slipping past one another ensuring the arms will be able to be retracted. This feature is evident in the next two figures. Figure 36 give a good indication of the separation between each set of arms. This separation, although forced by the design, helps reduce the amount of gas flow blockage. Even if there were not an axial spacing between the arrays, the module would create no more blockage than an orifice meter. Figure 37 shows the uniform spacing of the sensors.

Figure 36: Design 2, isometric view, fully open.

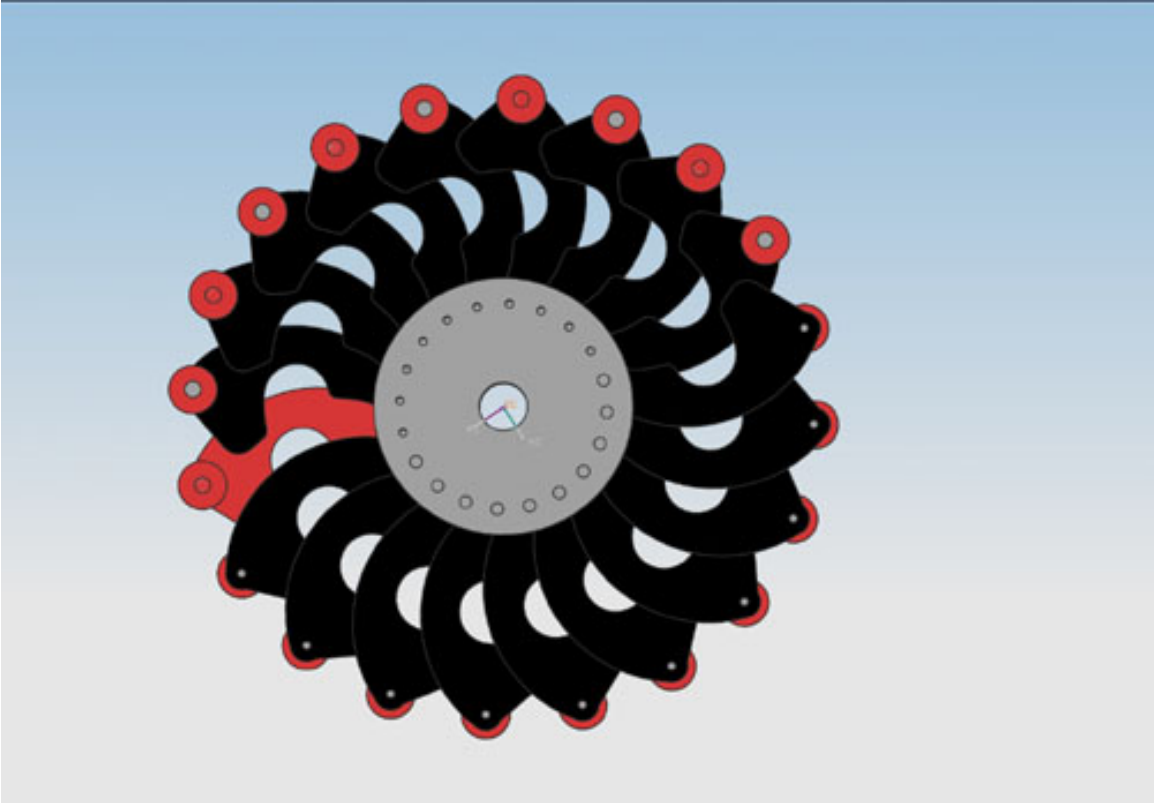
Figure 37: Design 2, top view, fully open.

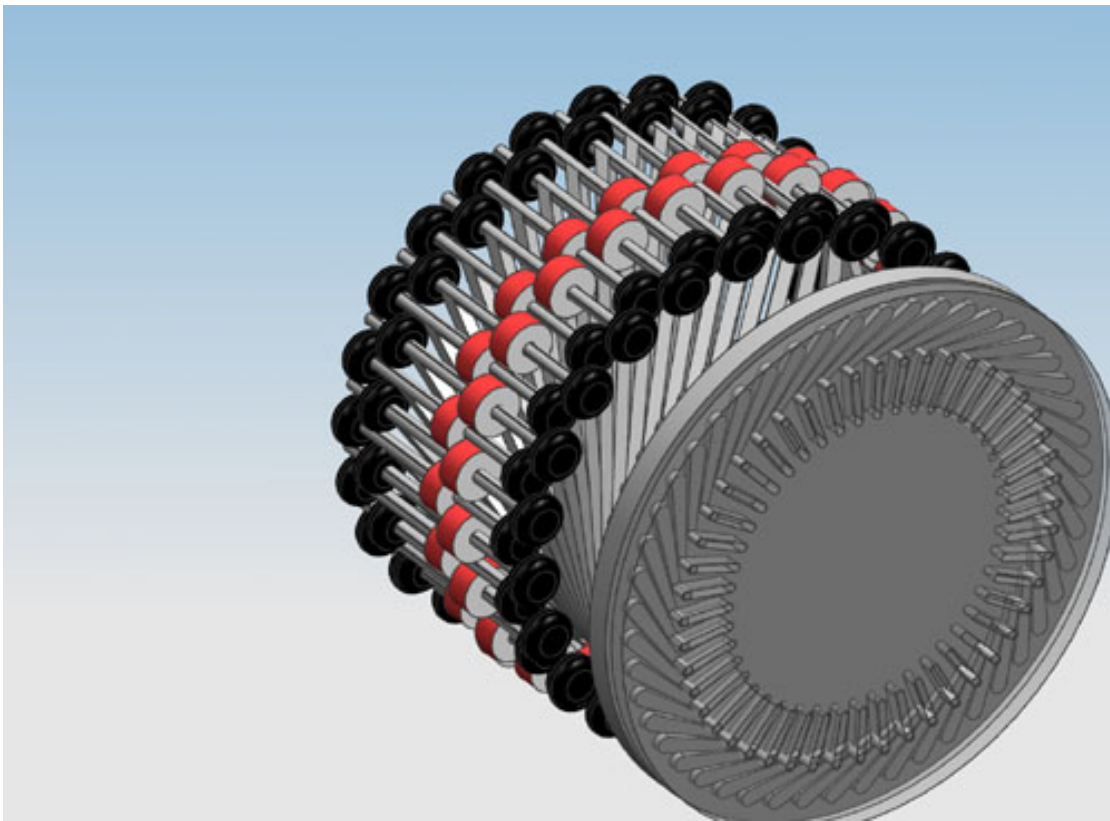
Since the required expansion ratio was smaller, making use of the entire radius was no longer necessary and so the arm design was made simpler. The arms used for this design were all identical and machined from a flat plate. Figure 38 shows the design in its closed state.

Figure 38: Final Design, isometric view, closed.

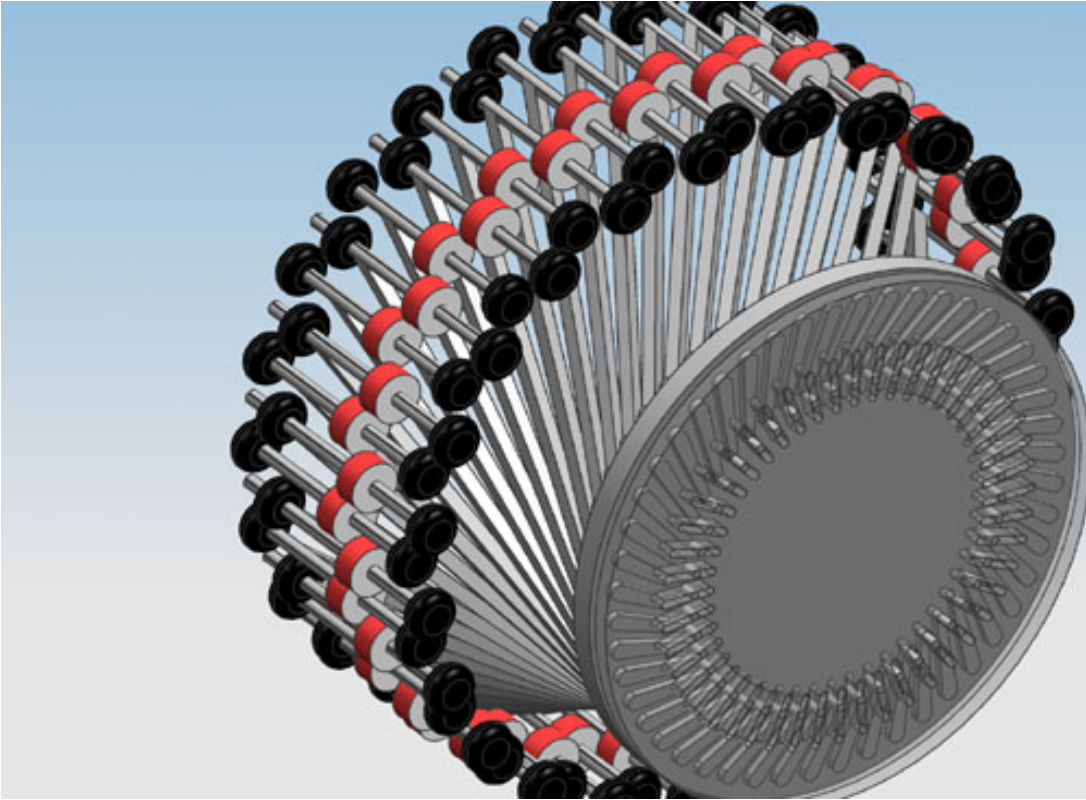
Forty-eight radial slots were machined out of an end plate. The slits allow the pinned end of a crank arm to slide. The crank arm serves as a connecting rod between the arms and the plates allowing the rotation of the plate to open the arms simultaneously. Figure 39 shows the device as the plate has been turned. The pins have traveled half the length of the slot. In Figure 40, the pins have traveled to length of the slot and are on the return as the arms are opened to their maximum position.

Figure 39: Final Design, isometric view, partially open.

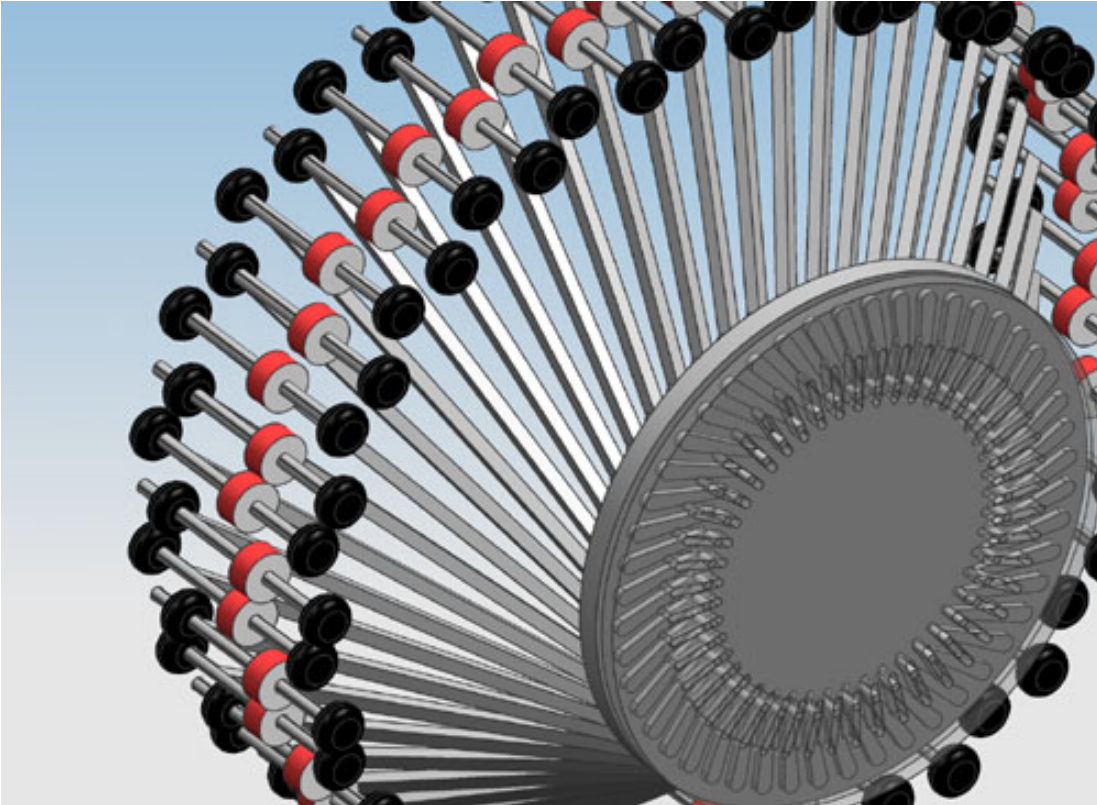
Figure 40: Final Design, isometric view, fully open.

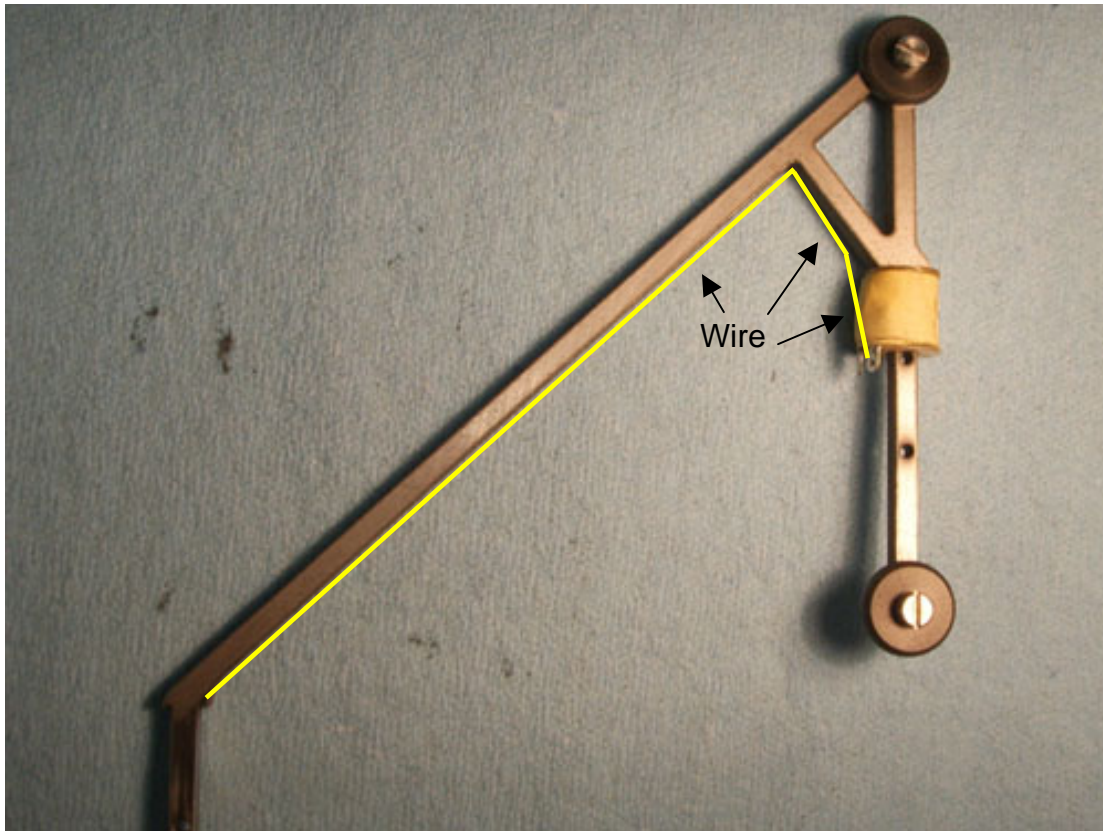
GTI built a prototype from the 10" to 16" design plans. The arms were water-jetted from spring steel to add some compliance. All the arms are identical and have holes to pin the sensors into place. The sensor placement is alternated from arm to arm so that they will nest with each other upon the arm assembly closing. After the sensors are mounted, wheels are attached as shown in Figure 41. The wheels serve to keep the sensors at a set location from the pipewall and prevent damage to the sensors by the pipewall. The design of the arm provides some protection for wiring between the sensor and the microprocessors. The wires would most likely be epoxied to the underside of the arm as depicted in the figure below.

Figure 41: Single arm with coil.
