Reduced Mandated Inspection by Remote Field Eddy Current Inspection of Unpiggable Pipelines

Technical Final Report

Reporting Period Start Date: October 1, 2005
Reporting Period End Date: September 30, 2006

Prepared by:
Gas Technology Institute
1700 S. Mount Prospect Road
Des Plaines, Illinois 60018

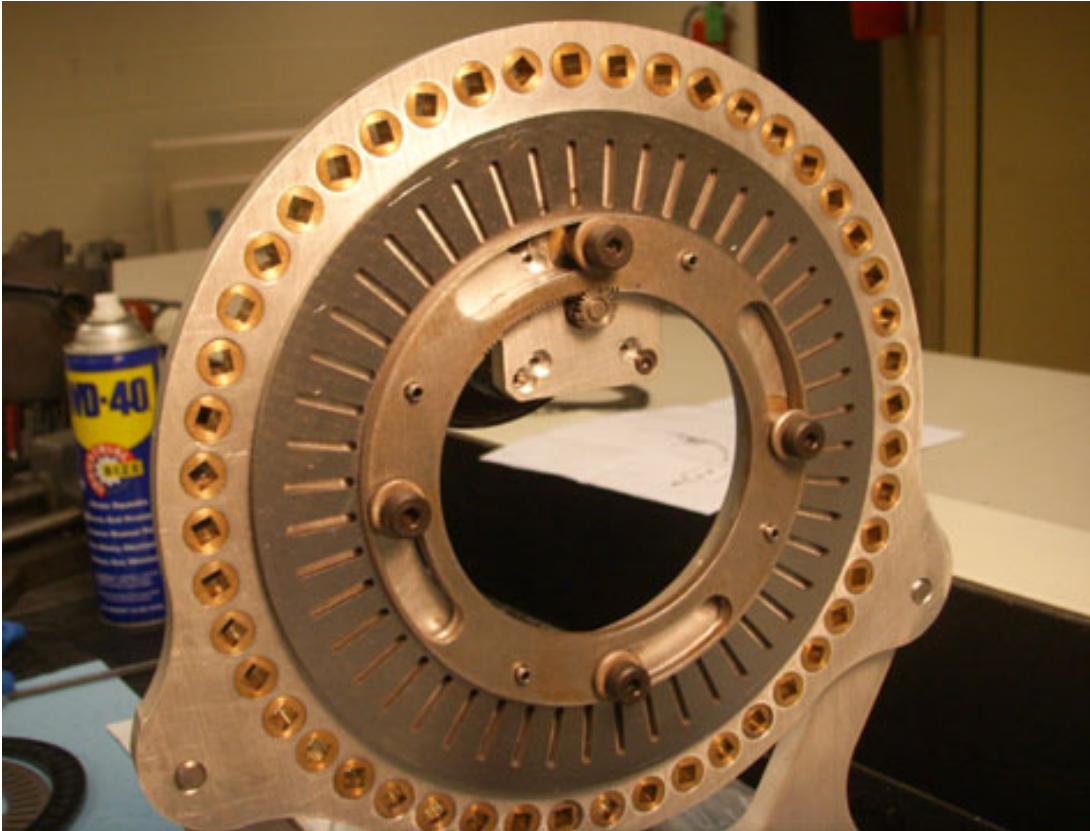
There is a ring mounted to the drive plate. The drive plate is allowed to rotate approximately 35° and is contained by bushings in slots on the ring.

Figure 42: Base plate, pre-mounting.

Motion is accomplished by gearing. The ring has teeth machined into the inside diameter. The motor and the gear mounted to it are shown in Figure 42 at the top, center position. When the gear turns, it drives the ring and drive plate. The drive plate's motion causes the pins on the crank arm to travel which causes the arms to turn.

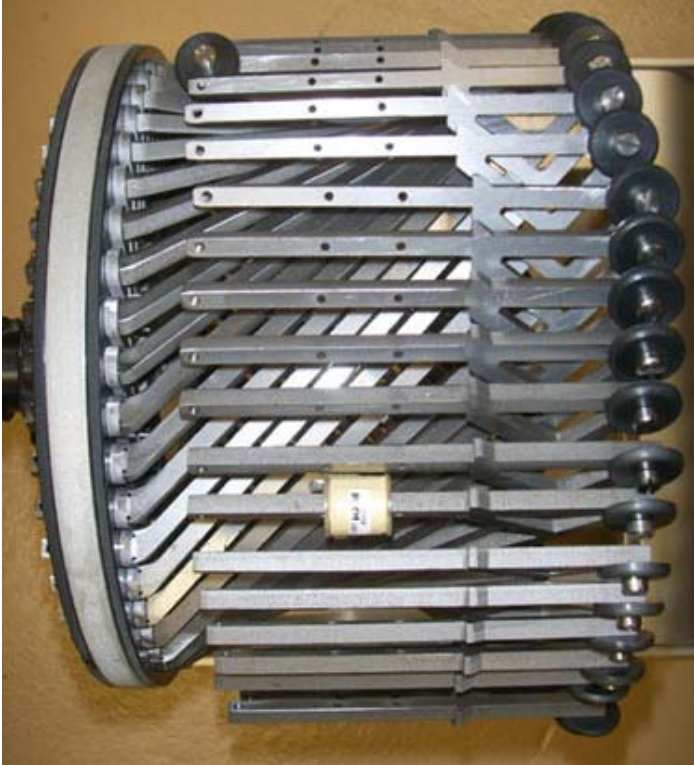
Figure 43: Module, top view, closed.

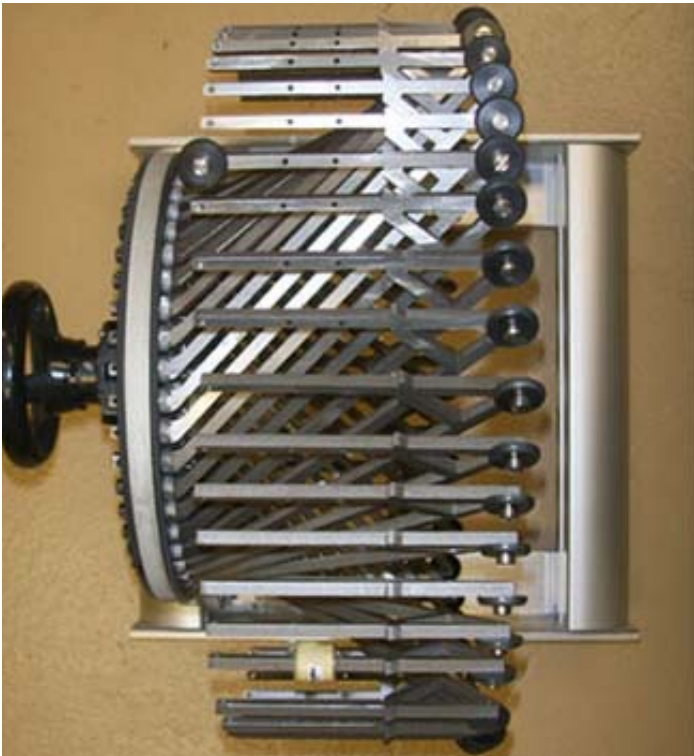
Figure 44 shows the module as the arms have opened part of the way. Note the amount of travel of the arm with the sensor.

Figure 44: Module, top view, partially open.

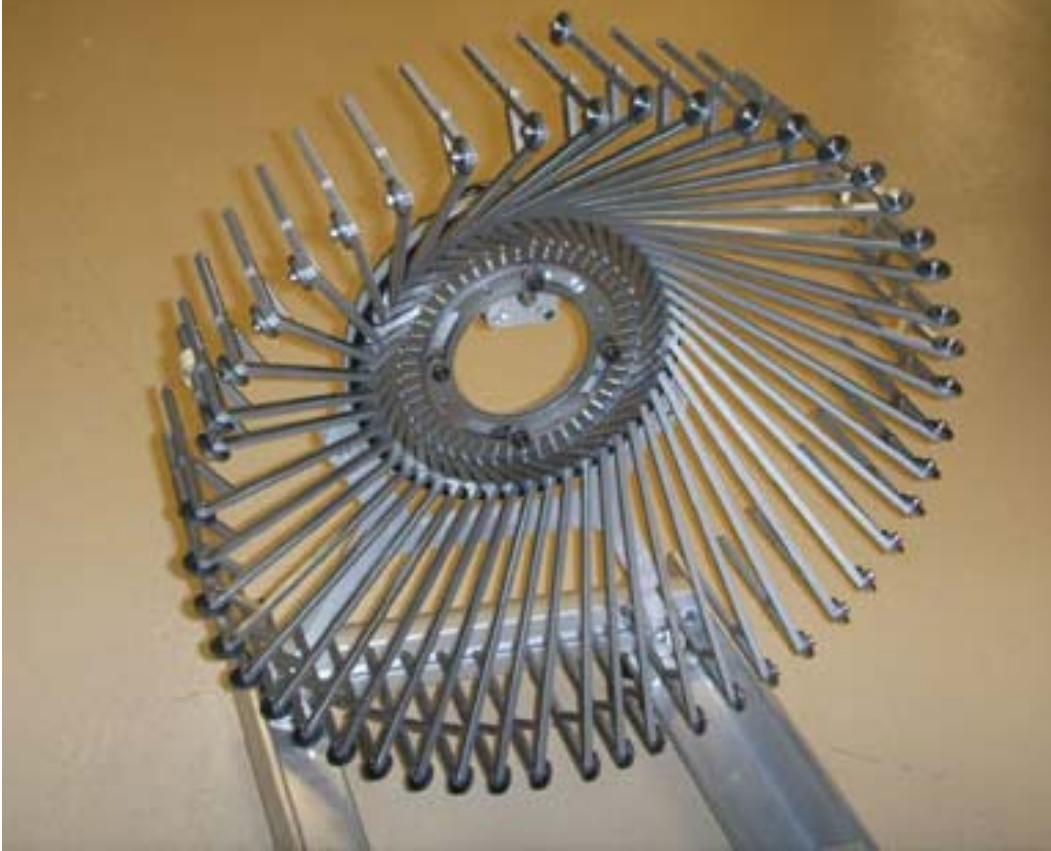
Figure 45: Module, isometric view, fully open.

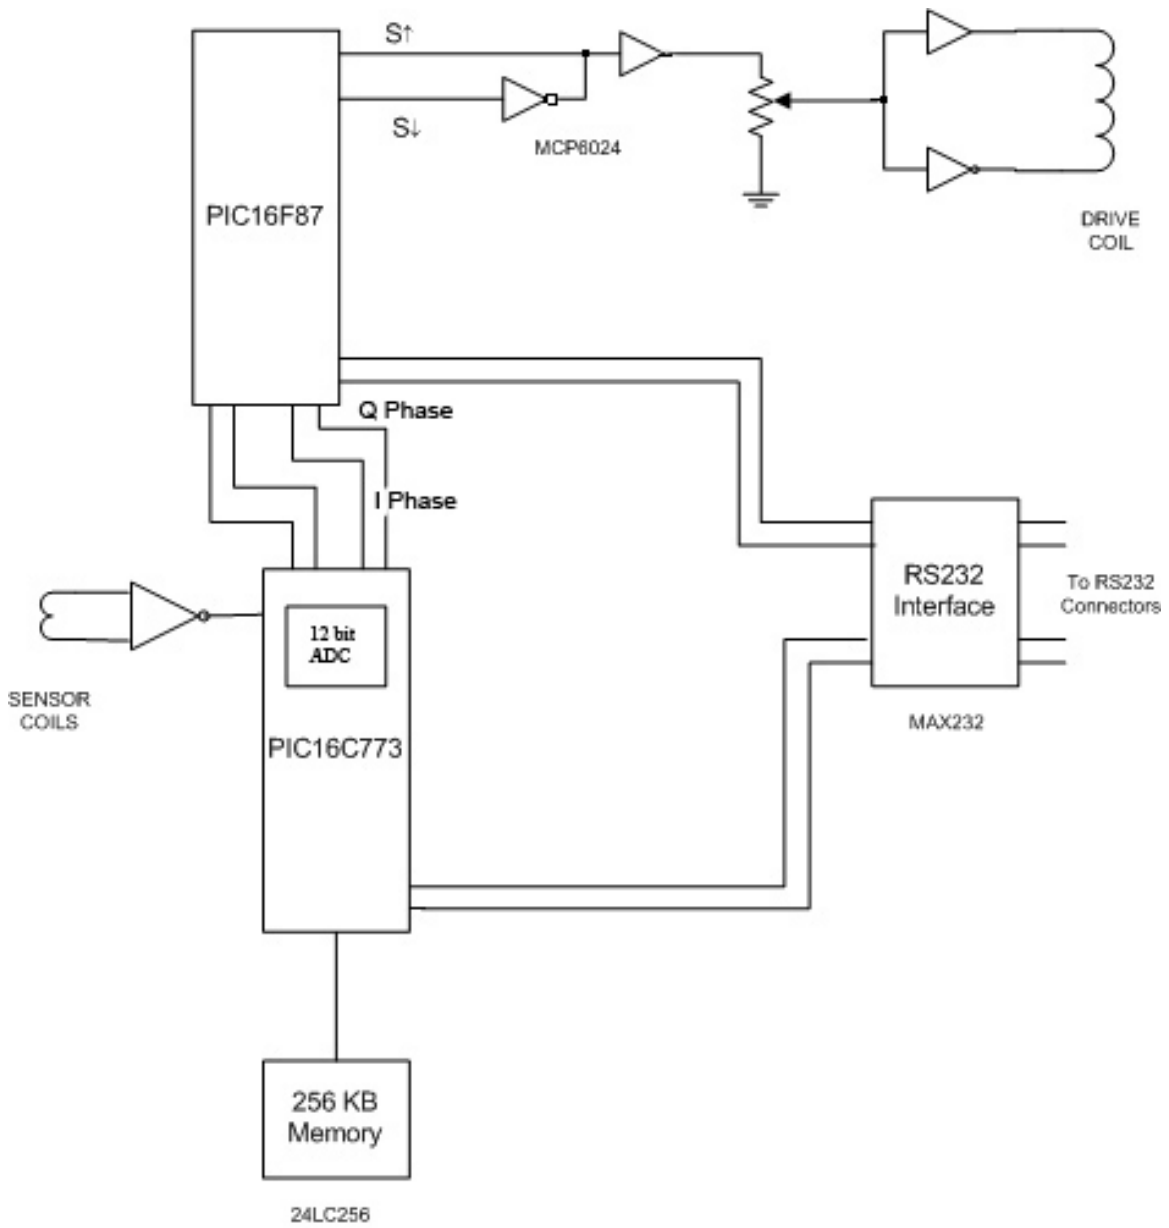
Figure 46: Block diagram of the electronic components.

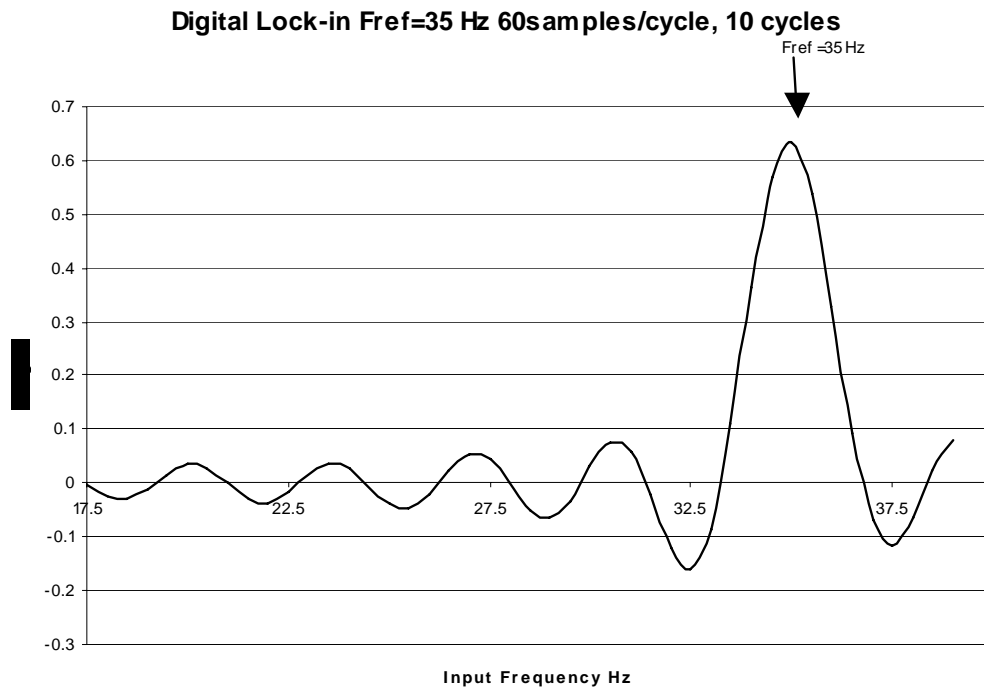
Digital lock-in amplifiers, programmed into the slave processors, are used to filter the input signals from the sensors. The method basically consists of summing the amplified sensor signals into In-Phase and Quadrature-Phase bins for a programmable number of cycles. Figure 47 shows the frequency response to sine waves from 17.5 Hz to about 40 Hz for a digital lock-in with a 35 HZ lock frequency integrated over 10 cycles.

Figure 47: Digital lock-in response as a function of frequency: the lock frequency was 35 HZ.

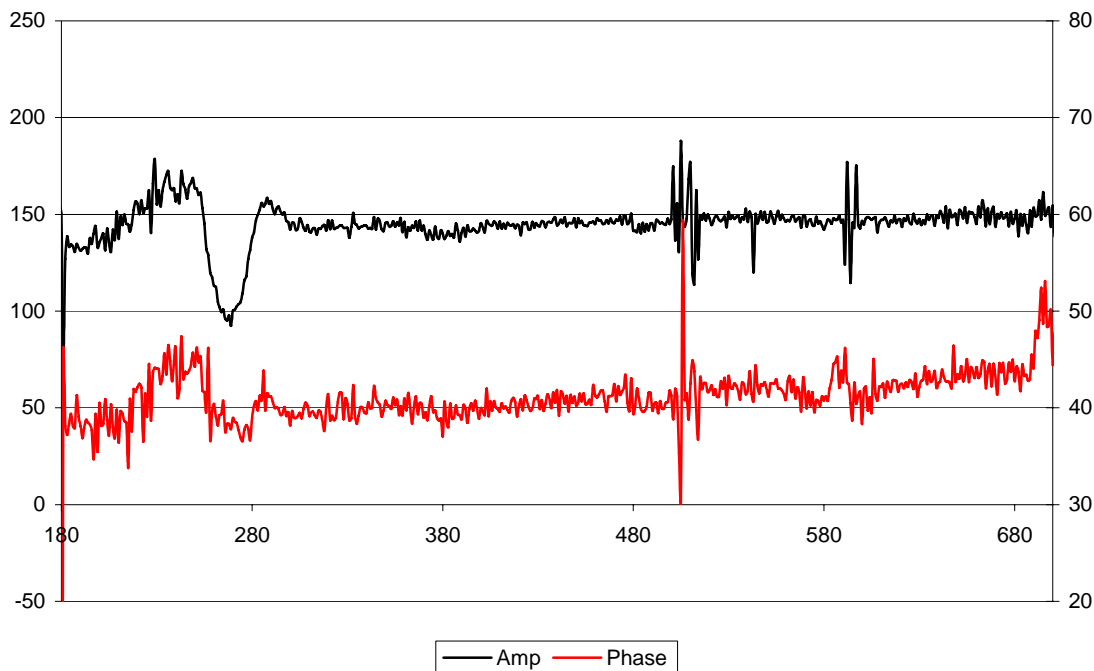
The master microprocessor and one slave processor were assembled and tested in the seamless 6" pipe with previously manufactured drive and sensor coils. Early results showed unacceptable noise that was traced to too much vibration of the sensing coils and too wide a bandwidth for the sensor signals. The system was modified to reduce mechanical vibrations. One of the better results is shown in Figure 48. The signal from a large ferromagnetic mass is easy to see. Also visible are signals from much smaller defects (see earlier sections of this report) machined into the seamless pipe. The noise is still larger than preferable, but further mechanical improvements and better filtering should reduce noise levels to where the defect signals stand out as clearly as obtained with standard laboratory equipment.

Figure 48: A test run of the electronic assembly using a master and one slave microprocessor programmed with a digital lock-in amplifier.
