A COMPARISON BETWEEN EMPIRICAL PROCEDURES FOR THE DEFINITION OF VULNERABILITY CLASSES OF MASONRY BUILDINGS: APPLICATION TO FIVE HISTORICAL CENTRES STRUCK BY 2016 CENTRAL ITALY EARTHQUAKE

YLENIA SARETTA^{1*}, LUCA SBROGIÓ¹ AND MARIA R. VALLUZZI¹

Keywords: Masonry, Vulnerability Classes, Damage Analysis, Strengthened Interventions

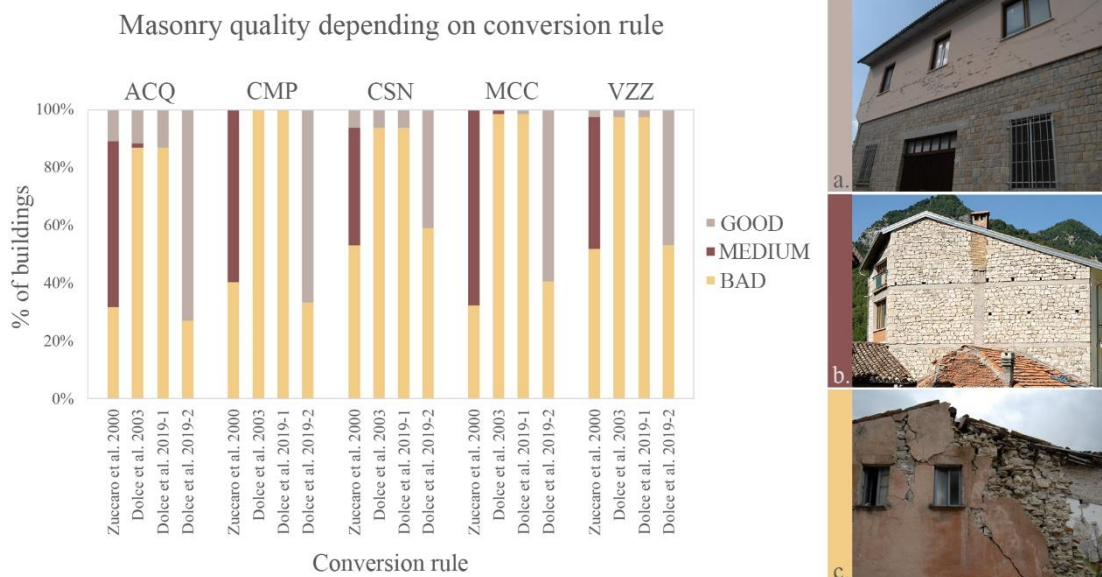
Figure 1: Masonry quality depending on conversion rule. On the right, some examples of masonry quality: a) good, CSN; b) medium, ACQ; c) bad, CSN

Figure 1 shows masonry quality as a function of the conversion rule. In the case of compresence of different masonry textures, the worst were considered. As one may see, *medium quality* results only from the application of [13], characterized by more possibilities in the structural combination, at the expense of the rapidity of the whole procedure. Results from the application of [14] and [9]–1 are similar, while a more precise interpretation of a building’s behaviour comes from [9]–2.

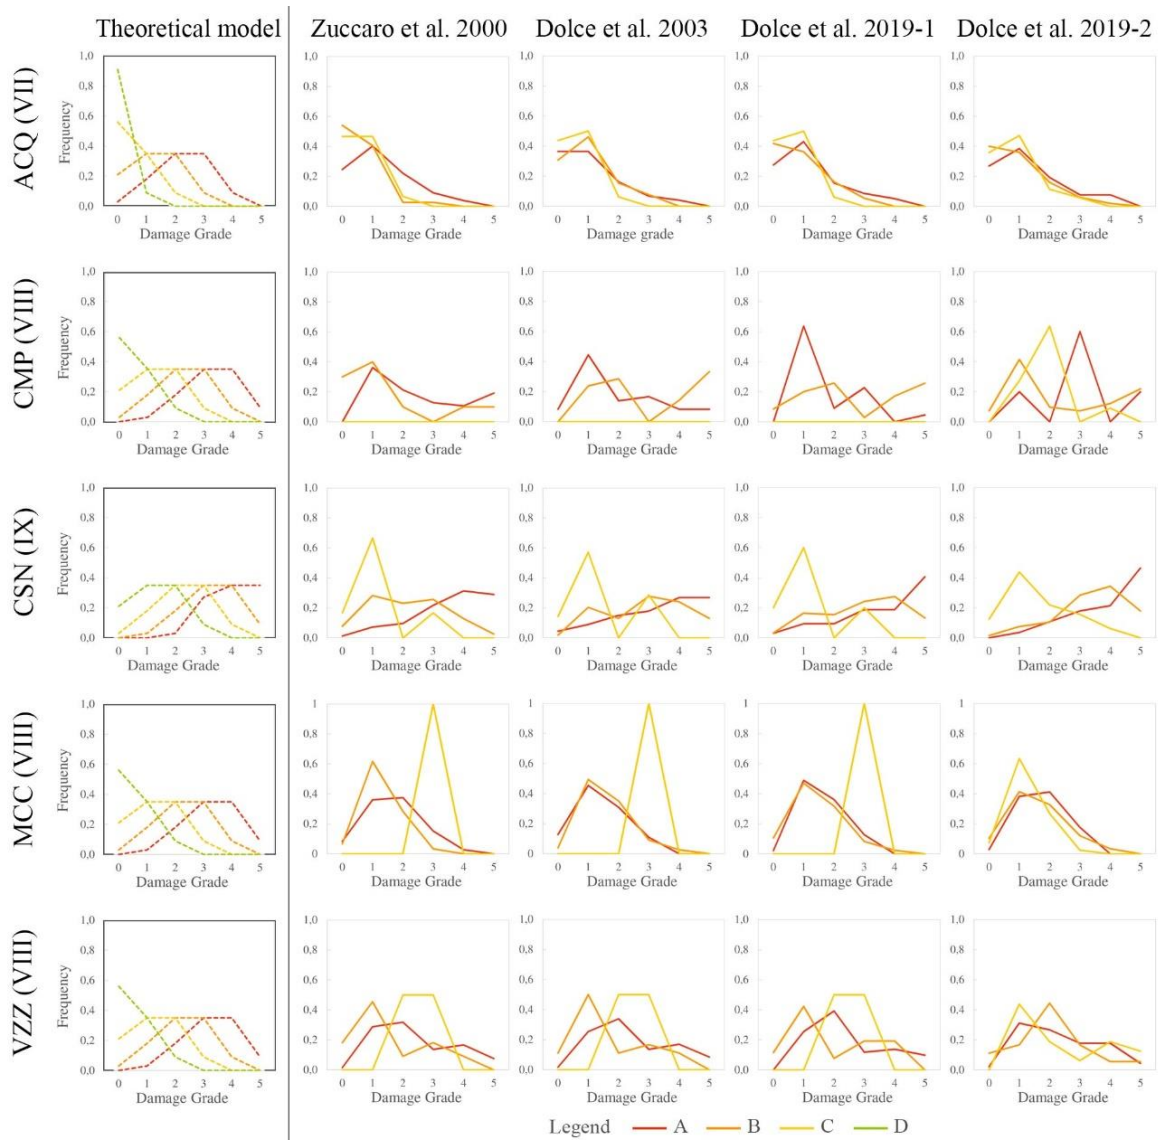
Figure 2: DPMs for surveyed centres. Application of conversion rules to the sample of buildings (from second to fifth column) and comparison with theoretical model [5] (first column, dashed lines)

The empirical DPMs of the sample were defined according to the three chosen conversion rules (Table 1) and considering also the two approaches for [9] (Figure 2). It is worth noting that class D is totally absent and only a few buildings belong to class C (Table 3). Class A is typical of most cases, especially with [13]’s rule, except for MCC, where the widespread rigid diaphragms cause a half of the buildings to belong to class B. According to [9]–1 rule, most buildings are classified as B, but in the case of ACQ the 12% of the surveyed dwellings are in class C, thanks to a better masonry quality (coursed layout). The application of [9]–2 allows to observe an increase of buildings in class C and a decrease in class A, except for VZZ where masonry’s original features are more preserved.

The obtained DPMs were compared to the theoretical ones, defined starting from the EMS-98 [5], with poor results. The recurring presence of peaks in low damage grades (D0 and D1) and an overlapping of damage grades for the three classes happen at low macroseismic intensity (ACQ, I=VII), differently from [5]. Similarly happens for I=VIII:

- in MCC, A and B classes overlap, D1 and D2 are the most recurrent damage grades, even though D3 and D4 should be the peaks according to [5];
- in VZZ a bimodal trend characterizes the damage grades of the two most vulnerable classes, with two frequency peaks in D2 and D4 for class A and in D1 and D3 for class B: as a consequence, B appears more vulnerable than A for [9]–1. One may suppose that the D2 peak for class A should describe buildings that actually belong to B or lower classes and that the D3 peak for class B could gather higher vulnerable dwellings;

- in CMP different results come out from each procedure.

In the case of CSN (I=IX), the first two procedures seem to be comparable to the theoretical model, although low damage for class A exceeds the expected, while [9]-1's procedure provides unfavourable results which could describe a I=X situation. More coherent results come from [9]-2's procedure, even though they cannot solve the contrast between the other procedures and the theoretical model. Therefore, the theoretical model derived from the EMS-98 is not coherent with the DPMs obtained from the conversion rules, although specifically adapted to the sample. Class A sometimes appears to be less vulnerable than B or they show the same damage grades. This fact may be explained with the compresence of buildings belonging to different vulnerability classes in the same group.

The application of the literature conversion rules to the data set (Figure 2) has highlighted their limits in the vulnerability classification. In fact, these procedures do not take into account the influence of structural strengthening interventions applied on buildings in a recent past, observing only the presence of tie rods or tie beams. The effectiveness of these connection systems on seismic behaviour is taken for granted, especially if they are associated to rigid diaphragms (cfr. Table 1 and 3). However, observations demonstrated that the effectiveness of tie rods is limited by masonry quality at the anchoring (Figure 3a, see also [25]), while r.c. curbs on weak masonries cause crumbling, overturning and sliding of the walls (Figure 3b, c) [21].

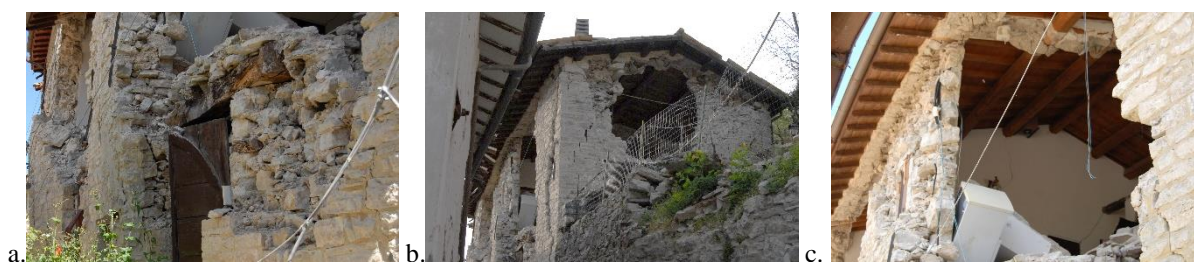
Figure 3: Examples of poor seismic behaviour in a strengthened masonry building, CSN: a) Not effective tie rods on bad quality masonry; b) overturning of last storey and c) of internal bearing walls due to r.c. curbs and to excess of stiffness and weight of reinforced timber roof

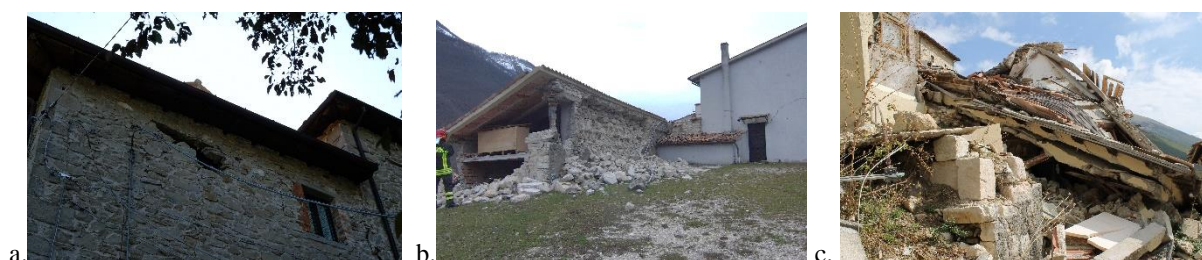
Figure 4: Examples of damage due to rigid roofs: a) Slip of the roof and horizontal arch (VZZ); b) Masonry leaves separation and local overturning (CSN); c) Total collapse due to crumbling of masonry (CMP)

Moreover, according to the conversion rules, the unconditional favourable effect of rigid slabs on a building's seismic behaviour yields to classes B or C. In the authors' opinion, on the basis of the empirical evidence, that could be true only in case of low levels of seismic input (Figure 4a), while near the epicentre rigid diaphragms on poor masonries induce crumbling phenomena and a building's collapse (Figures 4b and 4c). Therefore, the vulnerability increases, and the building is prone to suffer of a higher damage, as already appeared after the 1997 Umbria-Marche earthquake [27].

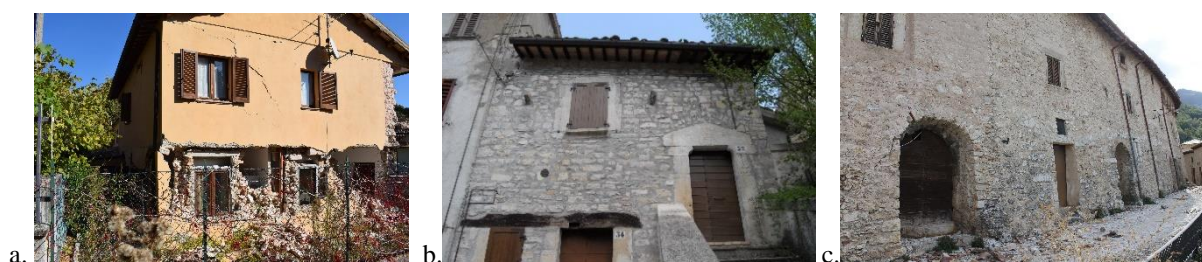
Figure 5: a) Class A building: poor masonry quality and floors replaced with rigid ones (MCC); b) C class building: random layout limestone masonry reinforced by deep repointing with cementitious mortar (CSN); c) D class building: random layout limestone masonry reinforced by grout injections and r.c. jacketing (internal side) (CMP)

Another problem of the literature rules is the limitation to the first three classes, among which class C generally defines buildings with artificial blocks or dressed stone masonries; this classification needs to be widened to better explain the real seismic behaviour. The issue has been recently discussed by the authors [21,23], underlining that buildings with holistic interventions could be actually described by class D, typical of new buildings (§1.1), while partial interventions yield class A. Original buildings without strengthening interventions (stone masonries and timber floors) belong to class A, such as buildings with original unreinforced stone masonries and replaced diaphragms with rigid or semirigid ones (Figure 5a). As well as recent buildings (Table 5), deep repointing and thick cementitious plasters on bearing walls allow to reach class C (Figure 5b), while core interventions, such as grout injections and r.c. jacketing, could lead to class D, regardless floors' stiffness (Figure 5c). Class B is not explicitly defined, but it expresses the possible range of vulnerability thanks to the structural details and the masonry quality.

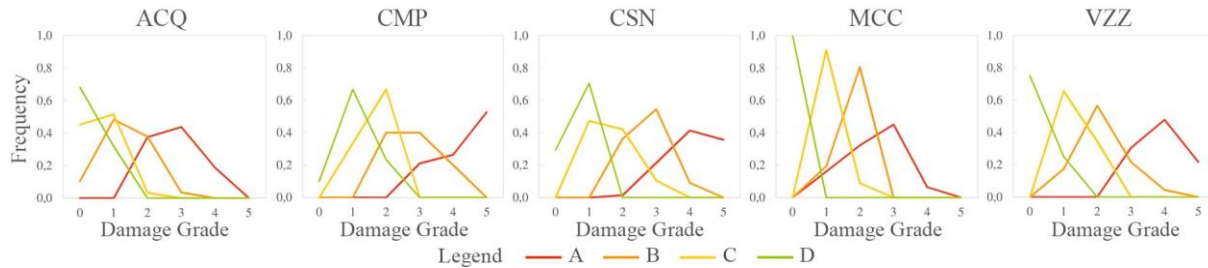
Figure 6: Empirical DPMs according to Table 5

Figure 6 shows the new DPMs derived from the proposed classification for the five case studies: the widened classification (from class A to D) better describes the observed buildings' seismic behaviour and the comparison with the theoretical model (Figure 2), with more coherent results. Bimodal trends have been removed, the use of class D and the spreading of class C for each centre lead to a better distribution of the six damage peaks.
