**A. Güemes\*, A. Fernandez-Lopez, P. Fernandez, A. Lozano**

## Detección de daño en laminados mediante sensores de fibra óptica

## Damage detection in Composite laminates by Fiber optic sensors

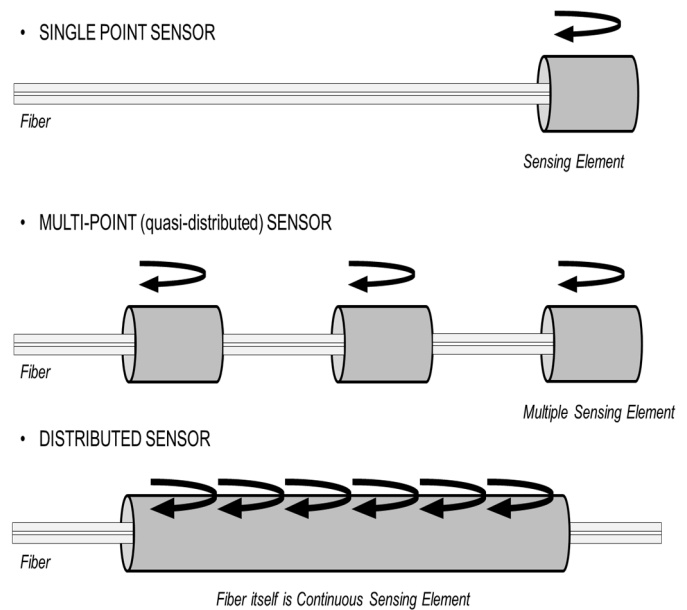
**Figure 1** Topology of Fiber Optic Sensors

Fiber Optic sensors (FOS) offer a very low size, the optical fiber has a diameter of 150 microns, so it can be embedded within a ply into the composite material during manufacturing. Other benefits for FOS are EMI/RFI immunity, wide temperature range, very long cabling if needed, because of the low attenuation, and the multiplexing capability (several sensors on the same optical fiber). As sketched at figure 1, three topologies are possible:

- Point sensor: detect measurand variation only in the vicinity of a single sensor. Example: micromirror at fiber tip. This is mostly used for chemical sensors, but also for EFPI.
- Multiplexed sensor: Multiple localized sensors are placed at intervals along the fiber length. i.e . FBG (sensor length 10 mm typical). About 10 sensors/fiber if multiplexed by wavelength, up to 1000 sensors by using OFDR (Optical Frequency Domain Reflectometry).
- Distributed sensor: Sensing is distributed along the length of the fiber, the optical fiber works simultaneously for transmitting the information and for sensing the local external variables (temperature, strain).

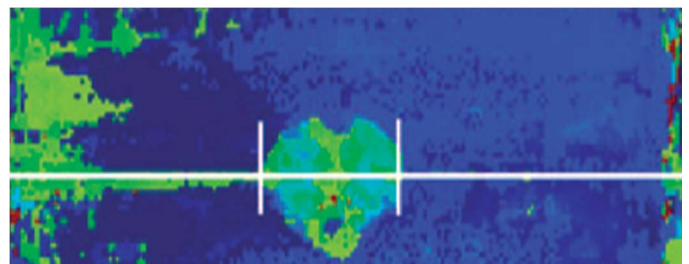
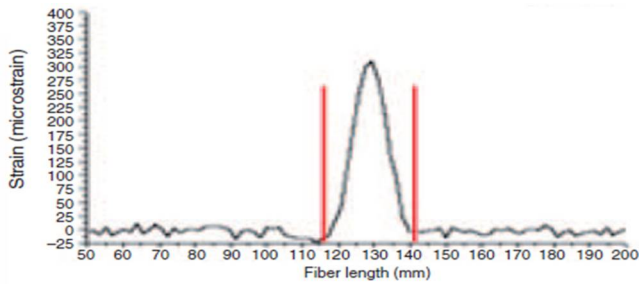
**Figure 3.:** Detection of the delamination caused by an impact; Ultrasonic C-Scan of the impacted laminate; (c) Strains measured along the white line of the upper figure by an O.F..

A sixteen plies crossply CFRP laminate was built from UD prepreg material by OOA (Out of Autoclave) procedures. A polyimide coated optical fiber was embedded inside the laminate during layup. The laminate was impacted by a drop weight test, and a delamination was produced. The white line show the position of the optical fibre, and the lower image (figure 3) show the strains measured by the optical fiber along this line. It can be seen the appearance of residual strains at the delaminated area. Worthy to mention strains caused by damage are significant, with a peak of 300 microstrains, and the delaminated length is perfectly depicted, 25 mm. In fact, the delaminated area can nearly be plotted if the optical fiber follows a crooked path, with parallel fibers every 5 mm. The strain field map of the area can be obtained with relatively high accuracy.

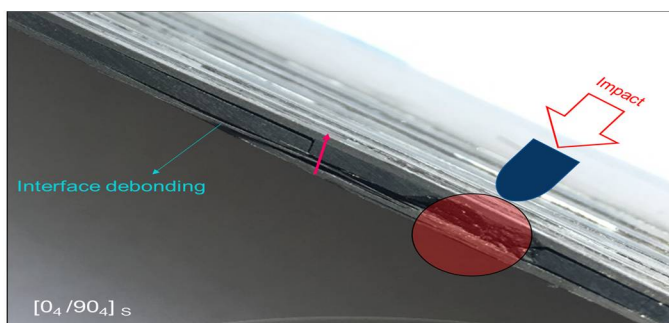
**Figure 5.** Delamination caused at a ( $0_4, 90_4$ )<sub>s</sub> CFRP laminate after a 5 J on-edge impact

The laminates were submitted to impacts of controlled energy, by using a drop weight test machine, both perpendicular to the laminate and on-edge direction. The energy was gradually increased until a visible damage was produced (figure 5), and the residual strains were recorded after every impact (figure 6).

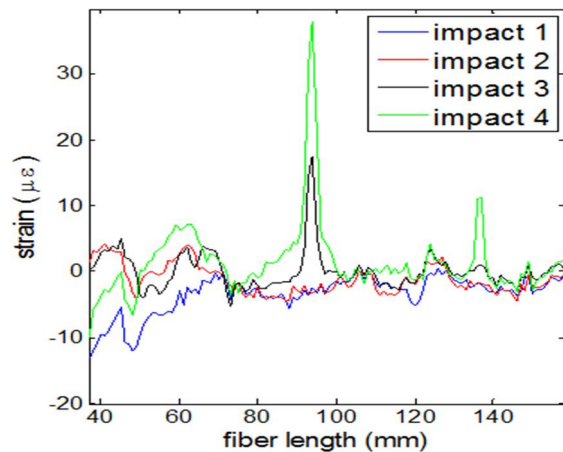
**Figure 6.** Strains recorded by the optical fiber after successive impacts of increasing energy, from 2 to 5 joules. The two identifiable peaks recorded at 100 and 400 mm are for the first and second loops of the optical fiber, respectively

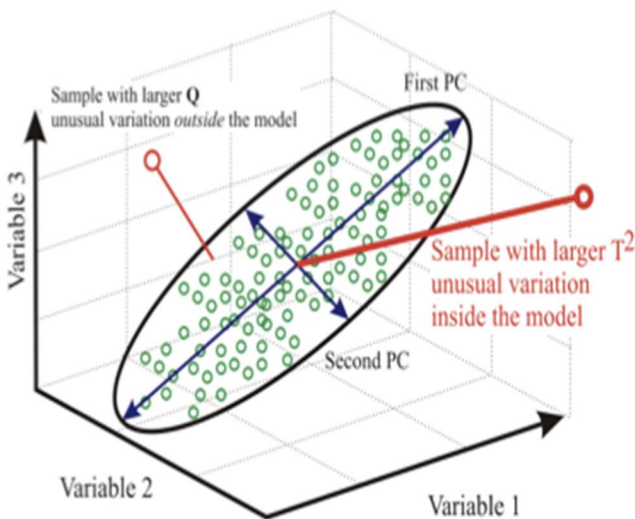
Fig 7. Schematics of the PCA algorithm. Firstly identify a new coordinate system which reduce the dimensionality of the data set. Secondly, identify if new data fits or not inside the former reference system.

Many algorithms are available to handle large data sets, one of the simplest and more effective approach is called Principal Component Analysis (PCA). PCA is a simple and non-parametric method of extracting relevant information from confusing data sets. It provides hints on how to reduce a complex data set to a lower dimension, revealing some hidden structure/patterns or abnormal data. This is done by converting a set of data of possibly correlated variables into a set of values of linearly uncorrelated variables called principal components. Textbooks and software tools are available explaining the use of PCA, and also related articles dealing with application of PCA to SHM [20], so only a brief explanation is given here. The steps to follow are:

1. Organize the data set as  $n \times m$  matrix, where  $n$  is the number of tests (each load case or load increment is a new test) and  $m$  is the number of measured variables (sensors) .  $X$
2. Normalize the data to have zero mean and unity variance

3. Calculate the eigenvectors-eigenvalues of the covariance matrix.  $C = X X^T$
4. Keep only the first eigenvectors as the principal components. Baseline
5. Project any new collected data into the former Baseline
6. Identify if new data follow global trends (Damage Index)

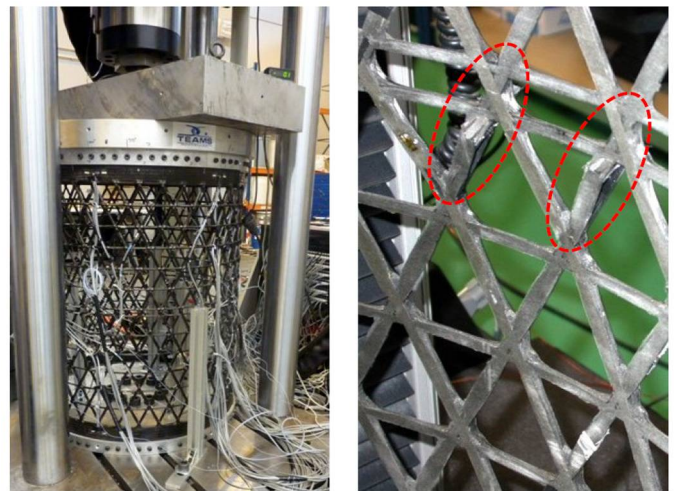
Figure 8. Isogrid structure under compression test. Detail of broken bars after exceeding the max. load

A large size structure, 1100 mm height and 800 mm diameter, has been manufactured by automatic tape laying process using high modulus graphite fiber and out of autoclave curable resin system. It was instrumented with 36 FBGs and tested to failure under compressive loads (figure 8). First failure happened at -330 kN, with some broken bars, but still the

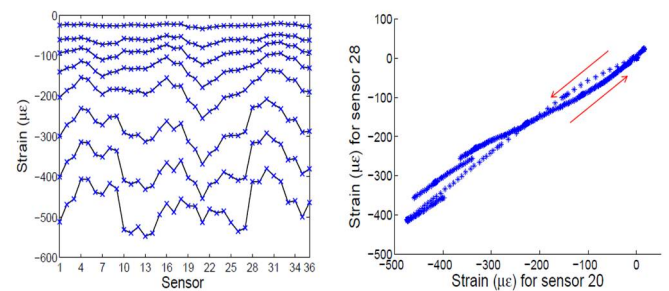
Figure 9. Isogrid structure under compression test. Detail of a broken bars after exceeding the first failure load

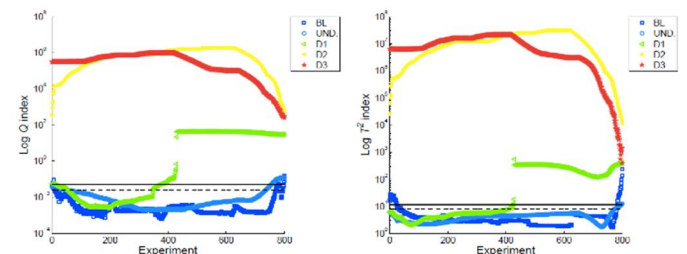
Figure 10. PCA algorithm applied to isogrid strain data. Blue lines are damage indexes calculated from strains acquired on the undamage structure, each experiment means a new data acquisition (load level); green line correspond to data taken under increasing loads, first failure happened at test 400.

The application of the PCA algorithm to the former data set is straightforward, with quite good results (Figure 10). Worthy to mention that there is no need to prepare the data, neither a FEM model. It is only needed to arrange the X matrix (36 X 800), there were 36 sensors, and 800 measurements were taken to generate the baseline. Next measurements, projected on this baseline, easily discriminate the load which produce the first failure, and after that, next measurements have a clearly detectable damage index.

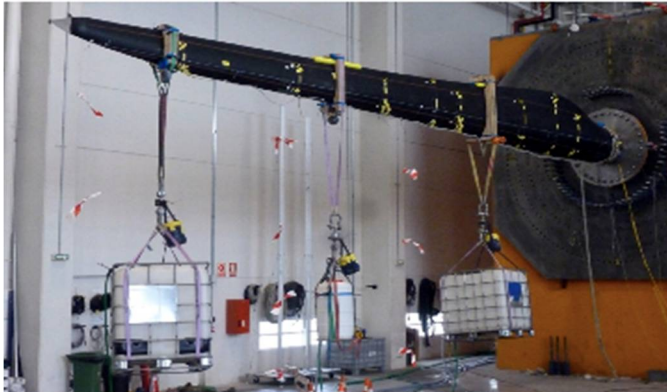
Fig. 11. PCA algorithm applied to isogrid strain data.

Compared to the former case, this experiment has two added difficulties: Firstly, the load cases are not as simple as it was for the isogrid structure, always uniformly distributed compressive loads of increasing values. As shown at Figure 11, different load cases, or distribution of weights were loads were applied, may be done; consequently, it will be found that there is not a single dominant Principal Component, the first three components play a similar role.

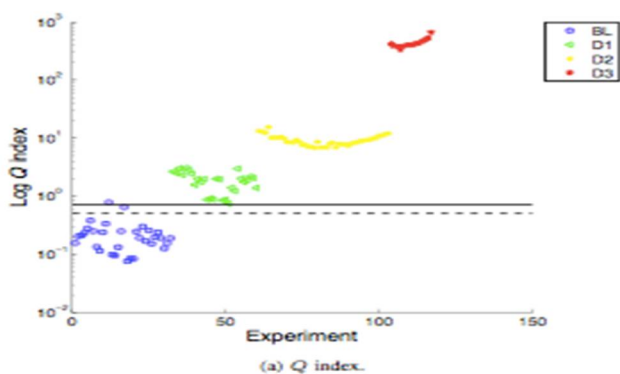
Figure 13. PCA algorithm applied to the Wind turbine blade

The damage index was calculated, and it was found that when debonding was 100 mm long, it was clearly detectable. Results are shown at figure 13, green dots. Obviously when new damages were inflicted at the main spar, as load carrying member, they were more easily detectable.
